EARTHQUAKE HAZARD CENTRE NEWSLETTER

Vol. 20 No. 4

APRIL 2017

Summary of the paper “Performance of Masonry and Concrete Buildings During M7.8 Gorkha (Nepal) Earthquake of April 25, 2015”

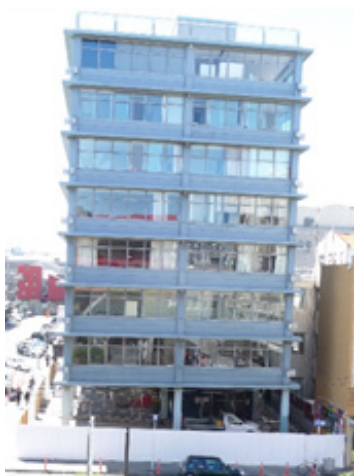
As seen in Figure 1, this is obviously not the case here. The lateral resistance is provided by frame action from the spandrel or upstand beams and relatively small section reinforced concrete columns. By today's standards, this building exhibits what we call 'critical structural weaknesses', and these have led to the building being seismically retrofitted.

Figure 1. Elevation of the building being retrofitted. Note weak columns and strong perimeter beams.

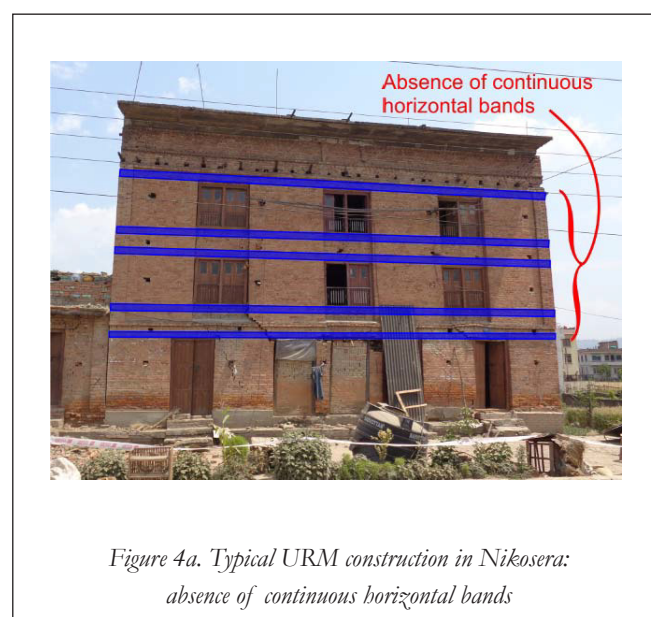
Unreinforced masonry buildings were the most prevalent building type before masonry infilled RC structures became popular in Nepal. Many 50-60 year old unreinforced masonry buildings in Bhaktapur were severely damaged not only due to their deteriorated strength but also due to their inherent structural defects. The box-like action achieved by integrating peripheral walls in unreinforced masonry buildings is an important earthquake resistant feature. The provision of continuous horizontal bands at different levels of the building helps in maintaining structural integrity with all walls and floor diaphragms acting together as a single unit under lateral loads. However, in most of the collapsed buildings, it was observed that there were no horizontal bands connecting the wall units (Fig. 4a). The cross walls in this type of construction were simply butt jointed and had no interlocking features which resulted in their separation by the formation of vertical cracks at the corners (Fig. 4b). However, as per the present Nepal National Building Code, at the junction of two or more walls, reinforcement in the

Figure 4a. Typical URM construction in Nikosera:
absence of continuous horizontal bands

form of timber or steel should be provided to integrate the box action for the peripheral walls. Due to the absence of positive connection between the walls at corners and at T-junctions, these walls behaved as free-standing slender walls subjected to large out-of-plane seismic forces due to their heavy mass which often exceeded their capacity. Thus, these separated walls were vulnerable to out-of-plane collapse and many failed during the shaking.

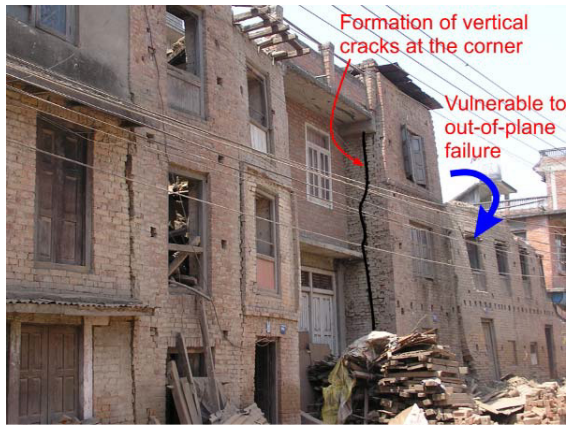
Figure 4b. Typical URM construction in Nikosera: formation of vertical cracks at corners which resulted in separation of cross wall from main wall

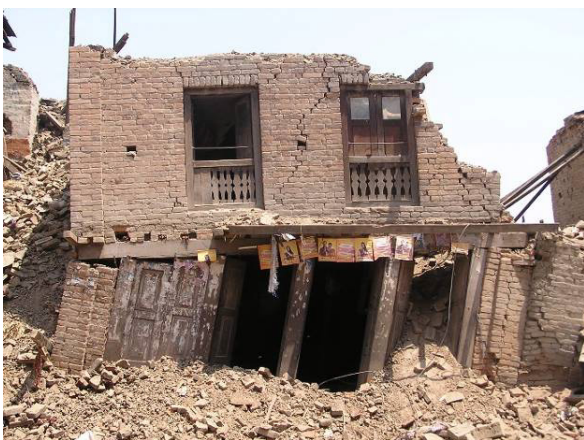
Though the out-of-plane failure of walls in unreinforced masonry buildings was more common, the in-plane damage by step-type diagonal cracks in masonry walls extending to the full storey height was also observed

Figure 5a. URM buildings failures in Nikosera: collapse of three storey unreinforced masonry building

which further reduced the out-of-plane strength of walls and increased the risk of out-of-plane collapse (Fig. 5a). From the failure pattern of building shown in Fig. 5b it can be observed that the in-plane damage was followed by out-of-plane collapse. Closely spaced large openings are detrimental to the seismic performance of masonry structures, which was also observed in the partially collapsed URM buildings in Bhaktapur and provision of openings of irregular sizes is also not a good earthquake resistant practice.

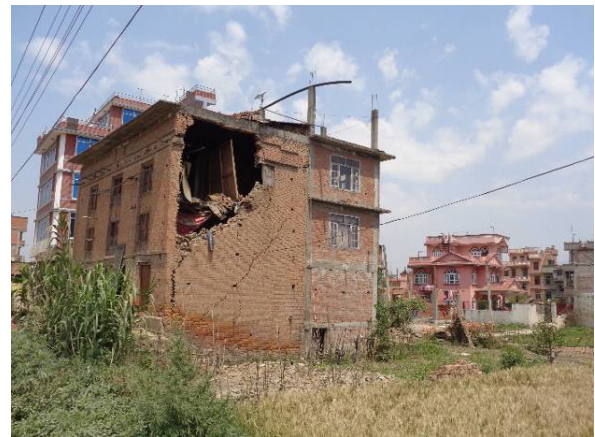
Figure 5b. URM buildings failures in Nikosera: combined in-plane and out-of-plane failure of the wall

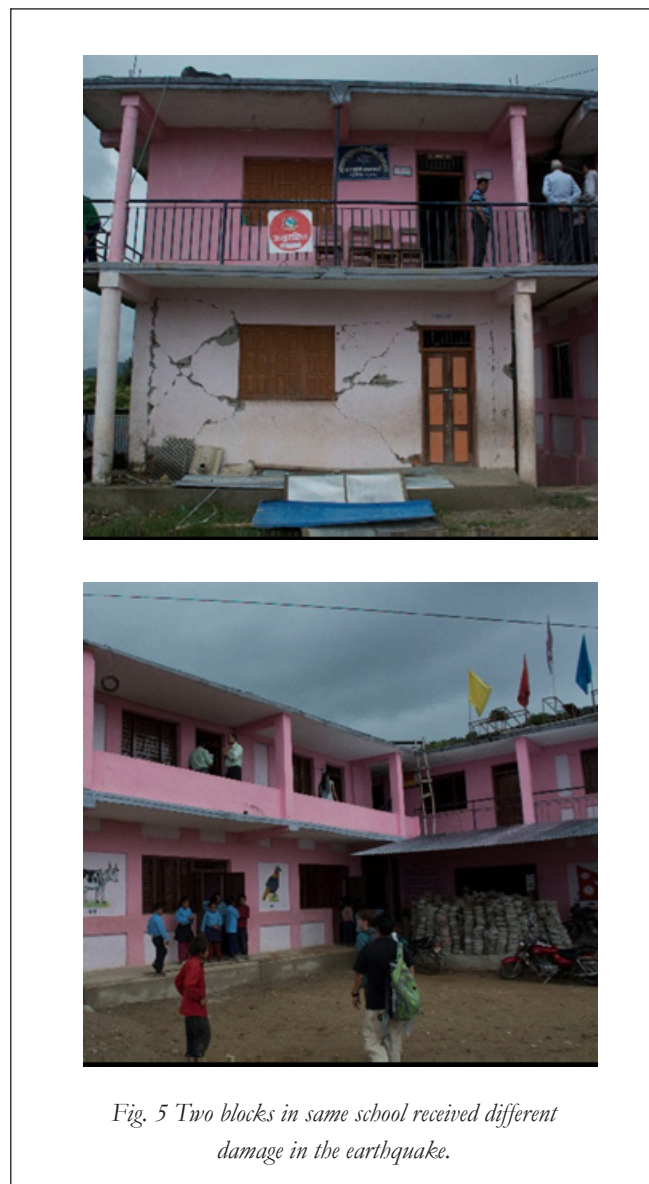
Fig. 5 Two blocks in same school received different damage in the earthquake.

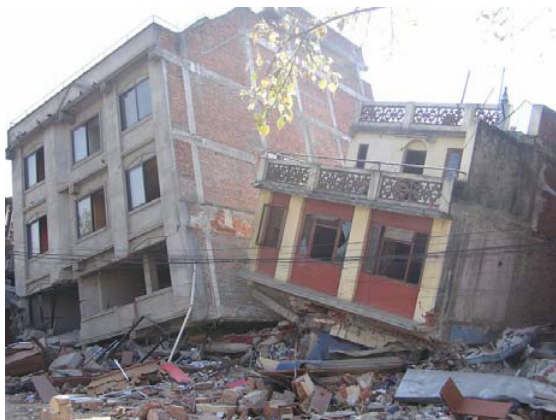
Four storey buildings in Sitapaila, Kathmandu

Buildings with open ground and weak storeys are infamous for their poor behaviour in the past earthquakes and this event was not an exception. Many open ground storey buildings collapsed completely due to soft/weak storey mechanism (Fig. 6). Buildings which were partly used for commercial purposes collapsed, often with pancaking of floor slabs, due to open ground and intermediate storeys in the absence of infills. The collapse of these buildings was primarily triggered by the formation of soft/weak

Fig. 6. Open ground and weak storey failures

storey mechanism due to the inadequate wall area, small sizes of RC frame members and poor reinforcement detailing at critical locations.

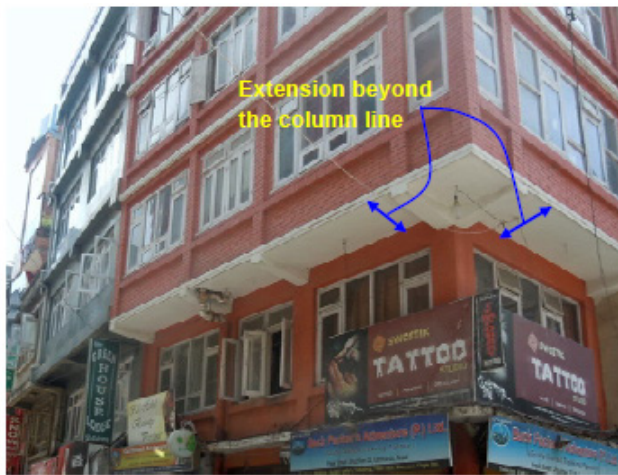
*Fig. 7. An example of RC building with upper storeys supported on long cantilever slab or beam, and
(b) a building with very large length to width ratio (L/B)*

are supported on long cantilever slab or beams (Fig. 7a). Buildings with aspect ratio (such as length to width ratio and height to width ratio) much larger than the code prescribed value of three were surprisingly common in the region (Fig. 7b). Such configurations are generally weak in resisting lateral forces and buildings with such plan and vertical irregularities which did escape with minor damage this time are likely to suffer severe damage in case of stronger shaking expected in the design level earthquake. Many buildings in the worst affected areas were built very close to each other and in many cases with almost no gap between them as they extend up to property lines. Pounding of such buildings either led to chain of collapses involving surrounding buildings or left them leaning out of plumb.
