EARTHQUAKE HAZARD CENTRE NEWSLETTER

JULY 2016

Preliminary Reconnaissance Report on Building Damage from the 2016 Kumamoto Earthquake

Performance of RC Frame Structures with Brick Infill

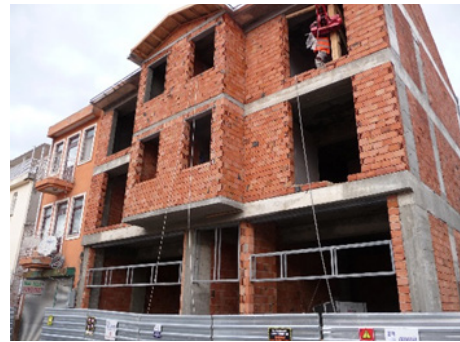
The first issue we notice is the use of masonry infill walls built at the tip of the cantilever slab. First, there is no problem concerning this layout from the perspective of gravity loads. Clearly the cantilever is strong enough to take the dead loads of the wall. It might deflect a little over time as its concrete creeps, but let's assume any additional deflections are within the acceptable range. However there is likely to be a problem during an earthquake. When the ground shakes parallel to the street, because the wall supported by the cantilever is not separated from the cantilever slab above, any horizontal deflection of the floor above will push the top of the wall in the direction of its length. The wall will experience shear forces and its bending moment will induce additional vertical compression and tension loads onto the cantilever. Since the cantilever won't have been designed for the additional compression loads it is likely to fail. Falling masonry will pose a considerable risk to life.

Another aspect of this building that is of concern is the hazard created by unreinforced and unrestrained masonry infills. All these walls are likely to perform poorly in an earthquake. Due to both the interstorey deflections of the frames and the inertia forces acting on the faces of the walls it is highly probable that collapse will occur in a moderate to severe earthquake. We just need to look at photos of this sort of construction that are taken

Figure 1: The front of the apartment building as seen from the street.

So how might we improve similar buildings? First, we would use non-masonry lightweight walls above the cantilever slabs. Due to their relative flexibility any additional vertical loads they would apply to the cantilever during an earthquake would be negligible. Next we would place a strong moment frame along the front of the building. This would consist of far deeper columns and perhaps deeper beams as well. And finally, we would either separate the infill walls from their frames and provide some them with some type of reinforcement and steel connections to the main structure to prevent collapse, or alternatively design and construct them as confined masonry walls.

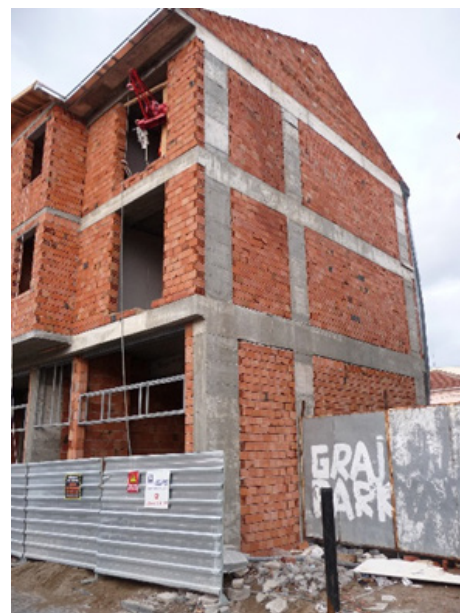
The next issue we note is the possible absence of primary structure to resist loads parallel to the street. The columns and beams of frames normal to the street are clearly seen (Figs. 1 and 2) but there is little strength in the other orthogonal direction. Perhaps the columns nearest to us are expected to form a frame in that direction. But this is unlikely. The front beams do not frame directly into the column. This situation is even worse at the second floor where the beam is set-out from the end of the column. Perhaps there are some concrete walls or a strong RC frame at the rear of the building. That would definitely improve seismic performance, but then quite a high torsional moment would occur due to the resistance in that direction not being placed symmetrically in plan.

Figure 2: An end wall of the building.

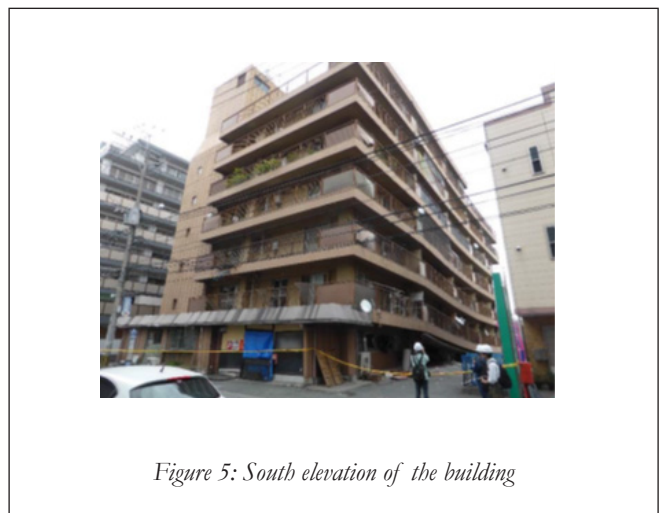
1. Structure: 7-storey reinforced concrete, without basement, setback on the top floor
 Building use: Apartment
 Damage outline: Storey collapse of 1st storey
 Building description : L-shape floor plan with first floor columns.

Figure 5: South elevation of the building

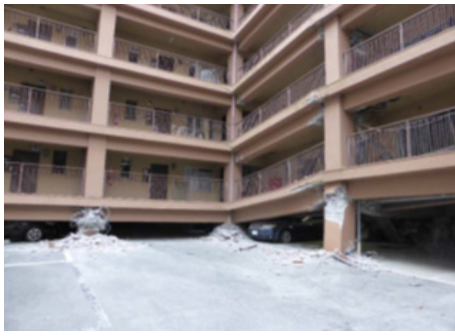
- 5 bays in the longitudinal direction and 4 bays in the transverse direction
- 1st storey collapsed due to formation of plastic hinges at the top of the columns in the main shock (Figs. 5 - 7)

Figure 6: Soft ground floor or 1st storey collapse in the north east frame

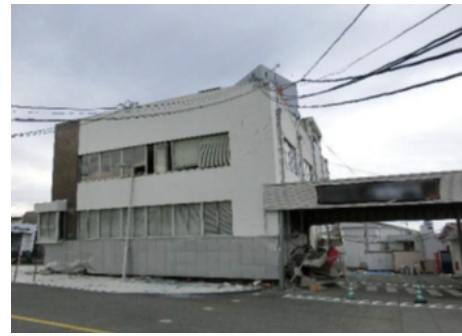
Figure 9: Southern view. The whole ground floor has been lost.

- 4 bay by 2 bay building structure
- West and south facade at the first floor had no walls due to shop windows.
- Longitudinal and transverse reinforcement of column found to be round bars.
- First storey collapsed with the south side of the second floor touching the ground (Figs. 8 - 10)

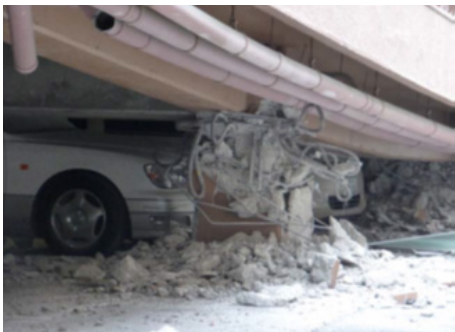
Figure 7: Crushed column in south frame

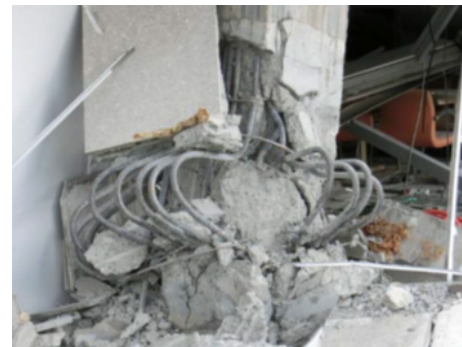
Figure 10: A crushed column

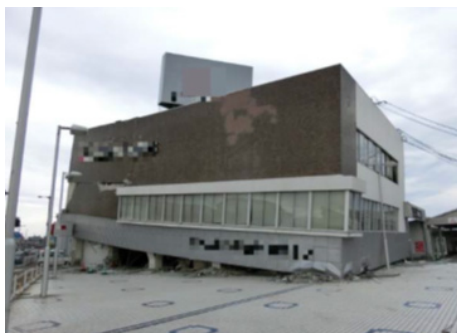
Figure 8: View from the west

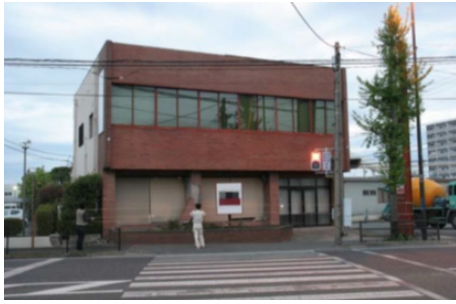
- Building frame consists of three bays in the longitudinal direction and one bay in the transverse direction. Exterior frames on the south and west are infilled with concrete shear walls with small windows.
- Shear failure was observed in a first storey column on the side facing the road.
- No other damage was observed in the structural system otherwise.

Figure 11: Overall view from the east of the building

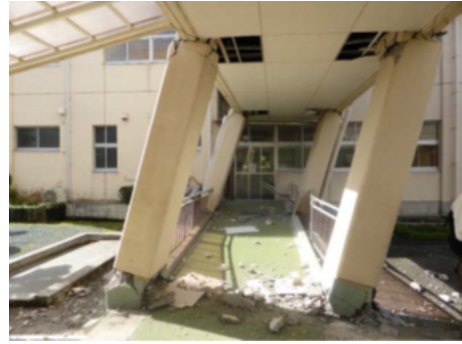
- Two parallel school building are joined by two connecting corridors. This connecting structure exhibits flexural failure at the top and bottom of columns, and is inclined largely in transverse direction. Residual drift ratio

Figure 14: Story drift in the east corridor

is 6 % in the west corridor, and 20% in the east corridor.

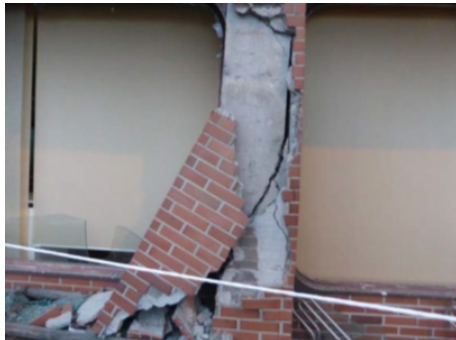
Figure 12: Shear failure in a column

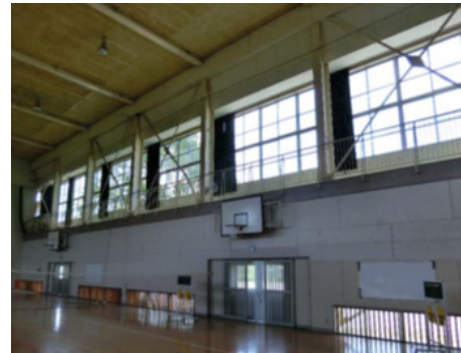
Figure 15: Inside of the gymnasium showing the steel

- The south building consists of 8 bays in longitudinal direction and 2 bays in transverse direction. No obvious damage was observed.
- The north building consists of 9 bays in longitudinal direction and 2 bays in transverse direction.
- All the steel braces in the second storey of the gymnasium show buckling. Because the braces are designed to withstand tension and not compression they can be expected to buckle provided they can still resist tension when the earthquake loading direction reverses.

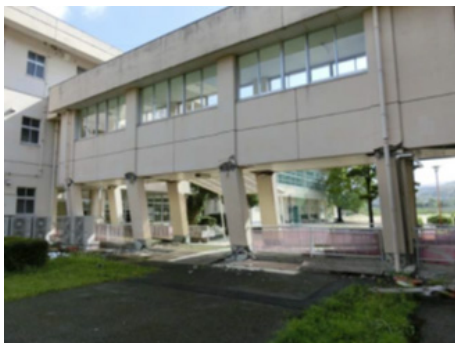
Figure 13: Elevation of the damaged east raised corridor

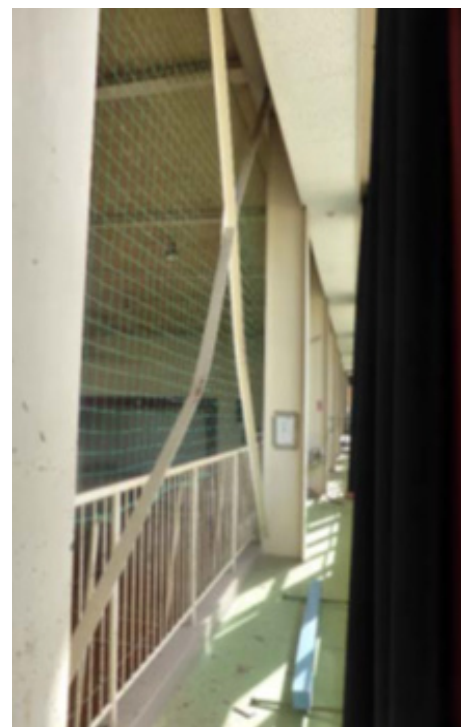
Figure 16: A buckled tension brace

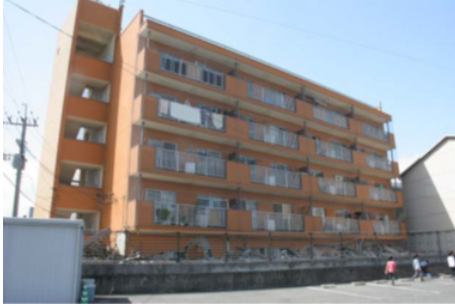
- First floor of the building is for office use and the floors above are for residential use.
- Framing consists of four bays in the longitudinal direction. Outside staircases are located at both gable ends of the building (Figs. 17 and 18)

Figure 17: Overall view of the building from the east

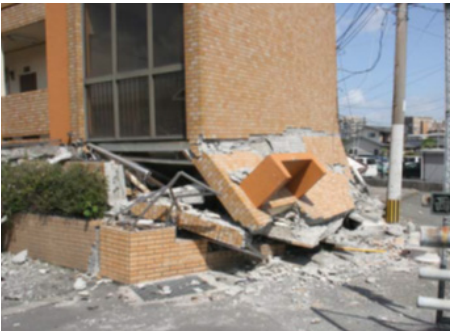
Figure 18: Failure of the southern wall due to the soft storey collapse

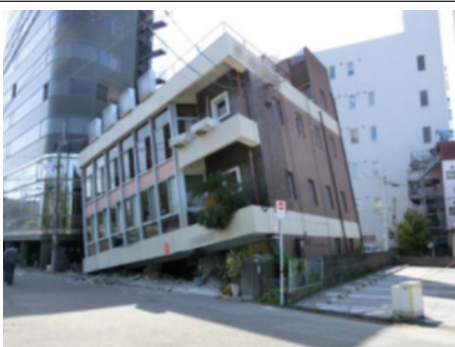
- Building is supported on stilts, having a parking area and an entrance hall at the first floor.
- Walls are arranged at an angle to the span direction.
- Walls at the first floor are located on the north side eccentrically.
- The south side of the first floor collapsed completely resulting in an inclined building (Figs. 19 and 20)

Figure 19: The soft storey collapse from the north-east

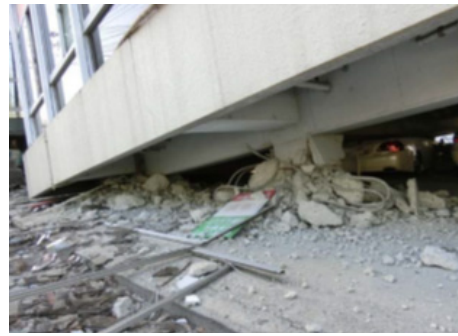
Figure 20: Southern columns crushed in the soft storey

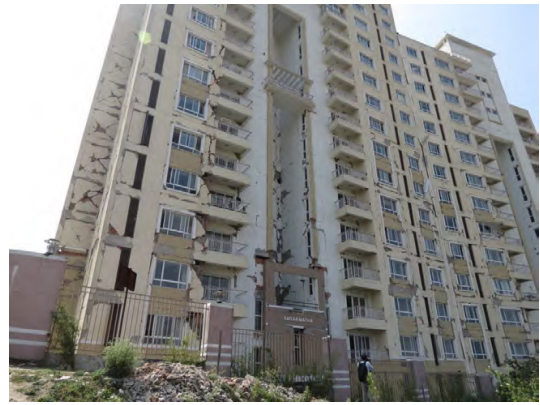
Severe in-plane and out-of-plane damage was observed in masonry infill walls of RC frame buildings constructed on proper foundations. These buildings dissipated a large amount of energy by cracking along both the in-plane and out-of-plane directions (Figure 22). Similarly, severe damage was observed in long infill walls due to diagonal and shear sliding crack at mid-height in a school building at Sankhu (Figure 23). As observed in several past earthquakes, such long walls are also quite susceptible to out-of-plane failure.

Figure 22: Severe damage to infill walls along both in-plane and out-of-plane directions in the high-rise apartment building at Dhapasi (photo and annotations: Hemant Kaushik)

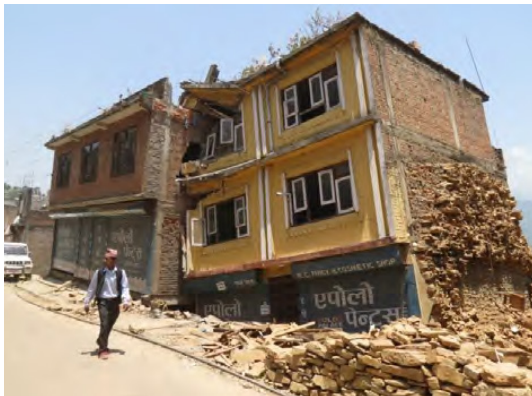
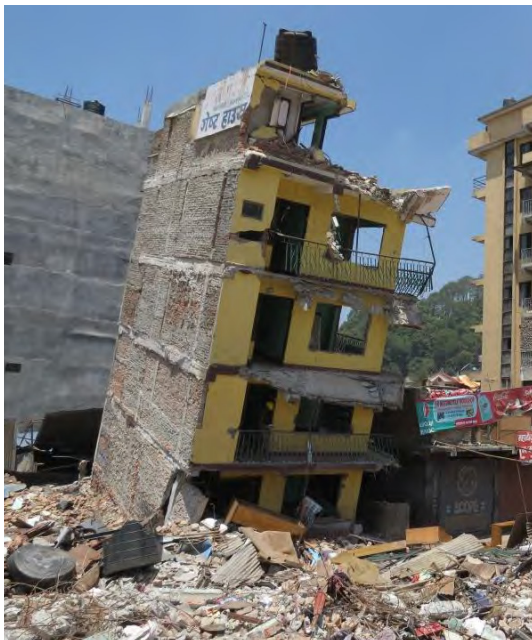
RC frame buildings with masonry infill walls are commonly constructed in urban and semi-urban areas throughout Nepal. Most of the new government buildings and a large number of privately constructed new buildings fall into this category as there is a general perception that such buildings are much safer than the URM buildings. However, most privately built buildings are non-engineered and lack basic earthquake resistant features. Depending on functional requirements, low-rise, medium-rise, and high-rise buildings are all constructed as RC frame structures. RC frame buildings of all heights suffered damage ranging from minor to severe, and even to collapse, depending on their location and configuration (Figure 21).

Figure 21: Damage sustained by RC frame buildings with masonry infills with different heights: (a) three-storey building in Chautara, and, (b) six-storey building in Balaju, (photos: Hemant Kaushik)

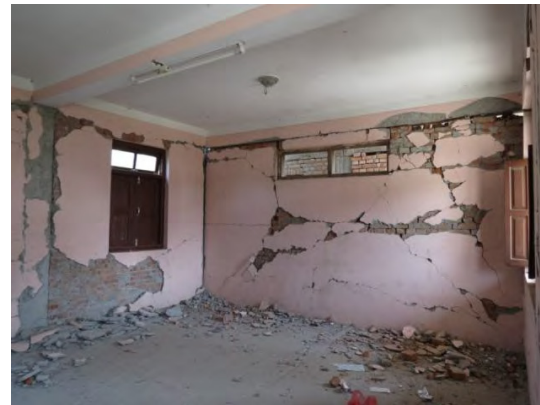
Figure 23: Severe damage to infill walls due to diagonal and shear sliding crack at mid-height of walls in a school building at Sankhu (photo and annotations: Hemant Kaushik)

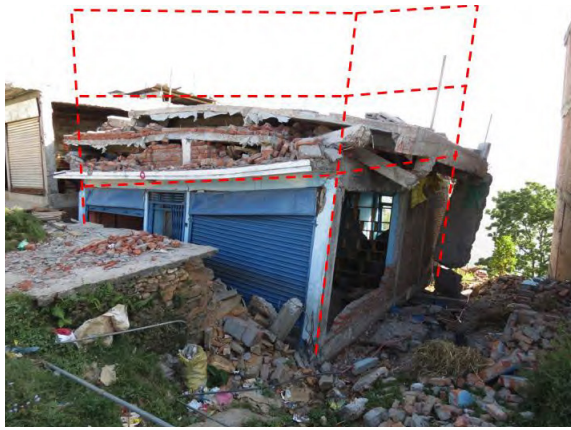
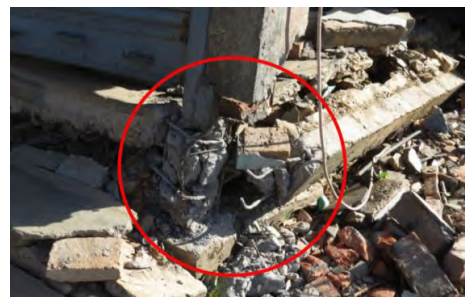
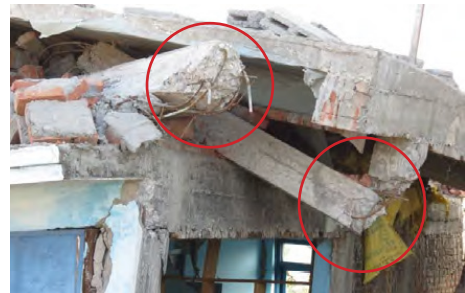
Non-seismic reinforcement detailing in RC members was another important reason of poor performance for RC frame buildings. Poor design and detailing in combination with poor configuration resulted in ‘pancake’ style collapses, failure of beam-column joints, and shear failure of columns near door or window openings due to short column effects (Figure 24).

Figure 24: Poor seismic design and detailing in combination with poor geometric configuration resulted in severe damage in RC frame buildings with masonry infill walls: (a) collapse of a four-story building at Irkhu, (b) failure of beam-column joints in the same building, (c) rupture of reinforcing bars in first-story columns of the same building (photos and annotations: Hemant Kausbik)

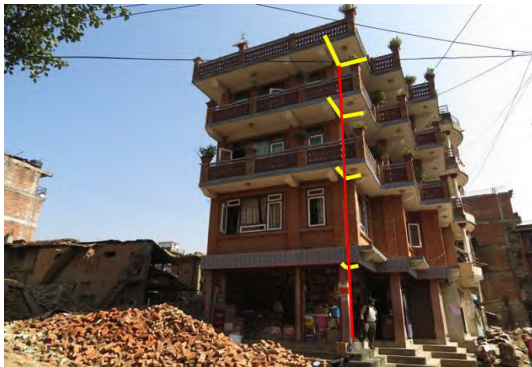
Poor geometric configurations of buildings further reduced the seismic capacity and redundancy in many RC frame buildings resulting in poor performance. Large overhangs (progressive increase in floor area in upper stories by extending beams/walls beyond column grid lines), trapezoidal plan buildings with one end too narrow, floating columns, and soft stories were quite commonly observed in many buildings; this resulted in severe discontinuities in lateral stiffness, lateral load transfer path, and subsequent failure (Figure 25 and 26).

Figure 25: Large overhangs in both directions at building in Sankhu (photo and annotations: Hemant Kausbik)

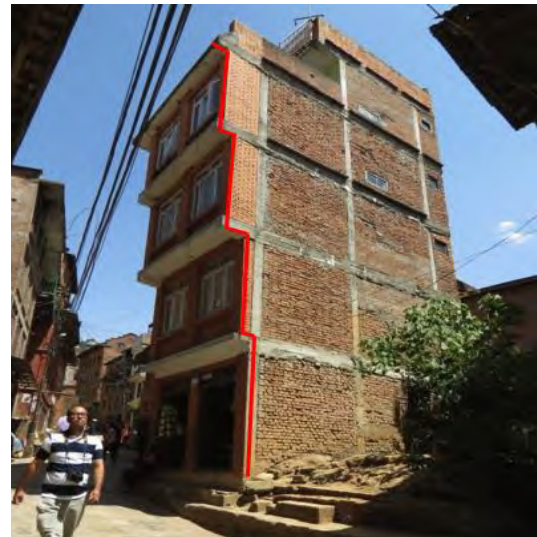
Figure 26: Large overhangs in one direction at building in Dhulikhel (photo and annotations: Hemant Kausbik)
