EARTHQUAKE HAZARD CENTRE NEWSLETTER

Vol.19 No.4

APRIL 2016

Virtual Site Visit No. 41: Masonry Infill and Partition Walls

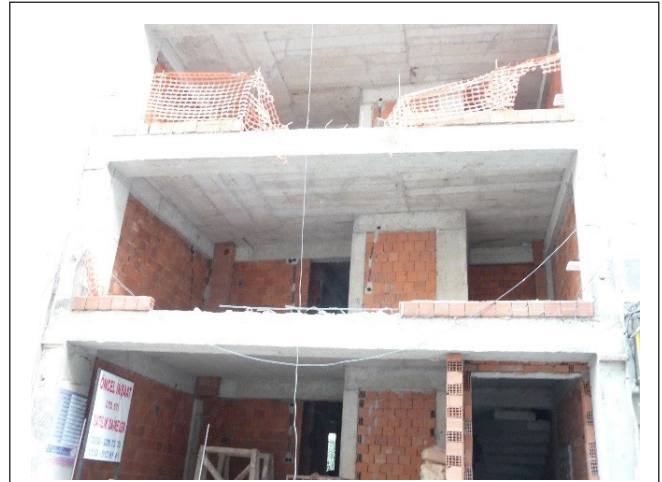
The first building, located in Izmir, Turkey, consists of a reinforced concrete frame building with large numbers of masonry walls (Fig. 1). The main structure has been completed and construction of the masonry walls has begun. As seen in Figure 2, the walls consist of perforated masonry units. The perforations are helpful in reducing the seismic weight of the building, but nonetheless these walls are hazardous during a damaging earthquake. There are no mechanical connections between walls and structure nor reinforcement in the wall itself. The only connections to the sides and tops of the walls are of mortar. During an earthquake when the structure sways, cracks will open up and along these mortar joints and the walls will become unstable. Some might rock for a few cycles of shaking and many will collapse.

Figure 1: Reinforced concrete building with masonry walls.

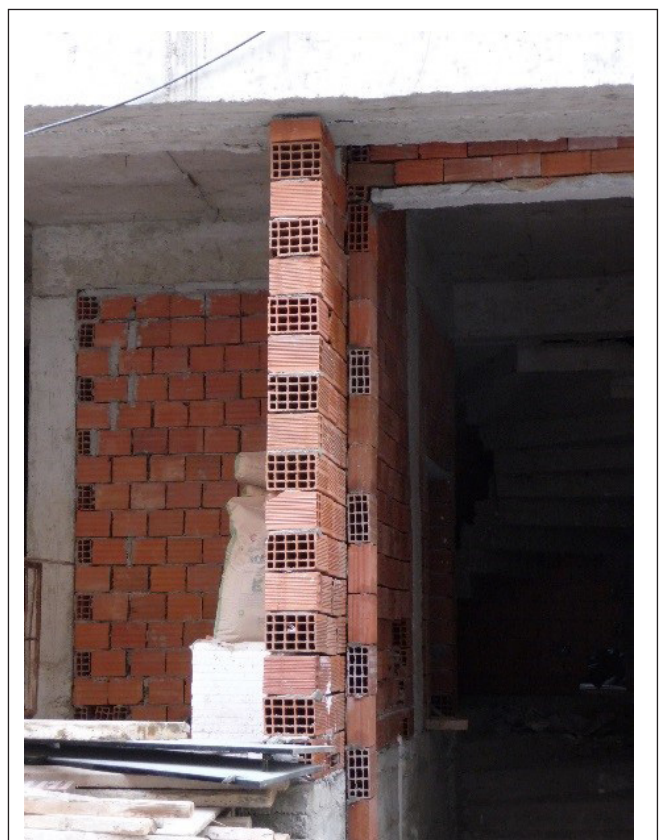
Figure 2: Some of the masonry walls.

These two examples illustrate dangerous unconnected and unreinforced masonry walls. But what can be even more dangerous is the impact of such walls on the structural frame members around them. Connection details and separation strategies that have been discussed in early newsletters and shown in other best-practice examples need to be implemented.

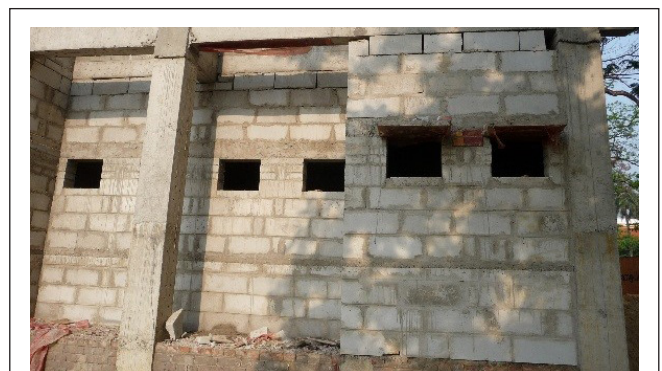
The same problem is observed on the next building site, in Kolkata, India (Fig. 3). Here the earthquake hazard is greater due to the more solid blocks. The difficulty of forming a reliable structural connection between the top of a wall and the RC beam is evident. Not only do walls like these need some physical connectors, like reinforcing bars projecting from the sides of the columns and some other details that tie the wall to the underside of beams and slabs, but the walls themselves need reinforcement. Otherwise, as well as falling into and away from the building, they are likely to fail in bending at mid-height under face loads.

Figure 3: A RC frame building with external masonry walls.

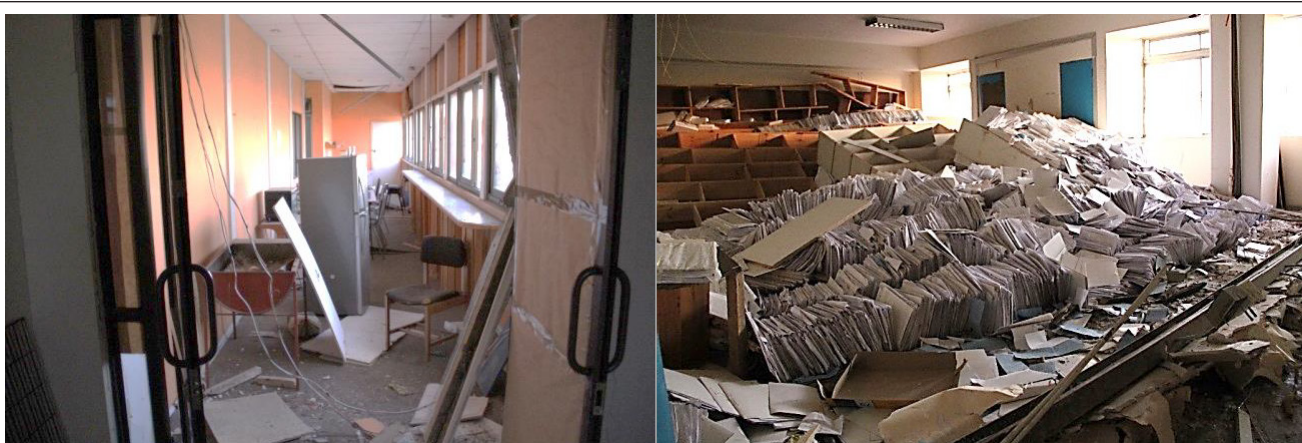
Figure 4: Non-structural damage decreased the capacity of providing healthcare services in the Coquimbo hospital (left). Some of the hardcopies of the medical records, without digital backup, were lost in the region (right) (Photos: Claudio Fernández).

In general, hospitals underwent only non-structural damage and loss of contents, affecting the normal functionality of healthcare services. In some of the hospitals, hardcopies of medical files and records did not have digital backup and information was lost (Fig. 4). Despite this, the healthcare network experienced only a minor reduction of its capacity. A notable exception was Coquimbo's hospital, which sustained severe non-structural damage in one of its buildings. Patients and services from the upper floors were relocated internally in the hospital, significantly reducing its overall capacity.

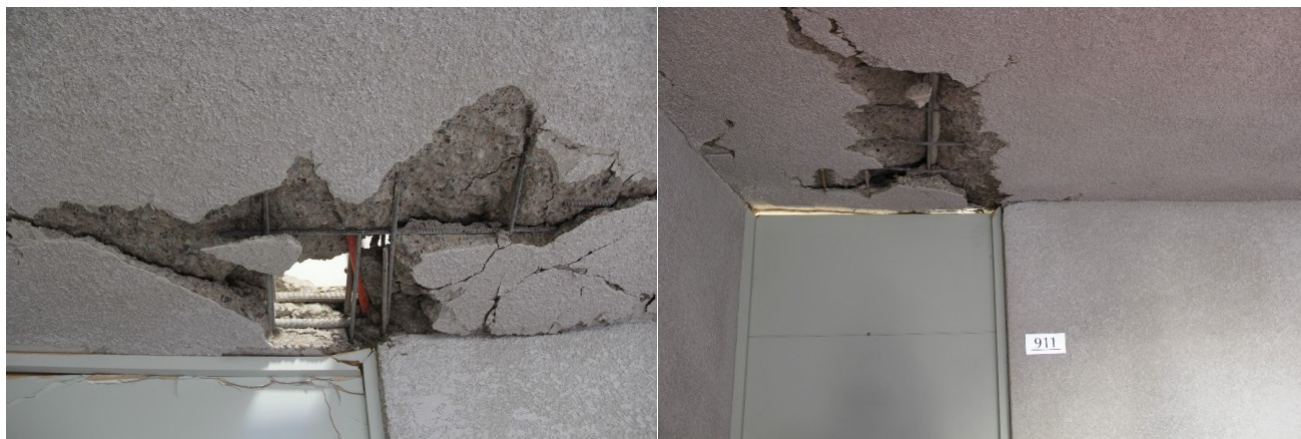
Figure 5: Structural damage in the slabs of a RC building in La Herradura, in the city of Coquimbo (Photos: Claudio Fernández).

In La Herradura, Coquimbo, a 16 story RC building with an irregular C-floor plan and no construction joints underwent structural damage in the slabs at the intersection with walls from the 3rd storey and above (Fig. 5). Concrete crushing was observed in the slabs, probably due to the large bending and shear induced in the floor diaphragms aggravated by the horizontal irregularity

of the building, and the small slab thickness.

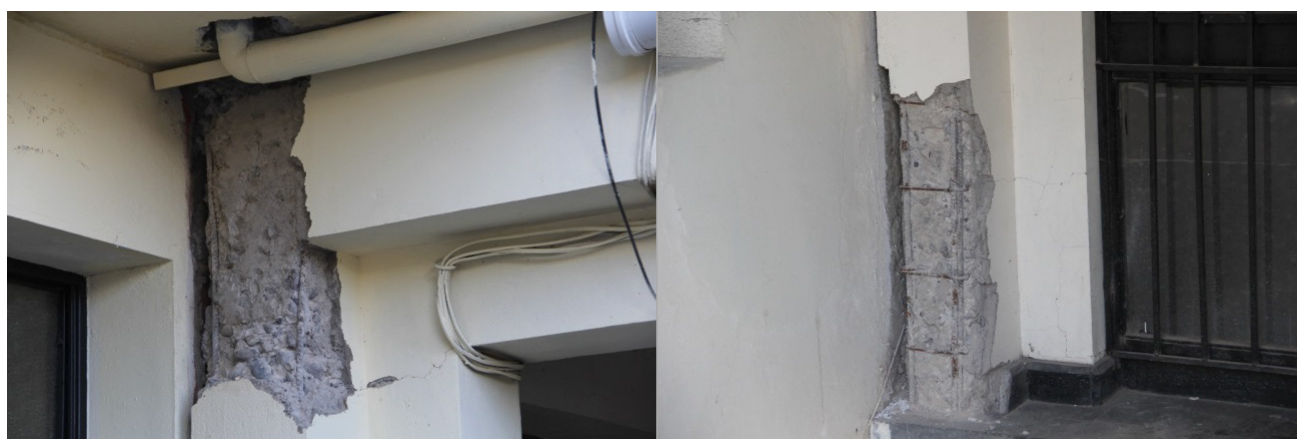
Figure 6: Spalling of concrete was observed in structural elements in the hospital of Illapel (Photos: Claudio Fernández).

The Coquimbo Hospital presented severe damage in non-structural components, ceilings, partition walls, and spalling of the concrete cover in some RC columns. Likewise, buildings in Illapel showed significant damage in structural and non-structural components. In the Illapel's hospital, the concrete spalling in some beam-column joints exposed the rebar (Fig. 6), some very thin horizontal cracks were observed in partition walls, and the ceiling collapsed in many rooms. The adobe structure located in the Municipality and non-confined masonry walls of a 2 stories house were also severely damaged by the ground shaking, and joints between structural and non-structural components were exposed.

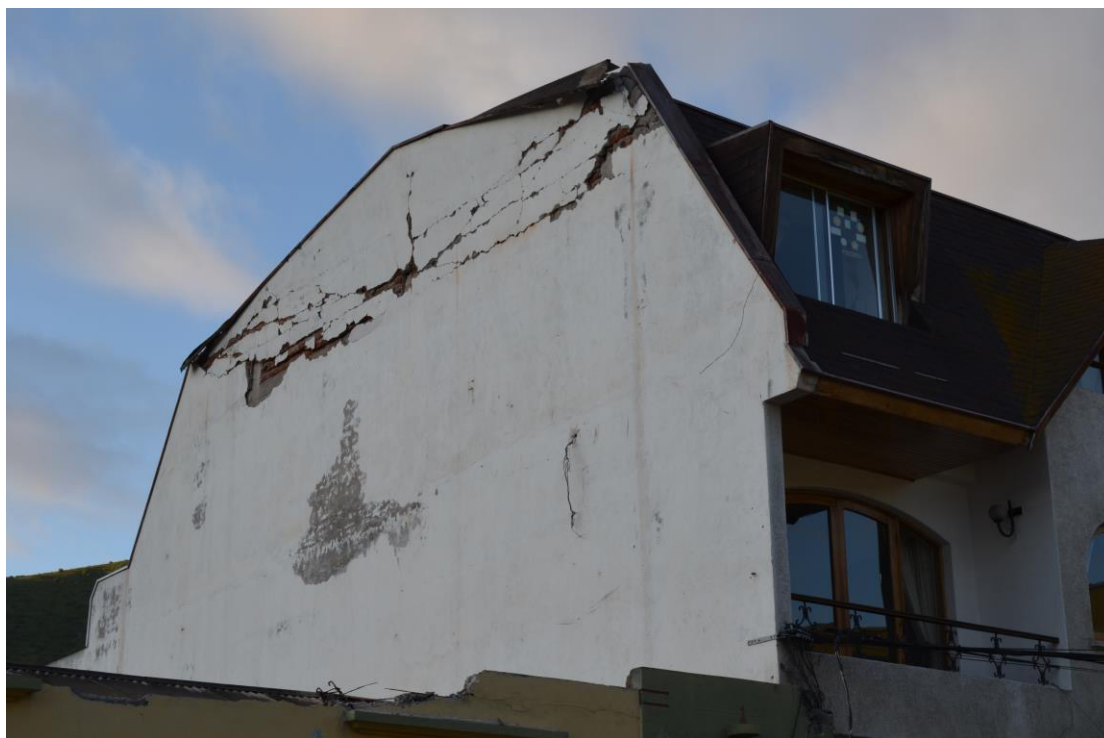
The dwellings in the area affected by the earthquake were mainly masonry structures of one or two storeys, only a small percentage of which were damaged exclusively by the strong ground motion. Figure 7 shows damage to one house caused by the earthquake.

Figure 7: Masonry structures affected exclusively by strong ground motion. Illapel.

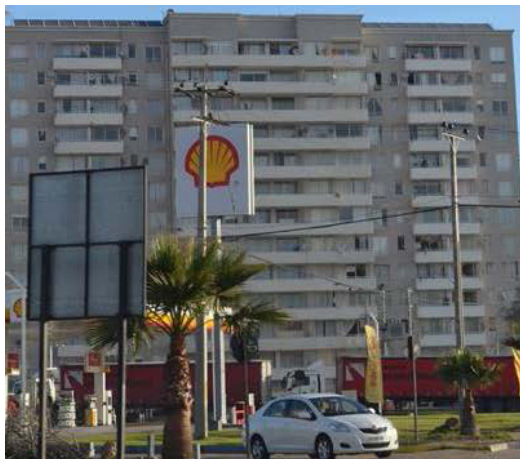
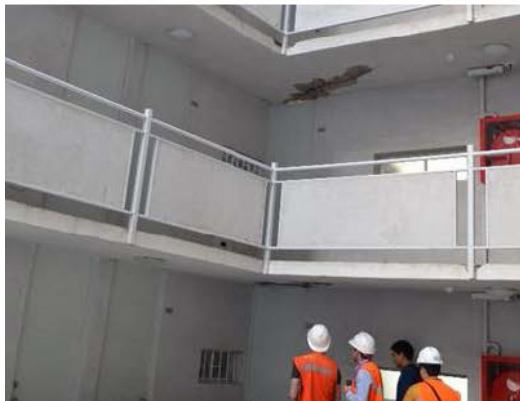
The damage in the Puerto Bahía building was the most interesting structural damage observed as a result of strong ground motion because of the particular kind of failure that only occurred in this building. The damage was concentrated in specific areas of the slabs and occurred at the same location of the slabs in almost all the floors of the building. This building has an irregular C-shape plan, and torsion could have imposed non expected stresses on the slabs, which might have not acted as rigid diaphragms. Besides, the wall located next to the failed slabs is discontinuous on the first two stories, creating a vertical irregularity. Apparently, the slabs did not have sufficient capacity to transfer horizontal loads effectively. However, other main structural elements such as beams and walls were not significantly affected by the earthquake, hence the building is repairable although it may be exposed to the same type of damage in a future earthquake. Figure 8 shows images of the damage produced in the Puerto Bahía building.

Figure 8: Damage concentrated in specific areas of the slabs of the Puerto Babia condominium. La Herradura, Coquimbo.

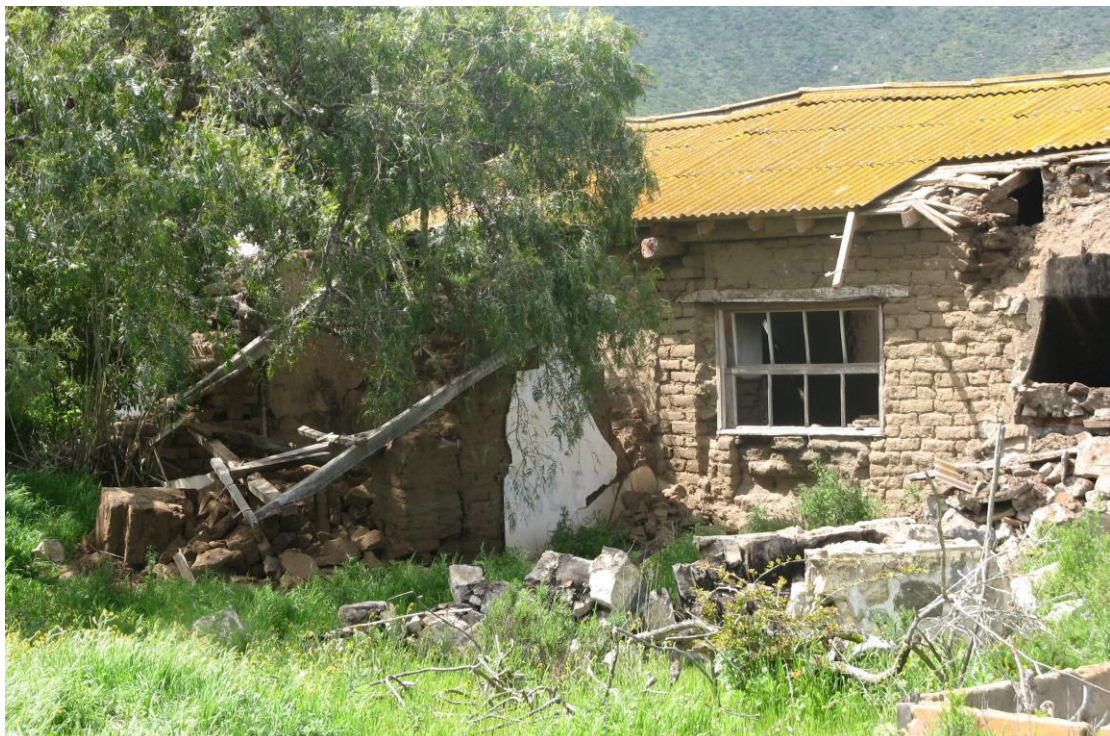
Adobe structures are old traditional buildings. The greatest damage due to strong ground motion was observed in this type of structures, some of which had or will have to be demolished. Damage to one house is shown in Figure 9.

Figure 9: Damage caused by the strong ground motion in adobe structures. Communa de Canla Baja, km 283 at 5 route.
