EARTHQUAKE HAZARD CENTRE NEWSLETTER

Vol. 20 No. 3

JANUARY 2017

Comparative Assessment of Performance of School Buildings in the 2015 Gorkha (Nepal) Earthquakes

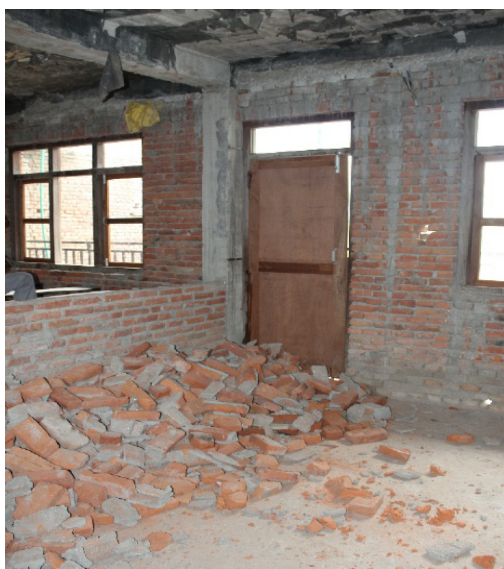
Fig. 6 School building 101-1 experiencing only moderate shaking deemed unsafe.

Infill walls had unreinforced brick or stone walls which form exterior walls or classroom partitions. During the earthquake, many cracked where connected with beams and columns. Others developed more noticeable damage at corners or even diagonal shear cracks. At the schools observed, the infill walls did not have vertical or horizontal reinforcing steel to support them, a common practice prescribed by international building codes and NBC as well. When they cracked, as is expected in an earthquake, they became unstable because of the lack of reinforcing or other means of holding the walls in place.

These infill wall cracks, although considered minor damage from a structural engineering perspective, were a serious problem in schools (Figure 6). Teachers and principals would demonstrate by pushing on the cracked walls, causing the walls to visibly move. With the risk that these walls could topple over and crush occupants in large aftershock or future earthquake, many schools with infill wall damage were given 'red tags' by Ministry of Education inspectors. A seemingly minor damage relegated untold thousands of students and staff to temporary learning spaces and tents.

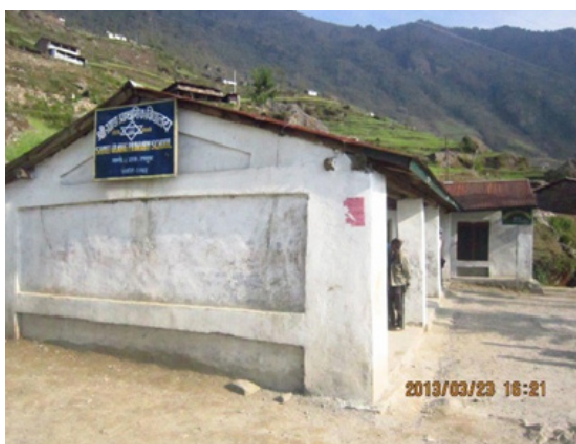
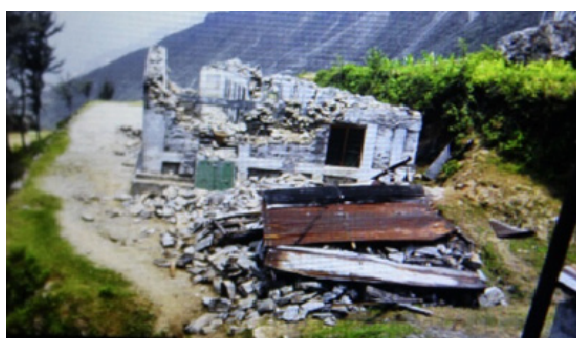
Fig. 7 Complete collapse of retrofitted school building in Rasuwa

A retrofit of a rubble stone school in Rasuwa fared even worse – it completely collapsed. The block had been retrofitted by a major INGO using stitch banding technology and the community had been told the school would be safer than any new construction. The project included little training and oversight, and even less adaptation to the limitations of the brittle stone building material. The donor organization sent a trained mason to

the site for only two days to train local workers, none of whom had professional training as masons. During the middle of the construction process, the donor's engineer came only once, briefly. Local workers found it impossible to adapt the stitch band retrofitting technique to stone masonry; they simply could not drill through the stone walls to stitch bands together, but the project implementation had no plan for adjusting the technology or stopping an unsafe solution. The result was a catastrophic collapse (Figure 7). Donor-funded retrofit of a stone and mud mortar school in Rasuwa collapsed in the earthquake, as the principal captured and showed us on his smart phone. The left of Figure 6 was before earthquake and right is just after the earthquake. The rubble had been removed by the time of the survey. Little training of masons and nearly non-existent technical oversight ensured that when masons struggled to implement the retrofit design, the problems were not caught and rectified. The principal estimates 120 out of 140 students and staff would have died. Had technical experts been involved in

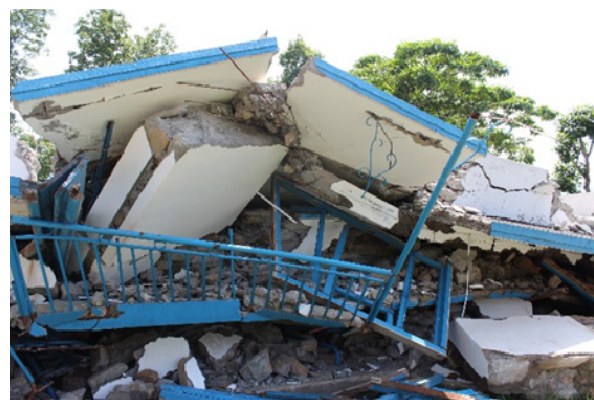
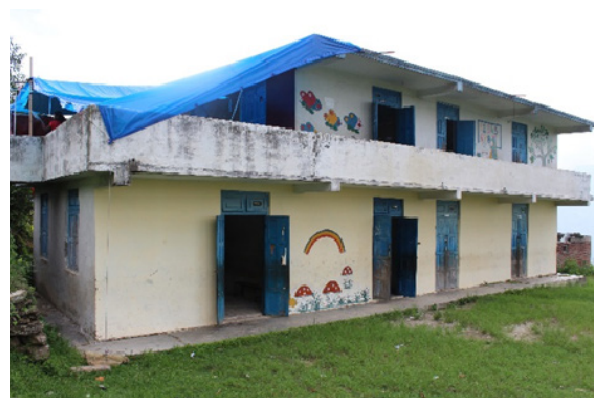
Fig. 8 Two neighboring schools in Sindhupalchowk both built through international donor support but taking different approach of community outreach for technology transfer.

Where local masons were appropriately trained and where trained engineers oversaw the construction practice by very frequent visits or continuous onsite presence, school performed beautifully. They were completely undamaged and few signs of poor construction practice were evident. In Figure 8, the first was built without technical support. The second was built after the community was given an orientation on earthquake safe construction and local masons were trained in safer construction techniques. An engineer and lead mason, both with experience in earthquake-safe school construction, carefully oversaw the process. After the earthquake, the second was operational; even the terrace had been covered and converted into a makeshift workshop for the local community. Clearly, the social supports of training and oversight are crucial to achieving safe school construction in Nepal.
