EARTHQUAKE HAZARD CENTRE NEWSLETTER

Vol.13 No.3

JANUARY 2010

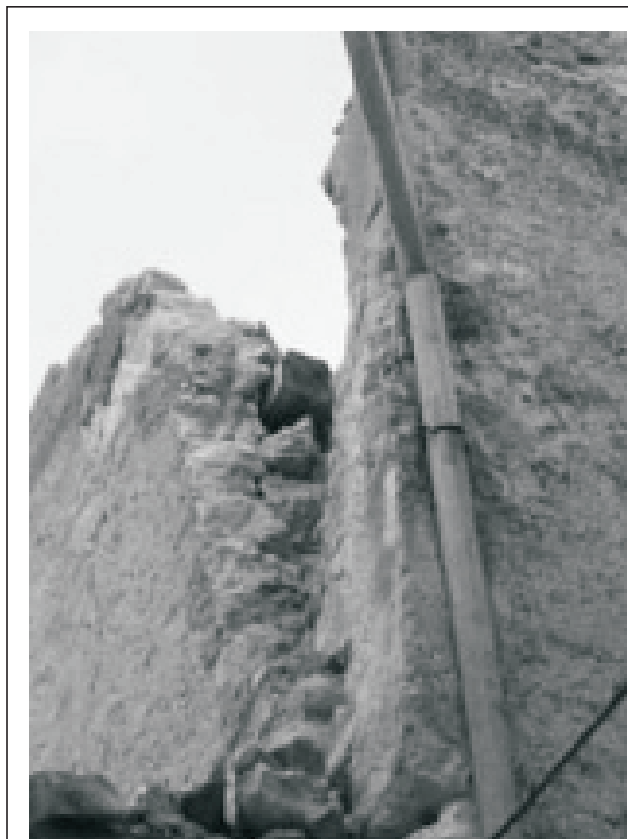
Fig. 4 Detail of 18th century wall strengthening system, where no ties connect the beam to the wall.

After the large major earthquake on the region in 1703, attempts were made to strengthen masonry walls by inserting a large (approximately 20 cm diameter) timber into the wall with wood or iron ties through the perpendicular wall. In Paganica, we saw numerous examples of this approach, where the first story was built after the 1703 earthquake using the timber –and–ties technique, but 2nd and 3rd floors were added in the 19th century without ties, as the technique was forgotten (Fig. 4).

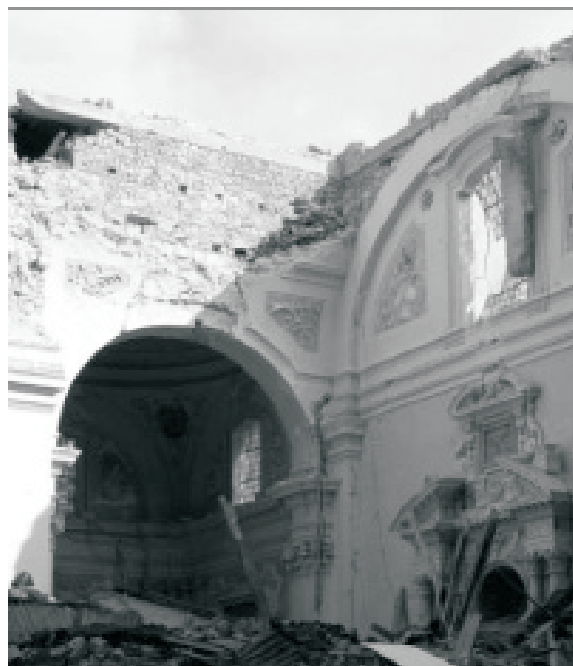
Fig. 5 Roof and cupola collapse in the Santa Maria di Collemaggio Abbey in L'Aquila. The reinforced concrete ring beam did not prevent the collapse of the cupola.

Another interesting retrofit from the modern era was the use of the concrete ring beam to stiffen the wall and prevent collapse. This was used on a number of churches (Fig. 5). Unfortunately, this system proved to be ineffective, and many structures, such as the building in Fig. 6, collapsed. The additional mass of the beam, the inconsistency between the deformation of the beam and that of the walls, and the lack of positive connection between the beam and the masonry walls above and below are reasons that were brought up to explain the generally poor results of this retrofit technique.

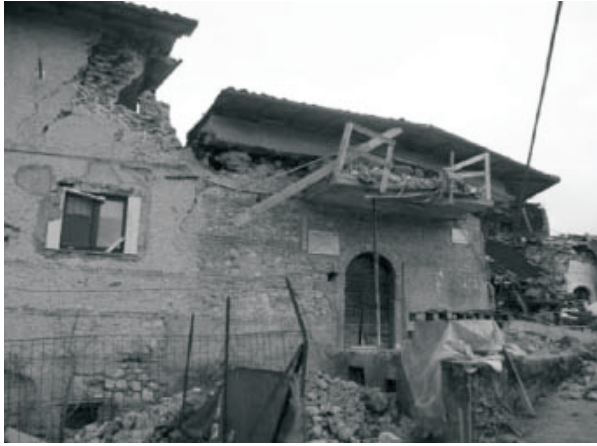
Fig. 6 Collapse of a masonry building in Tempera with concrete ring beam retrofit.

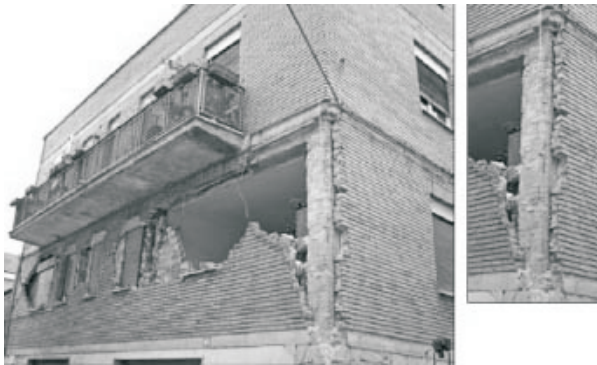
Fig. 7 Typical damage to infill walls.

We found widespread damage to exterior infill walls and interior partitions, varying from small cracks to collapse along with minor or no damage to structural elements. Several buildings completely lost their masonry infill walls at lower stories Fig. 7. This kind of damage extended to newer buildings, including structures that have been recently completed. In L'Aquila, the team also observed about 15 older low-to-mid-rise apartment buildings and one large hotel that suffered dramatic failures (Fig. 8), generally due to a soft-story at the first story. At all the collapse sites, the team noticed the remains of column-beam connections that showed insufficient transversal reinforcement in the form of 6 mm diameter stirrups, at a spacing of 25cm or more. In some cases, there were also poor distributions of fine aggregates and cement in the concrete, with a very porous core of disconnected larger aggregates. Short overlap of longitudinal rebar connecting columns between the upper and lower stories, short anchorage lengths of the longitudinal beam reinforcement, and smooth rebars may have been responsible for the reduced structural strength and ductility of these buildings.

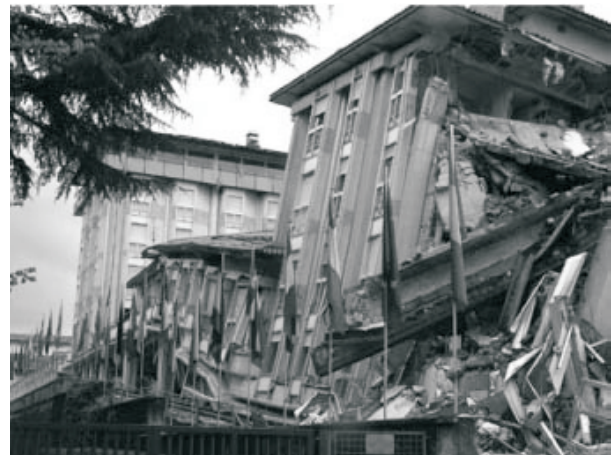
Fig. 8 Collapse of part of the Duca D'Abruzzi Hotel caused by a softstorey mechanism. The far part of the building was saved by a seismic separation joint.

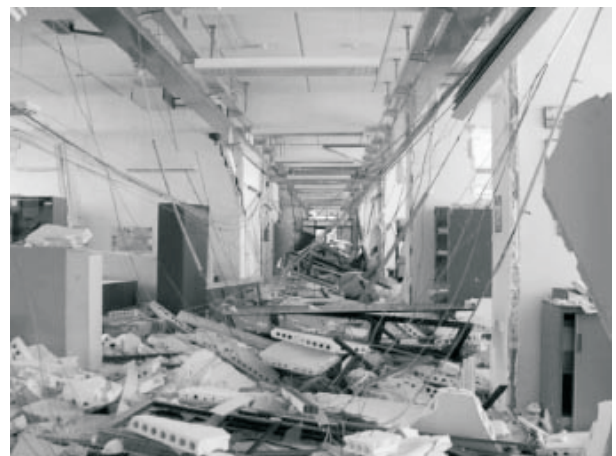
Fig. 9 The interior of the City Planning Offices in L'Aquila. Note that the building exterior has very minor detectable damage.

In summary, reinforced concrete buildings in L'Aquila region behaved, on average, fairly well, considering the limited seismic design requirements and the severe ground shaking, often exceeding the design level. From the perspective of the repair cost, however, reinforced concrete buildings showed higher losses due to widespread extensive damage to masonry infill walls and internal partition walls (Fig. 9).

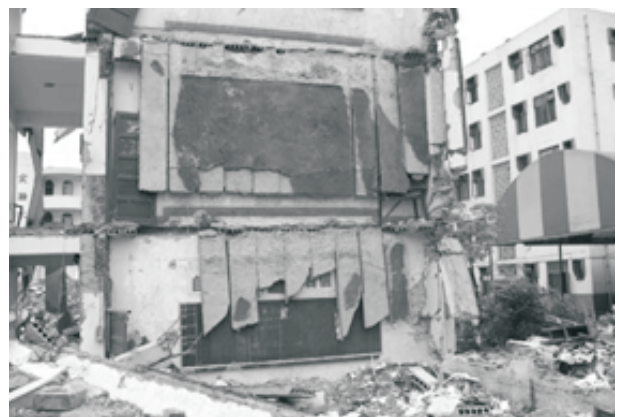
Fig 10: URM wall and RC floor plank collapse, Juyuan Middle School.

The three-storey Juyuan Middle School, approximately 20 kilometers from the fault rupture, was hit hard. The school, constructed in 1996, housed 1,000 students, and more than 700 died when the building collapsed. Construction consisted of non-ductile RC beams supported by URM walls, with precast concrete floor planks. This type of damage was quite common. A lab building adjacent to the collapsed school with similar construction, built in 1996, did not collapse. This better performance was likely due to the orientation of its URM walls.

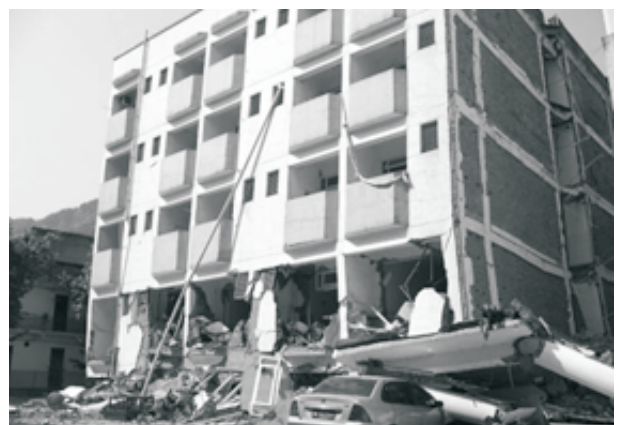
Fig 11: Soft-story collapse, Hanwang Hospital.

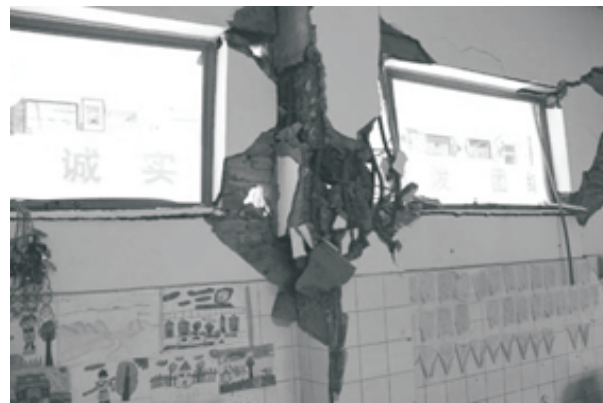
Fig 12: Captive column failure, Hanwang High School.

The four-storey Hanwang High School is within 10 kilometers of the ruptured fault, and sustained significant damage but no collapse. Construction consisted of CIP-RC framing and URM walls. The walls had extensive damage, and concrete columns failed because the URM walls created captive columns (Fig. 12).

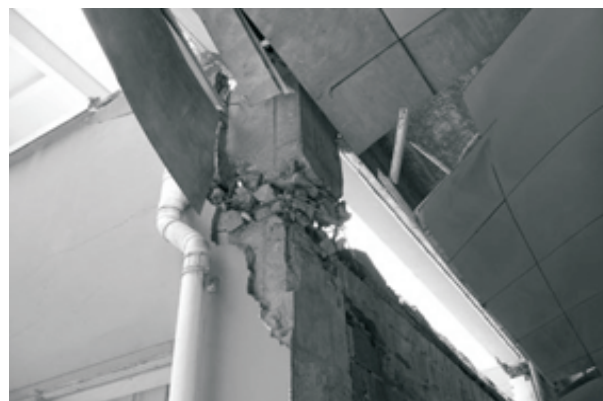
Figure 13: Column flexural damage, Mianzhu Experimental

kilometers from the fault rupture. Framing was comprised of non-ductile CIP-RC columns and beams, as well as URM infill walls, and there was significant structural damage. In particular, a large flexural demand and a lack of adequate confining transverse reinforcement resulted in severe column damage (Fig. 13).
