CARTHQUAKE HAZARD CENTRE

NEWSLETTER

Vol.13 No.4 APRIL 2010 ISSN:1174-3646

Performance of School Buildings in Turkey

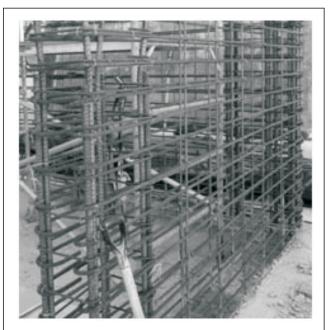
First we observe closely the reinforcement in a shear wall (Fig.1). Since this section of wall is near roof level, it is quite lightly reinforced. As well as vertical bars to resist bending moments, and horizontal steel that is well anchored at each end of the wall with 180 degreee hooks, confining ties at wall ends are visible. It is important to place confining steel at the ends of walls so the concrete in those areas is not badly damaged under the very large compression loads that occur when the wall resists gravity loads and bending moments during earthquake attack. The confining ties wrap around the larger wall compression and tension reinforcement and have 135 degree bends which will allow them to continue to provide confinement when the cover concrete spalls off due to high concrete compression strains.

Fig. 1 Shear wall reinforcement towards top of building.

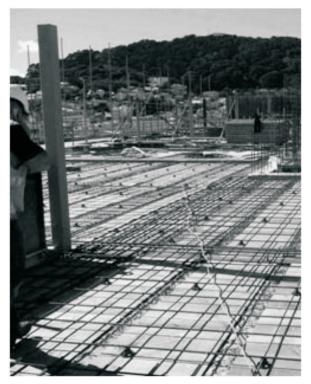
Secondly, two types of reinforcing steel in a floor diaphragm are noted. Over most of the floor diaphragm reinforcing bars are placed at about 300 mm centres in both directions. This reinforcement is usually sufficient to transfer horizontal inertia forces through the diaphragm into vertical shear walls. This nominal reinforcement is shown in the foreground of Fig. 2 However to the right of Fig. 2 and to the left of Fig. 3 we can see a concentration of reinforcing steel. This steel is forming a tie to

Fig. 3 Suspended floor slab ready to be poured. Note band of heavy diaphragm reinforcement to the left.

transfer inertia forces from certain areas of the floor slab into shear walls. Ties like this are required when shear walls are a considerable distance from some areas of a slab and where penetrations or notches in a slab require a strut and tie mechanism to reliably transfer horizontal forces through a diaphragm into a shear wall. If these ties were not provided the floor diaphragm would have insufficient strength to transfer its forces into the shear walls and would fail during an earthquake.

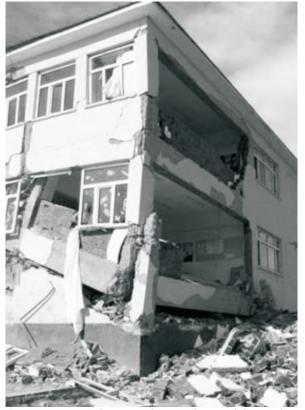
Fig. 6 Remains of the corner column of the ground floor of the building shown in Figure 5. The corner column failed in shear.

presence of captive columns formed by openings for the small windows in the masonry infill walls. There were at least two captive columns adjacent to the windows in the lavatories and around the stairwells in each school building. In addition, in seven of the schools in Bingöl, there was a furnace room on the ground floor level where the presence of small window openings adjacent to columns increased the number of captive ones from two to eight.

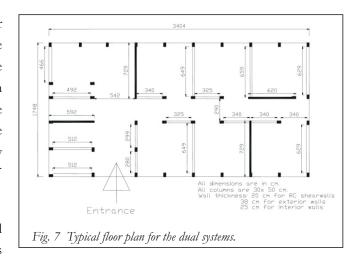
The five school buildings with dual systems have the same floor plan as those in Bingöl, with moment-resisting frames, except two bays in each orthogonal direction that are occupied by reinforced concrete walls (Figure 7). The thickness of these walls is 0.2 m. The total concrete wall area is estimated to be 0.4% of the floor area in the long direction and 0.5% in the short direction of the building. These buildings range from two-story to four-story. In addition, buildings with three and four stories had an additional stairwell separated from the main structure by an expansion joint. The most severely damaged dual system was one of the four-story
