# EARTHQUAKE HAZARD CENTRE NEWSLETTER

OCTOBER 2010

# **SUMMARY OF; “OBSERVED SEISMIC BEHAVIOR OF BUILDINGS IN NORTHERN PAKISTAN DURING THE 2005 KASHMIR EARTHQUAKE”**

## **SUMMARY OF “LEARNING FROM EARTHQUAKES- THE M<sub>w</sub> 8.8 CHILE EARTHQUAKE OF FEBRUARY 27, 2010”.** From, EERI Special Earthquake Report—June 2010

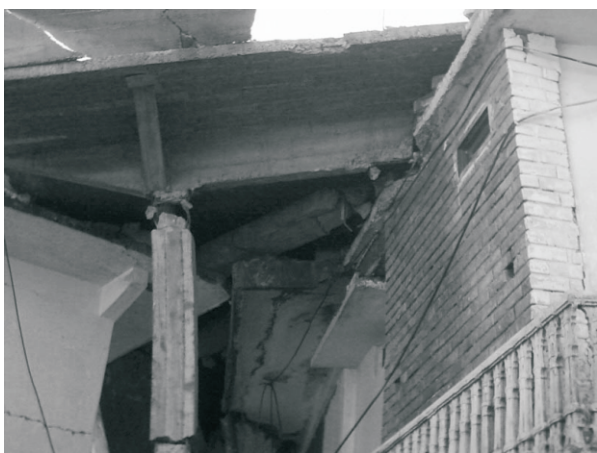
The least dimension of the column was commonly selected as equal to the dimension of the infill masonry unit (230 mm (9 in.) with fired clay brick and 203 mm (8 in.) with concrete block) so that the column would not project outward from the wall. The desire to have maximum space in the horizontal direction usually resulted in fewer columns with smaller cross sections. Also, most of the concrete structures were designed for gravity loads only. Probably because of these reasons, buildings with strong beams and weak columns were constructed. The weak nonductile columns suffered damage because of the lateral seismic demand, which could further be aggravated by axial forces from the elastic beams. The example of buildings damaged having strong beams and weak columns is illustrated in Figure 4.

*Fig. 4 Collapsed building due to strong beams and weak columns.*

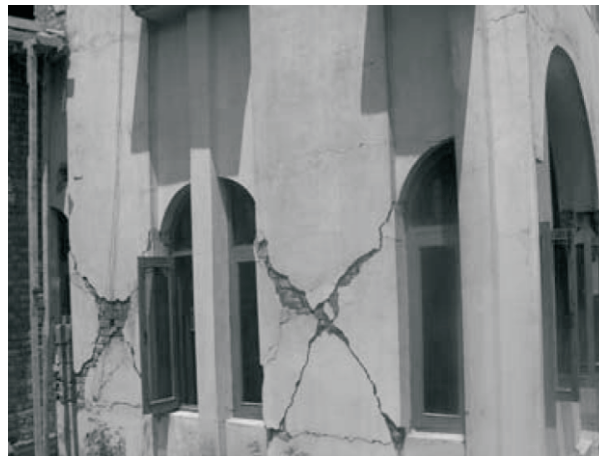
For heavily loaded masonry wall piers with low aspect ratios, in-plane shear forces of the wall causes diagonal shear failure in the form of X-cracks. This type of failure does not endanger the gravity load-carrying capacity of a wall unless cracking becomes severe or out-of-plane movement takes place. The diagonal shear failure is also associated with in-plane shear sliding of the masonry wall. Figure 5 shows building walls cracked in diagonal shear during the Kashmir earthquake. This type of failure could be seen throughout the affected area.

*Fig. 5 Diagonal shear failures of masonry wall piers.*

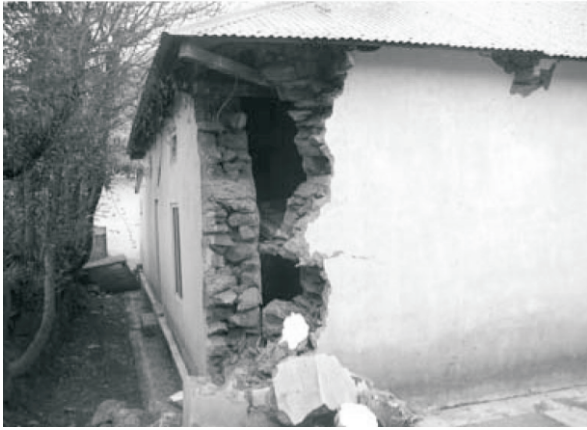
The corners of walls supporting roofs inclined in both directions are damaged due to the lateral thrust applied by the roof in addition to the inertial forces. The in-plane rotation of a rigid diaphragm also induces this type of failures at the corners. The lack of proper connection between walls and between walls and floor make the corners more vulnerable to cracking. Figure 5 illustrate this type of failure.

*Fig. 6 Damaged corner of a building in Mazaffarabad.*

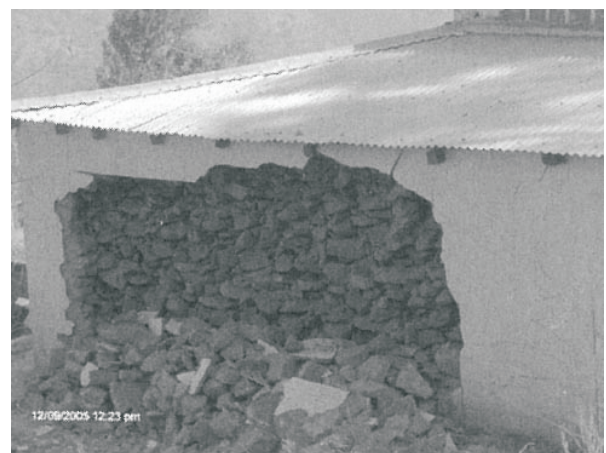
Rubble stone masonry constructed in weak mortar and without through stones is liable to fail at a very low level of seismic excitation. The external veneer usually fails first in the out of plane direction. This type of failure (Figure 7) was prominent in the rural parts of the affected area.

*Fig. 7 Collapse of external veneer of stone masonry wall.*

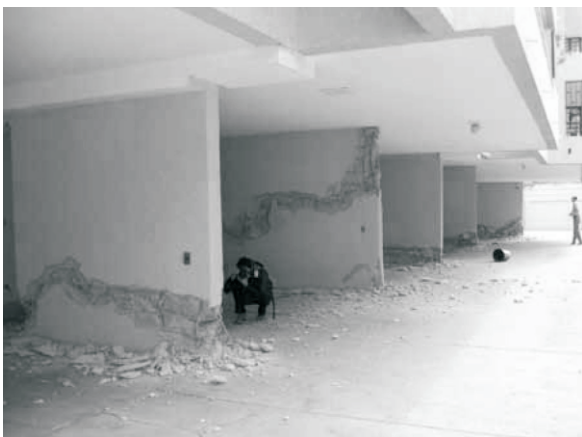
Figure 8 shows typical damage to a transverse wall in the first story of a ten-story building in Viña del Mar. Note the setback in the wall profile at this level, provided mainly to accommodate automobile access to parking spaces. This condition was observed in several buildings; in buildings with subterranean parking, this damage was likely

*Fig. 8. Wall damage, Vina del Mar (photo: P. Bonelli)*

in the first level below grade.

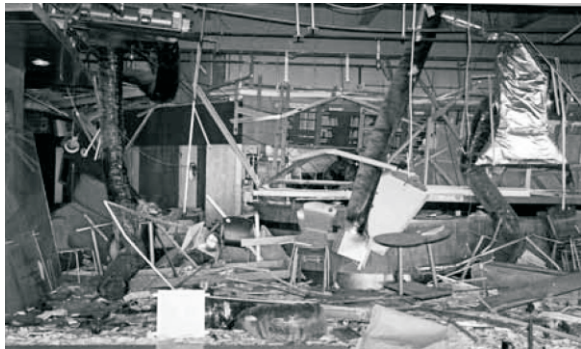
*Fig. 10. Nonstructural damage at the Santiago International Airport terminal (photo: E. Miranda)*

Non-structural damage resulted in the closure of the international airports in Santiago and Concepción, which together handle more than two thirds of the air traffic in Chile (Fig. 10).
