# EARTHQUAKE HAZARD CENTRE NEWSLETTER

Vol.15 No.2

November 2011

# **SUMMARY OF “DEVIL IN THE DETAILS: SUCCESS AND FAILURE OF HAITI'S NON-ENGINEERED STRUCTURES” by Lang, A and Marshal, J.**

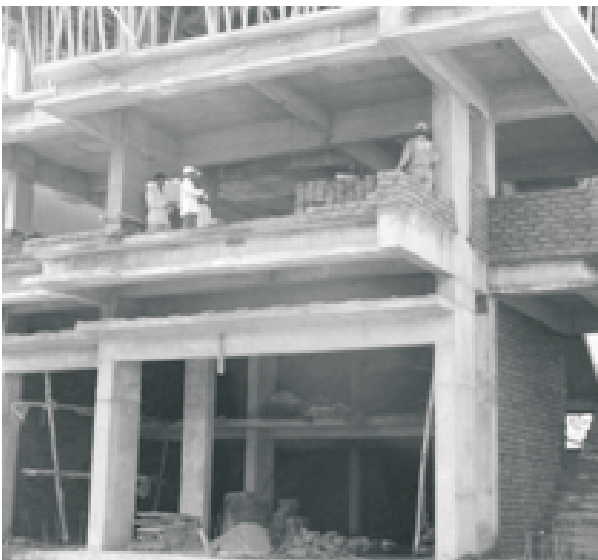
The four sites shown below are located in India. In every case the buildings are of RC infill frame construction. In those buildings under construction masonry infill is placed against smooth RC columns (Figs. 1-4). The bond between masonry and columns will be poor, and between masonry and the underside of beams, even weaker.

*Fig. 1. Masonry infills under construction within the RC frames.*

Most of these buildings, because they are low-rise could be constructed in confined masonry. At least in the longitudinal directions confined masonry is entirely feasible as there are many unpenetrated wall panels to act as bracing panels. However in the transverse direction additional bracing walls would probably need to be inserted to provide sufficient lateral strength. If that were not possible, then transverse loads would have to be resisted by RC moment frames.

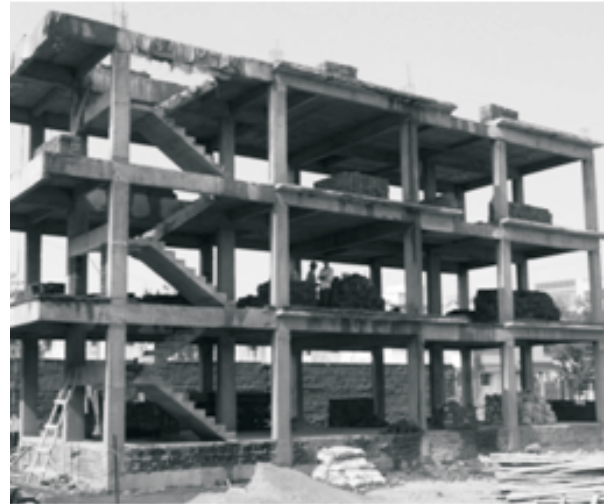
*Fig. 2. Infill walls are about to be laid between frame members.*

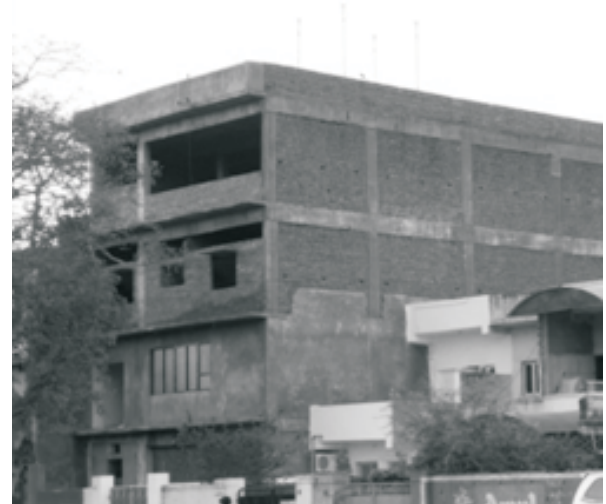
*Fig. 3. If constructed of confined masonry, the longitudinal walls would provide excellent seismic resistance.*

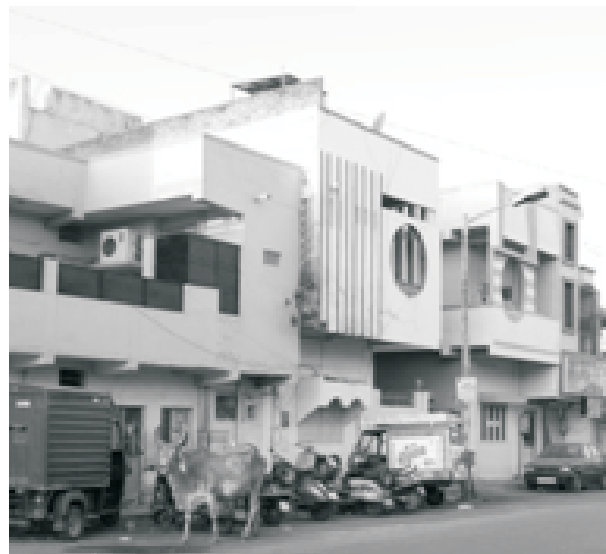
*Fig. 4. The seismic performance of these houses would be much improved if constructed using confined masonry.*

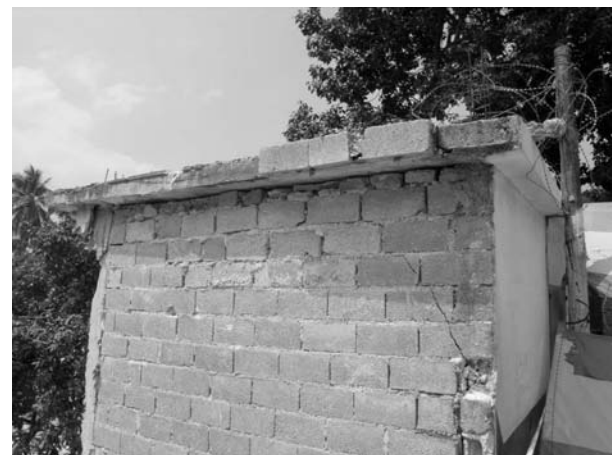
Fig. 8. Masonry walls are built short of the roof slab for all types of masonry construction; block debris is added to fill in the gap.

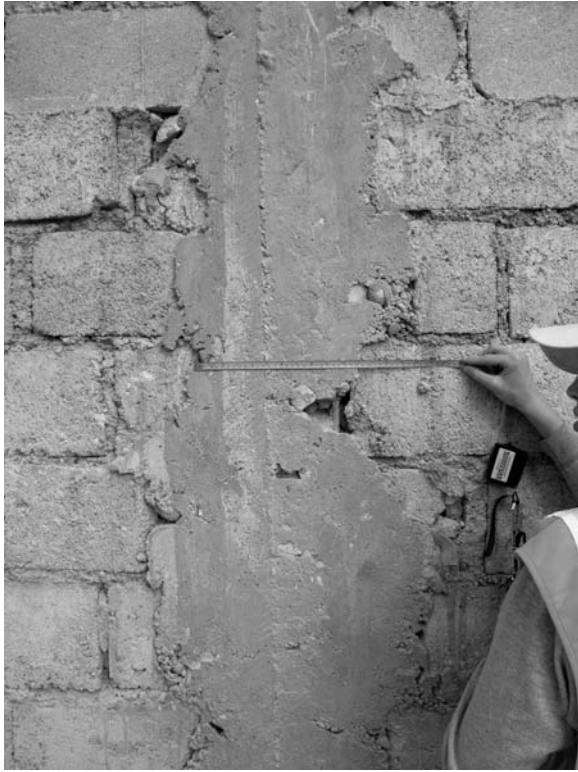
*Fig. 9. Wall-first construction is identifiable by the oozing of the column concrete around the masonry blocks.*

prevalent in Haiti. During reconnaissance, column-first construction was easily identifiable because of delineation or even a gap between the wall panel and the adjacent column. Wall-first construction was identifiable by the absence of this division and the presence of concrete oozed around individual masonry units. Evidence such as that shown in Figure 9 strongly indicates that the wall was in-place prior to pouring of the column.

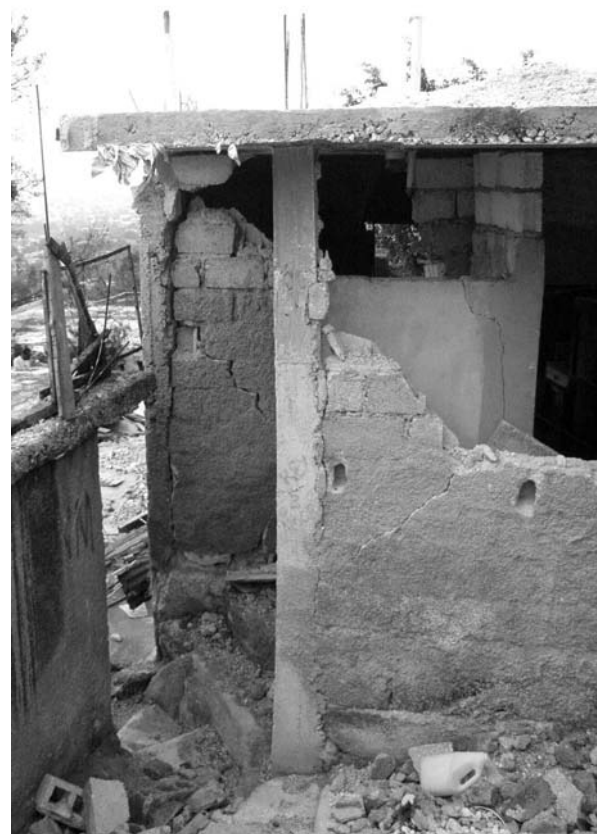
*Fig. 10. Infilled frame construction is distinguishable by clean lines between columns and walls. Typical failure is out-of-plane toppling, as shown*

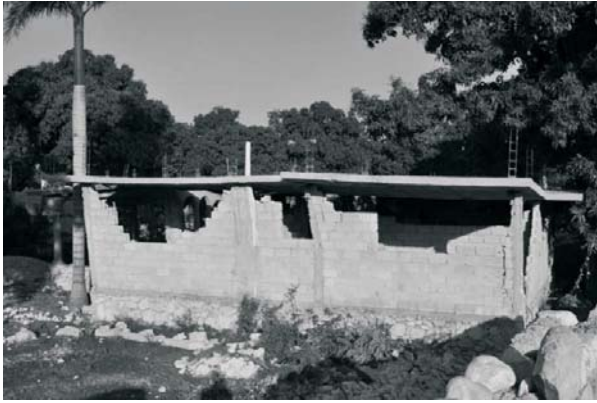
*Fig. 11a. Typical failures of infill masonry construction: Infill wall failure initiated at openings resulting in large rotational demands at beam-column joint.*

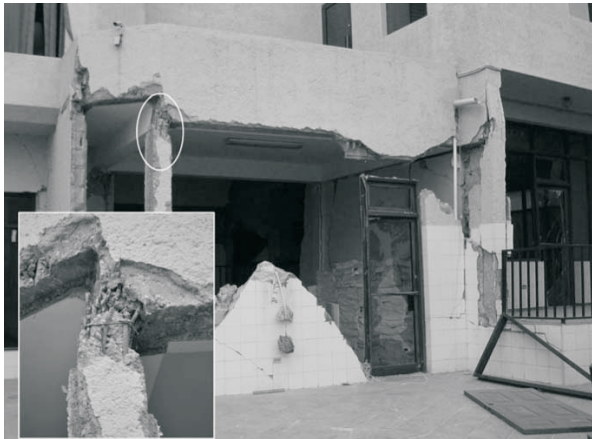
*Fig. 11b. Damage to reinforced concrete beam-column joints following failure of masonry infill.*

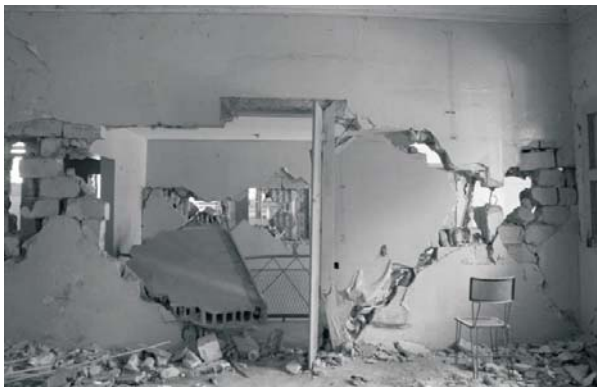
Because the masonry walls are typically not load bearing, as previously described, their lateral capacity is reduced due to the lack of friction development between the unreinforced masonry blocks. This frequently resulted in brittle X-cracking of the walls, often initiating at the corner of openings (see Figure 11c). Subsequently, wall panels did not significantly contribute to the overall lateral capacity of

*Fig. 11c. Common brittle in-plane shear failure (X-cracking) of masonry wall.*

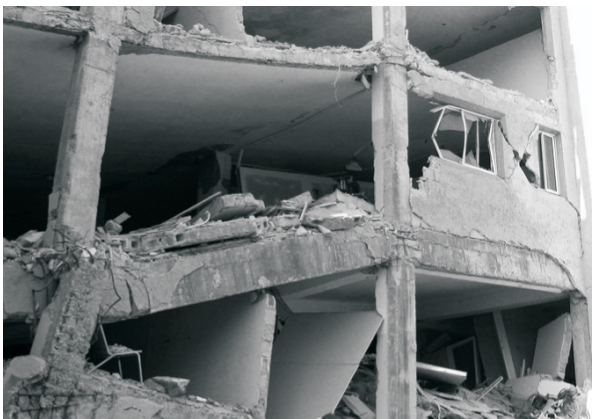
*Fig. 11d. Complete failure of infill panels followed by partial collapse due to poorly confined columns.*

structures once they were damaged. As described above, however, the walls reduced the unsupported length of slender columns, improving the in-plane moment resistance of the frames. Localized damage was often observed as a result of in-plane interactions between wall panels and columns. Column shear failures were common. In some cases the column failure resulted in partial or total collapse, as shown in

Figure 11d. Further, toppling and out-of-plane wall failures were frequently observed and caused the majority of the complete structural collapses. Even when they didn't contribute to building collapse, these out-of-plane wall failures caused innumerable injuries and deaths.
