EARTHQUAKE HAZARD CENTRE

NEWSLETTER

OCTOBER 2012

A summary of 'The M_w 6.9 Sikkim-Nepal Border Earthquake of September 18, 2011', an EERI Special Earthquake Report, February 2012 based on observations of the contributors listed in the original article.

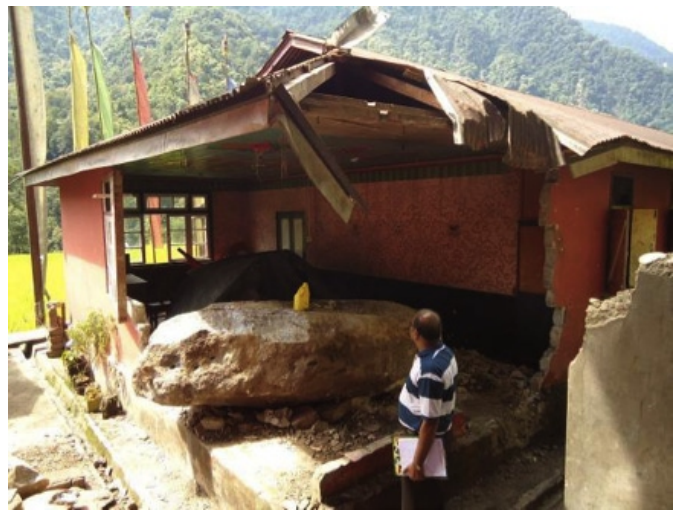
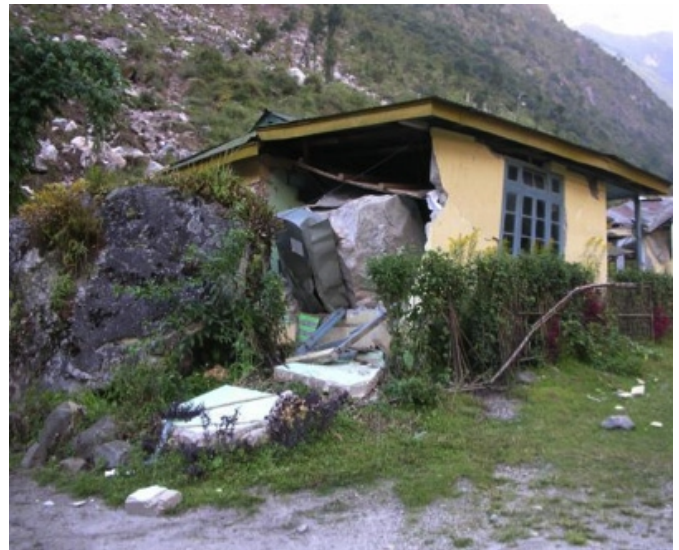
slides on weak mountain slopes, rolling boulder impacts, and ground shaking-induced damage (Figure 4). In some

Fig. 4 Damage to houses due to rolling boulder at Lingzja and Chungthang (photos: Arun Menon and Rupen Goswami).

cases, the latter type of damage may have been exacerbated by the 2006 event (if the structure was not retrofitted). Scientifically based land use zoning should be undertaken to demarcate obviously unsafe sites in the state of Sikkim. Many instances were observed of soil movement under buildings on hill slopes largely made up of metamorphic and sedimentary rocks covered with soft soil.

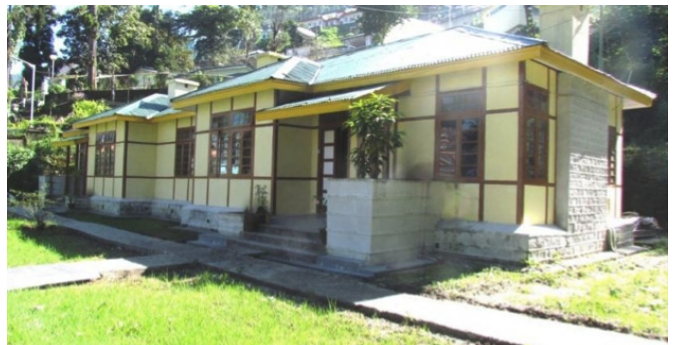
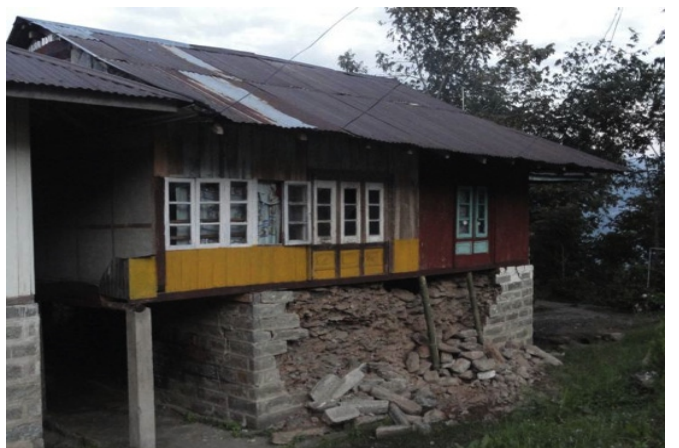
Fig. 5 above, Typical ekra house at Gangtok (photo: Alpa Sheth) below, typical house with wooden planks (Sbee Khim) with damaged rubble masonry plinth (photo: AR Vijayanarayanan).

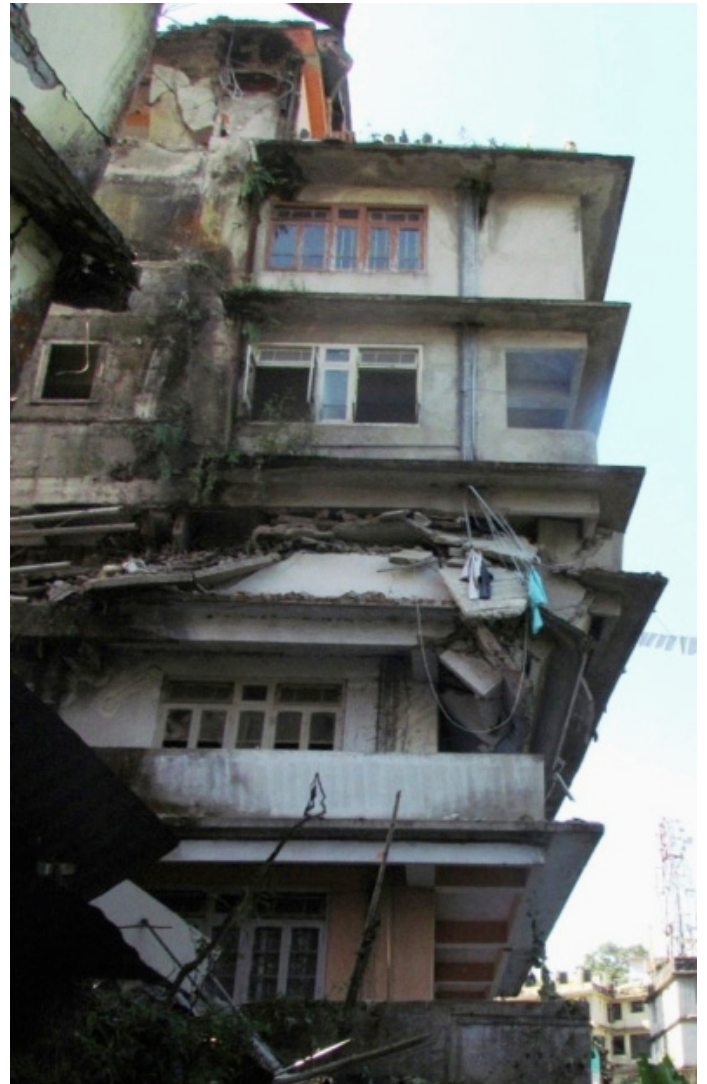
Fig. 6 - Top image, Pancaked nine-story Dzongpo House building in Gangtok; three intermediate stories collapsed owing to sudden change in lateral stiffness (photo: Alpa Sheth);

Buildings that had a sudden change in the stiffness pattern of the infill panel walls suffered significant damage or collapse (Figure 6). Buildings experienced torsion and collapsed when distribution of stiffness was poor in plan (Figure 6).

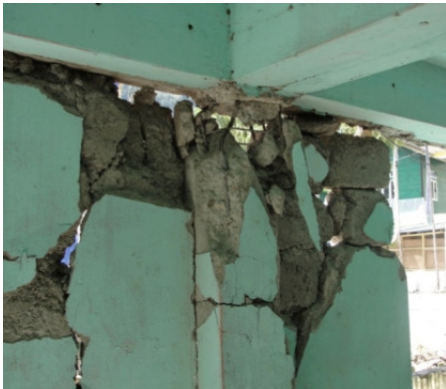
Left image, damage to storage facility building in Chungthang (photo: Ajay Chourasia);

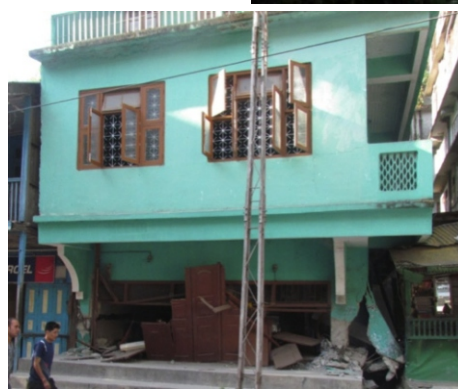
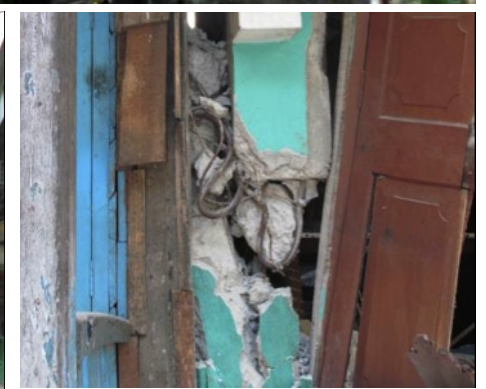
Middle and right image, collapsed three-story RC frame building at Singtam (photo: Alpa Sheth);

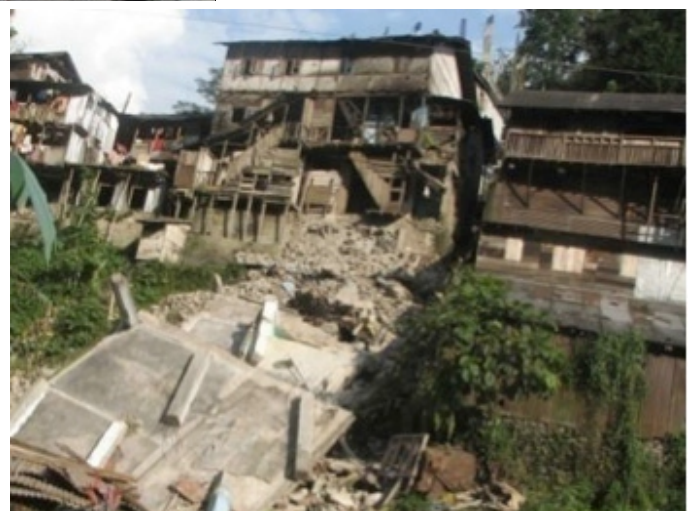
Bottom image, collapsed four-story house at Dikchu (photo: Hemant B. Kaushik).

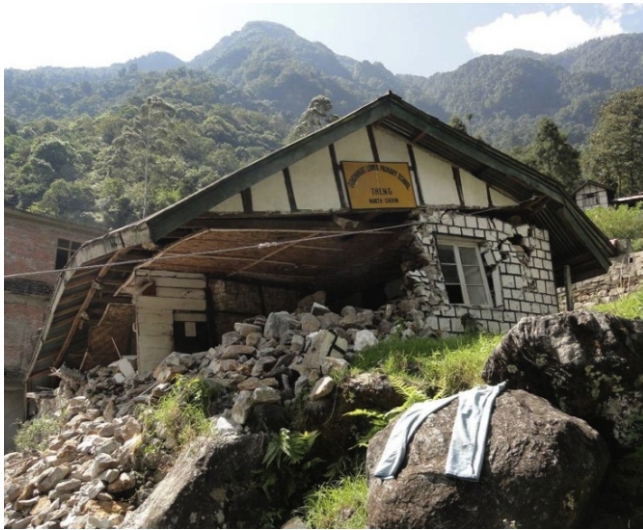
Fig. 7 Collapse of masonry building of the primary school at Tbeng (photo: Arvind Jaiswal).

Older schools are made of traditional Ekra construction, while the recent ones (including extensions and replacements structures) are URM and RC. Ekra construction performed relatively better than RC buildings, and damage to RC schools deprived the government of safe havens for post-earthquake relief camps and emergency services. Over 600 school buildings are said to have suffered extensive damage or collapse. One complete collapse of a school building was observed (Figure 7).

2. No new URM structures should be permitted in Sikkim, and existing ones should be retrofitted, especially the critical, life-line and government structures.
