# EARTHQUAKE HAZARD CENTRE NEWSLETTER

Vol.14 No.1

JULY 2010

### Summary of lessons for steel structures from the 2009 earthquake damage in Padang

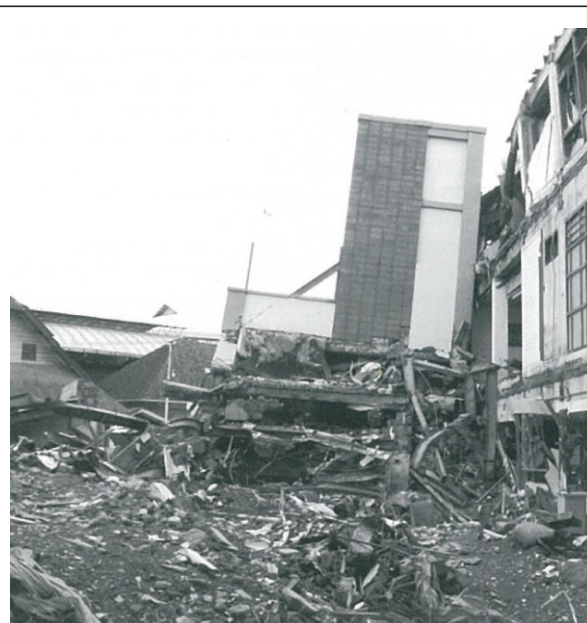
*Fig. 4 Collapsed 5 level two-way steel MRF addition to hotel.*

The collapse of a recently built five storey single bay width addition to an existing hotel involved a two way steel moment resisting frame (Fig. 4). The five storey addition totally collapsed under bending failure about the weak axis of what appear to have been concrete encased I-section columns. Brick infill panels are likely to have been incorporated with window openings into the outer wall line. The two way moment connections at the columns appeared to have maintained integrity, so it appears that the frame had not been able to cope with large displacements in the weak axis MRF.

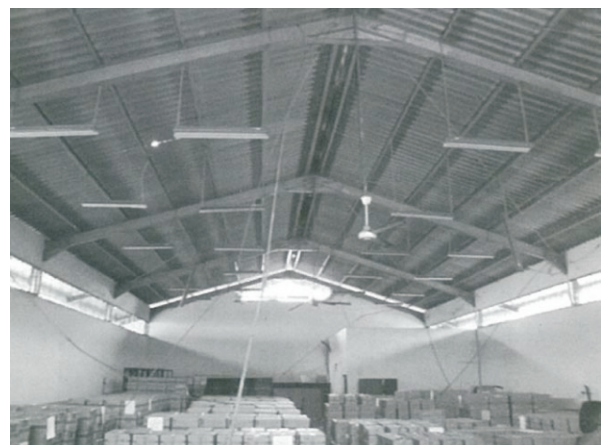
Diagonal rod roof bracing collapsed in a portal framed warehouse with high masonry walls. The rod bracing had broken free from the rafters after the failure of the weld connecting the rod bracing plate to the rafter (Fig. 5). The weld appeared to be a site weld, raising the issue of how to ensure site welding quality when performed at height. From a design perspective the weld should never be the weakest link in a primary structural member such as a roof bracing rod. The preferred hierarchy of failure is that ductile elongation of the rod itself protects against connection failure at the rod ends. The rod connection therefore needs to be able to cope with the over-strength demand of the rod.

*Fig. 5 Collapsed roof-level rod bracing in warehouse.*

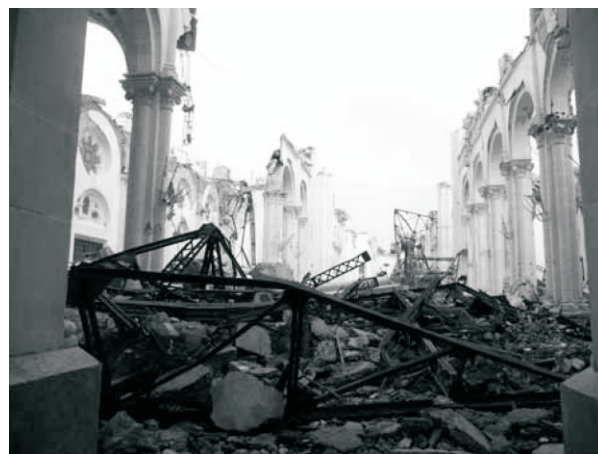
Fig. 6. Collapsed roof, interior of National Cathedral, Port-au-Prince (photo: Martin Hammer).

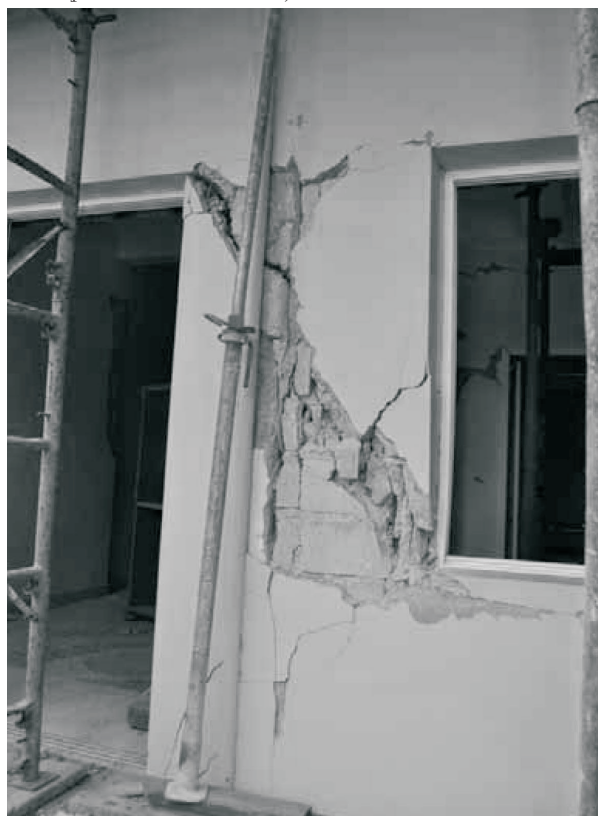
Fig. 7 Reinforced CMU wall from a hotel in Pentonville (photo: Amanda Lewis).

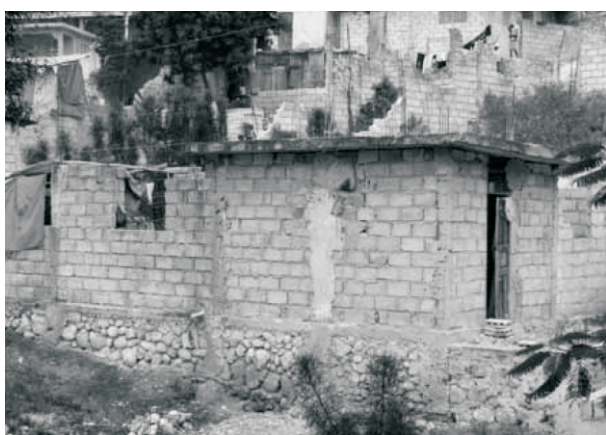
*Fig. 8. Typical construction of a residence, showing a rock rubble foundation, confined masonry construction technique, and reinforced concrete slab. Note blocks added to the top of the walls and reinforcement emerging from the slab, ready for construction of another level (photo: Anna Lang).*

lack sufficient cement and have high water content for workability and reduced cost (Fig. 8).

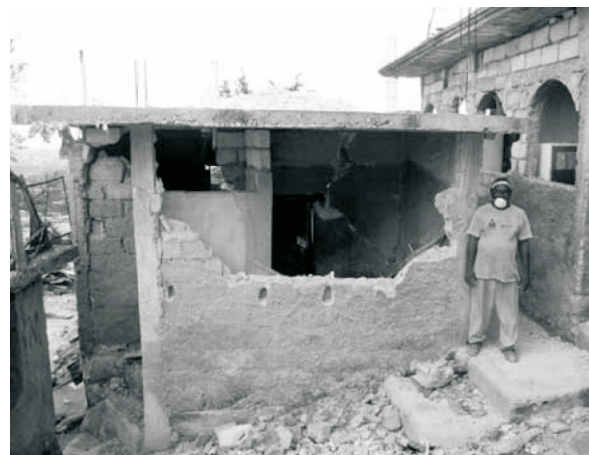
*Fig. 9. Typical out-of-plane failure of an infill masonry construction (photo: Anna Lang).*

bearing, and their strength capacity was reduced by a lack of friction between the blocks. Interaction between wall panels and columns resulted in localized damage, notably in the columns. Lateral capacity of the slender columns was generally insufficient to resist acceleration demands on the structure. P-delta effects ensued, proliferating collapse. Overturning and out-of-plane failures of wall panels were common place and caused the majority of complete structural collapses (Fig. 9). Even when they didn't contribute to building collapse, these out-of-plane wall failures caused innumerable injuries and deaths.

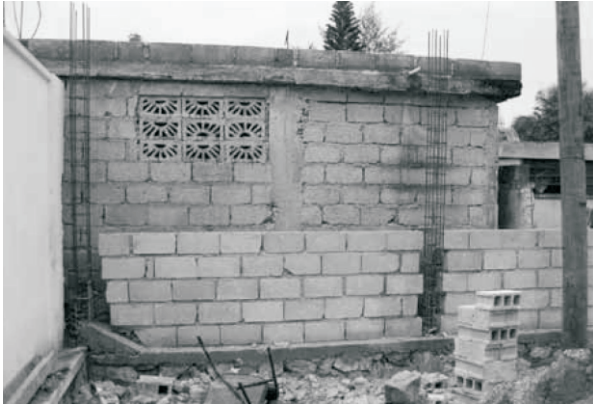
*Fig. 10. In foreground, new wall under construction shows staggering of blocks within the column cavity; this mechanically locks the masonry wall to the columns, causing them to act as a unit. In background, a typical one-story CM residence (photo: Anna Lang).*

Confined masonry structures generally sustained little or no damage during the earthquake (Fig. 10). A seemingly minor variation in the construction sequence resulted in very different behaviour. The confined masonry construction technique is similar to infill masonry, but walls are assembled first and then used to form the columns. If masonry blocks are staggered within the column cavity, a secure connection develops between the masonry wall and the columns. Instead of two structural systems acting independently, confined masonry performs as a singular system whereby lateral load is transferred from the column-slab connection to the walls directly. Though the walls are not load-bearing and therefore do not develop full capacity, they still contribute to the lateral resistance of the overall structure through the mechanical connection with the columns. Though of poor quality, this connection was sufficient to develop one-way bending and arching of the wall, greatly reducing out-of-plane failures during the earthquake.
