EARTHQUAKE HAZARD CENTRE

NEWSLETTER

Vol.16 No.3

JANUARY 2013

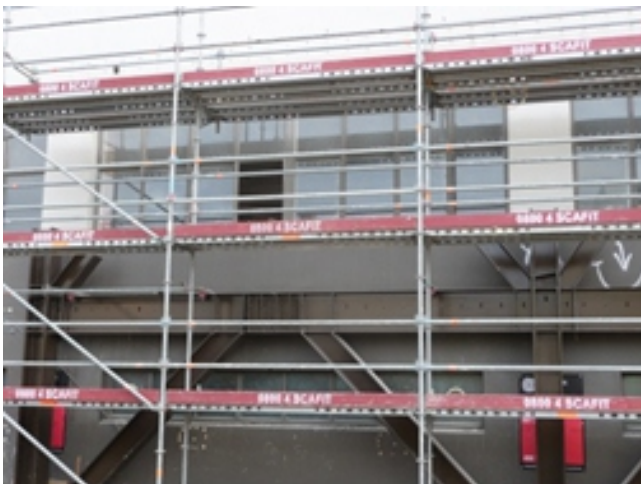
As can be seen in Figs. 1 and 3, the exterior frame consists of weak columns and strong beams. Because of its age which suggests non-ductile detailing, the building can be assumed to be both weak and brittle. In a moderate earthquake the exterior columns would probably fail in shear and be unable to support the weight of the building.

Fig. 1 The eccentrically braced frame with its beam at first floor.

To remedy these deficiencies new structural systems are being introduced into the building. On the northern face, the most effective solution has been to construct a new sprayed reinforced concrete wall. On the southern elevation, shown here, a three-bay eccentrically braced frame is being constructed on new cast-in-place piled foundations. Fig. 1 shows the top portion of the ground floor steel framing of the eccentrically braced frame. To provide a strong connection in order to tie the new frames to the existing building, reinforcing bars are grouted into the existing building to create a reinforced concrete corbel which is poured after the steel beam is in position and bolts along its length have been placed. This method satisfactorily overcomes problems of construction tolerances. Note that the plaster on the building surface has been removed and the concrete roughened so as the new concrete will bond strongly with the existing concrete. As the building is equally seismically vulnerable in the other direction, another two eccentrically braced frames, each of two bays will be constructed within the building. Conveniently, the building contains a full-height internal atrium. After new foundations are constructed, the new frames will be craned in over the roof and placed along two sides of the atrium and very strongly connected to the floor diaphragms.

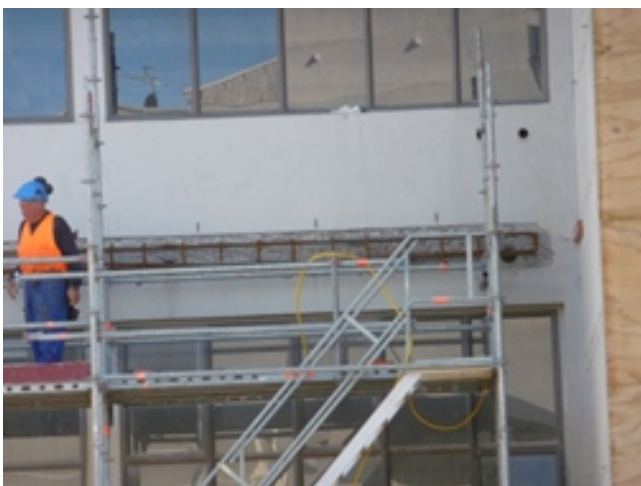
Fig. 2 Reinforcing tied into the existing building that will become the means of transferring seismic forces from the old into the new structure.

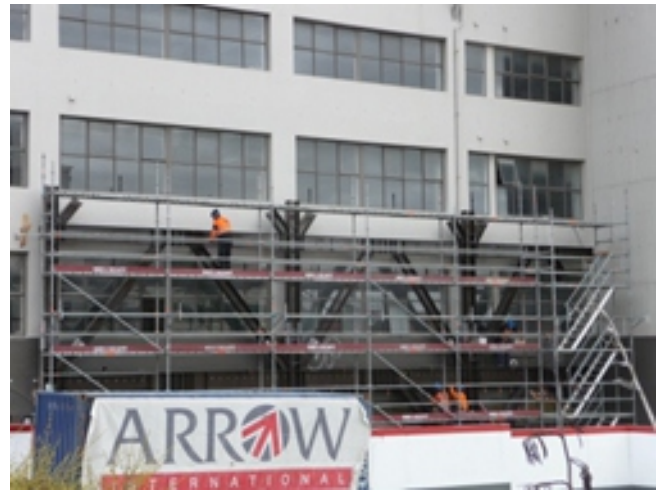
Fig. 3 The eccentric braced frame at the second storey level is being bolted to the steel framing beneath.

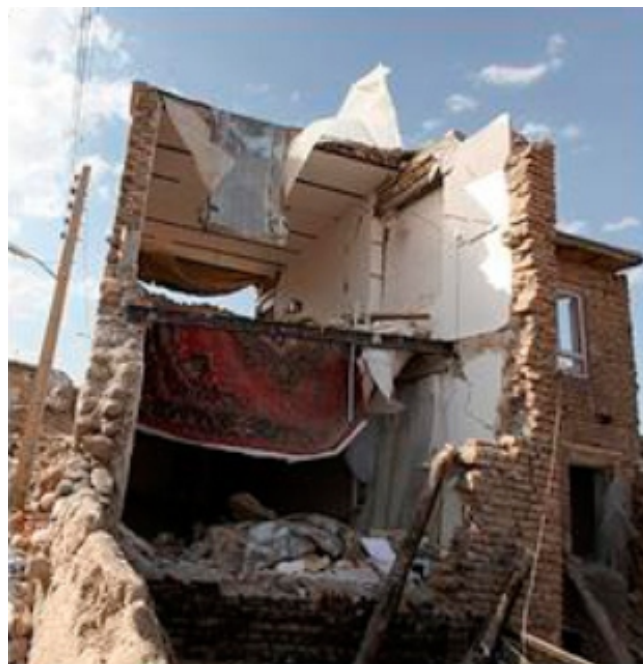
Fig. 4 Failure of heavy steel jack-arch and concrete roofs, and walls of unreinforced masonry buildings (photos: Mebr News Agency; Bastami).

plane failure of walls, and out-of plane failure of walls as shown (Figure 4). In general, performance of brick masonry buildings was better than that of adobe ones. Both framed (steel and RC) structures and brick masonry buildings are found in urban areas. No structural damage,

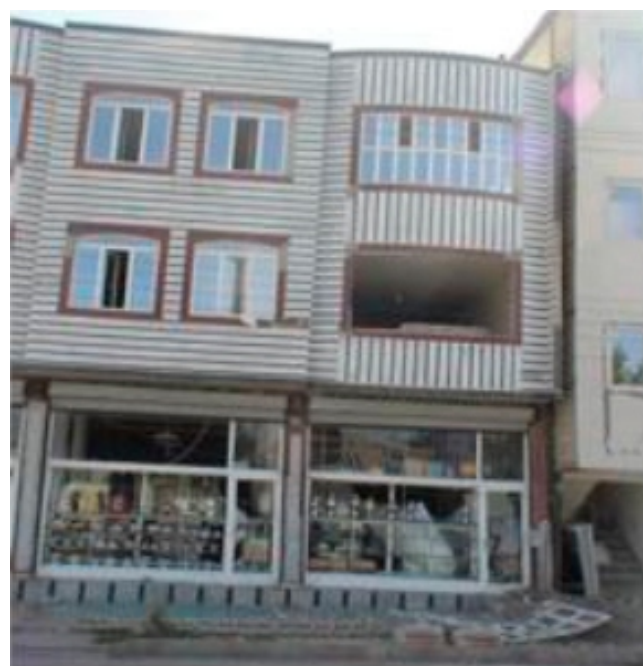
Fig. 5 Buildings that met minimum code requirements performed well (photos: Mebr News Agency; Kalantari; Bastami).

and little non-structural damage, was seen in residential buildings in Herris. However, residential buildings of different types were damaged in both Ahar and Varzaghan. Infill walls in some buildings cracked in the northern parts of Tabriz. Most buildings that met minimum code requirements survived the earthquake, as shown in Figure 5.

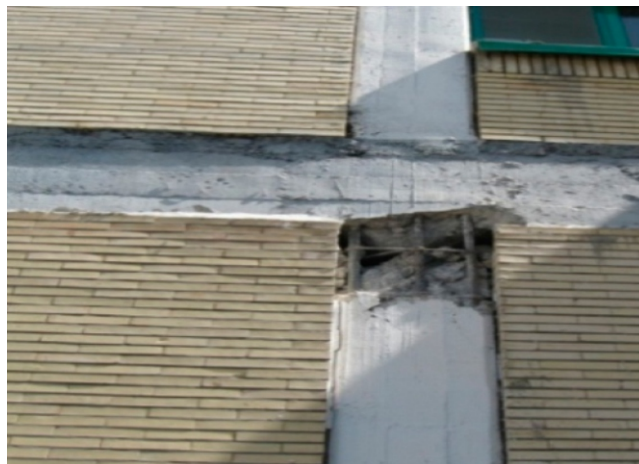
Hospitals: The performance of hospitals was unacceptable. The main Heriss Hospital, with a RC moment-resisting frame, had some structural damage due to plastic hinges and the failure of many columns near the beam-to-column joint (Figure 6). All of the observed plastic hinges were located in the columns of the first floor. Some of the columns had shear cracks next to the openings of the infill walls. In addition to the aforementioned failures, diagonal cracks were observed in some of the beams next to the column joint. The main reasons for poor performance were slipshod construction methods, low-quality concrete, and insufficient bondage of cement paste and the aggregates. Figure 7 shows photos of non-structural damage to the Herris Hospital: diagonal cracking and out-of-plane failure of infill walls, and failure of facades and false ceilings. The hospital was not operable after the earthquake. The Bagher-Al-Oloom Hospital in Ahar also had extensive non-structural damage and was put out of commission after the earthquake. In-plane failure of infill walls, failure of false ceilings, and overturning of medical equipment were the major problems.

Fig. 6 Herris Hospital structural damage: plastic hinges in beam column joints (center) and diagonal crack in a column (bottom).

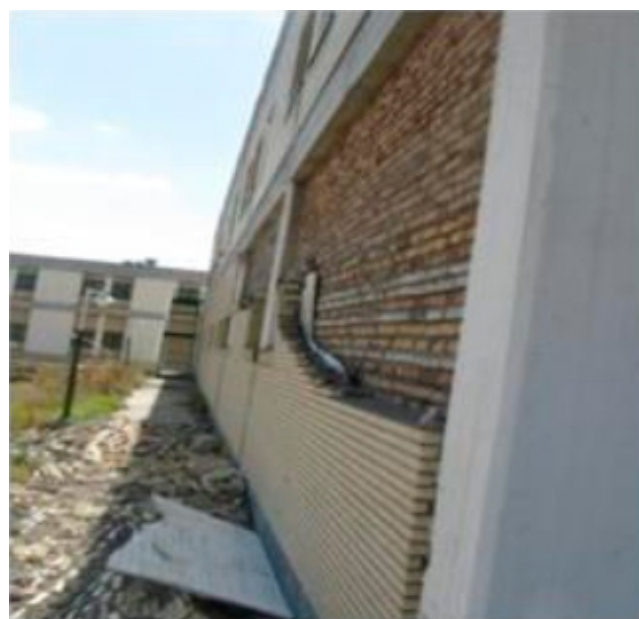
Fig. 7 Some of the nonstructural damage to Herris Hospital.

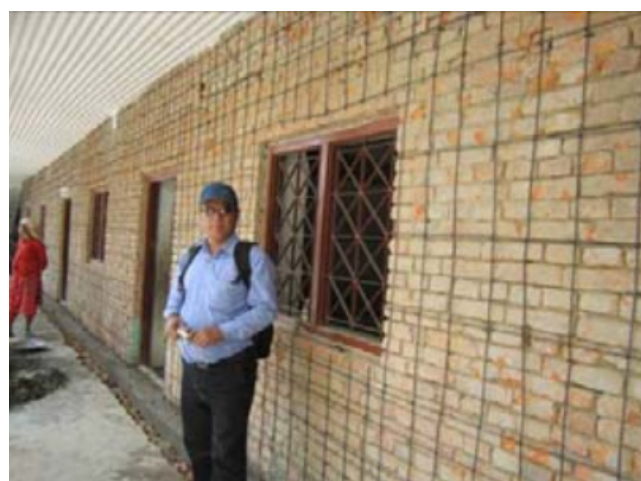
Fig. 8 RCC Jacketing of exterior walls.

The Figure 8 above shows reinforcement placed for jacketing of outer surface of the building and the Figure 9 shows the reinforcement details of the vertical splints and

horizontal bands in the inner walls of the buildings. These reinforcing bars are anchored properly with the wall through drilling holes and inserting galvanized steel bars throughout the wall cross-section. The size and spacing of the reinforcing bars differs in each buildings based on the design. These elements are supposed to hold the masonry unit as well as entire component of the building together to have box effect during an earthquake and minimize the extent of damage.

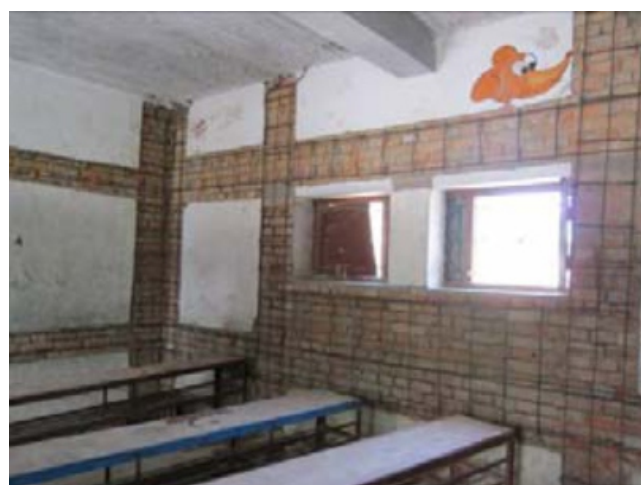
Fig. 9 RCC splints and bands on interior walls level.

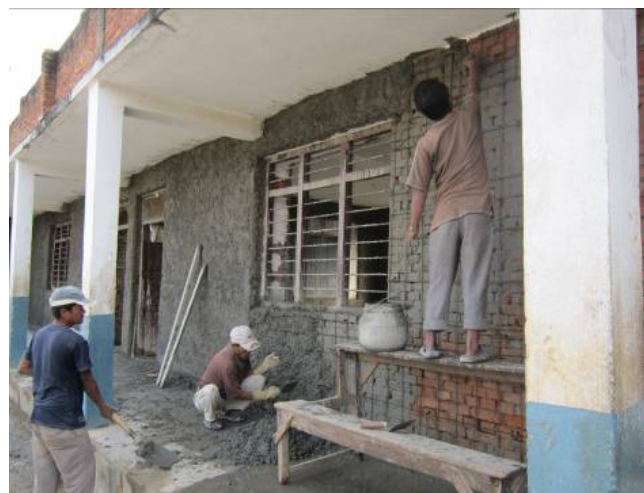
Fig. 12 Micro-concreting grouting.

Figure 12 above shows the masons grouting the reinforced wall with 50 mm thick micro-concrete of grade M20. Before applying micro-concrete, one coat of neat cement slurry was sprayed to ensure proper bonding of the concrete with the brick wall. Figure 13 above shows the final surface finish after 2 layers of microconcrete of 25 mm thick each was applied before plastering the surface. The final surface is ready for painting.

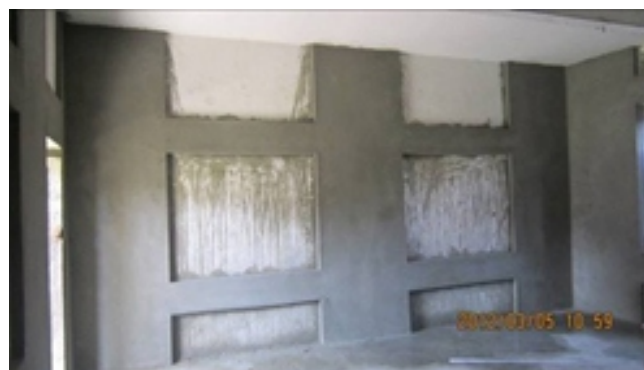
Fig. 13 Surface finish.
