EARTHQUAKE HAZARD CENTRE NEWSLETTER

Vol.17 No.2

OCTOBER 2013

A Summary of “Lessons to be Learnt from Seismic Disasters in Algeria”, by M. Chemrouk, from the Proceedings of the 15th World Conference on Earthquake Engineering, Lisbon 2012.

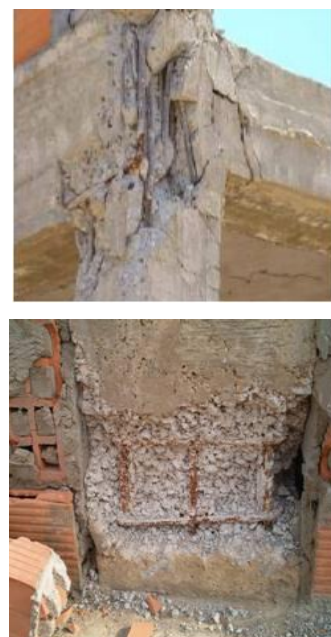
The necessary concrete mix should be carefully researched to obtain the targeted concrete material and the reinforcement detailing should be thoroughly examined by the control body before any concreting. In the construction process, full collaboration between the design office, the control body and the constructor is of a prime importance for a good quality construction that behaves as expected when confronted with a test of truth. Indeed, in many collapse cases examined, the construction process did not respect these steps and often the constructor did not have any site engineer; the lack of qualified workmanship with a tight supervision and better quality building materials appear to be the dominant technical causes of the earthquake disorders. In effect, it is worthless carrying out a sophisticated seismic design if it is not applied and fulfilled in practice at the construction stage with qualified engineers using a good quality building materials and good workmanship. The illustration in Figure 5 is a clear example of poor workmanship, leading

Fig. 5 Poor workmanship and bad quality concrete helped the seismic collapses.

to the neglect of transverse reinforcement at critical sections, and a bad quality building materials leading to concrete having very low strength; the deterioration of the concrete material and the corrosion of the reinforcement had started even before the earthquake.

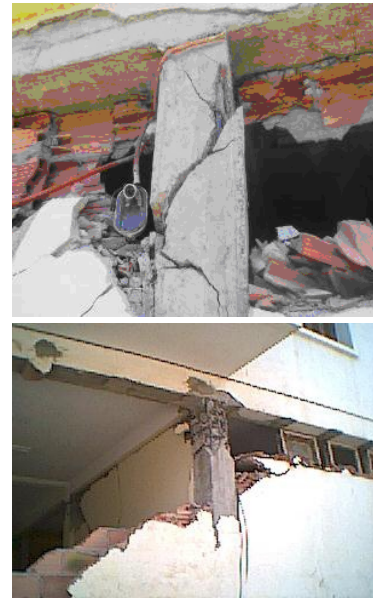
Inadequate seismic design and conception of concrete structures in a highly seismic region may also lead to collapses. Typically, the presence of short columns at the base of some buildings or the short column behaviour created at the lower floors by in-fill masonry or window openings has caused distinctive failures repeatedly as in Figure 6.

Fig. 6 Failure due to short column behaviour.

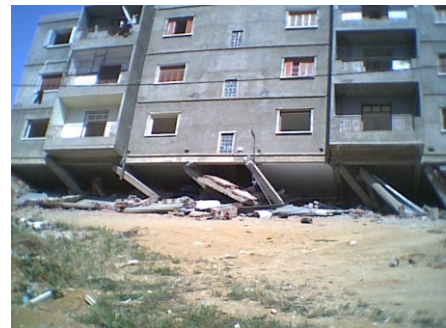
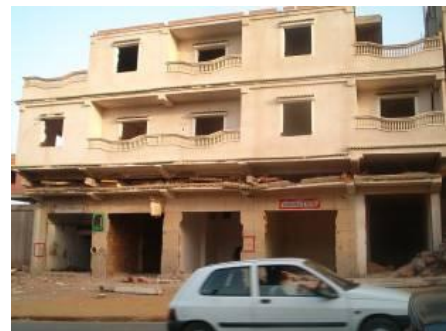
When designing a building, the stiffness of a given floor should not be too low by comparison to that of the adjacent upper and lower floors. This also implies that, for existing buildings, floors should not be transformed into open spaces for any reasons, putting down all the partition walls. This uneven distribution of floor stiffness creates the principle of 'a stiffer body resting on a soft base'. The presence of soft floors in highly seismic regions, whether due to inadequate conception or to a subsequent transformation of the building, leads undoubtedly to catastrophic collapses as in Figure 7 and hence should not be allowed.

Fig. 7 Failure due to soft floor effect.

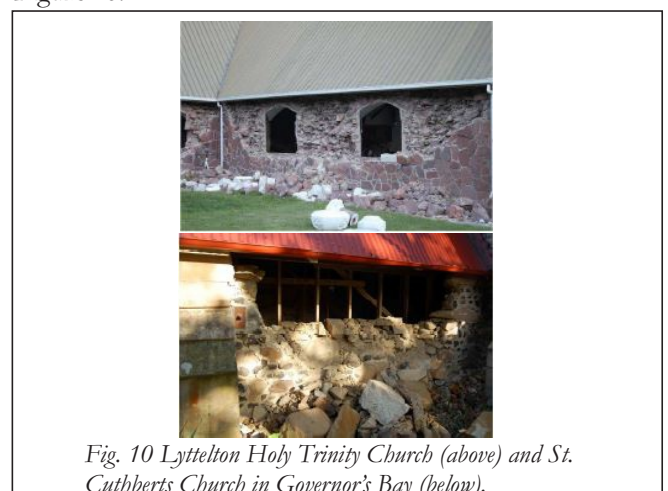
The quality of construction materials played a key role in the response of stone URM buildings. As previously described, one of the typical features of stone URM buildings in Christchurch is the different types of stone and mortar quality present in structures built with three-leaf walls. The use of soft limestone, such as Oamaru stone or the red tuff extracted in the Banks Peninsula, in conjunction with the use of low strength lime mortar, often led to poor earthquake response. Examples of such behaviour, frequently caused by hammering of the roofing system on the walls, include the Holy Trinity Church in Lyttelton, which is one of the oldest buildings in Canterbury, and St. Cuthberts Church as represented in Figure 10.

Fig. 10 Lyttelton Holy Trinity Church (above) and St. Cuthberts Church in Governor's Bay (below).

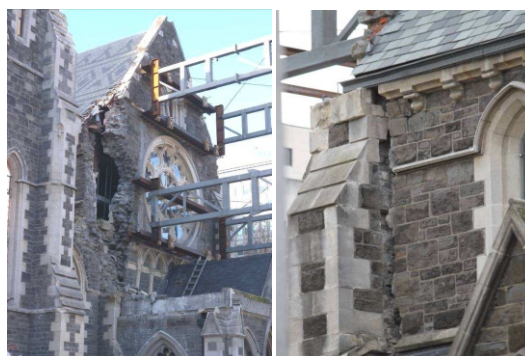
Out-of-plane failure mechanisms - an example of out-of-plane failure is shown in Figure 11 relative to the main façade of the Anglican Cathedral (now partially collapsed after the 13 June 2011 earthquake and aftershocks).

Fig. 11 Christchurch Anglican Cathedral: out-of-plane overturning of the front façade.
