EARTHQUAKE HAZARD CENTRE NEWSLETTER

Vol.17 No.3

JANUARY 2014

A summary of the Seismic Performance of Confined Masonry Buildings from “Seismic Performance of Engineered Masonry Buildings in the 2010 Maule Earthquake”

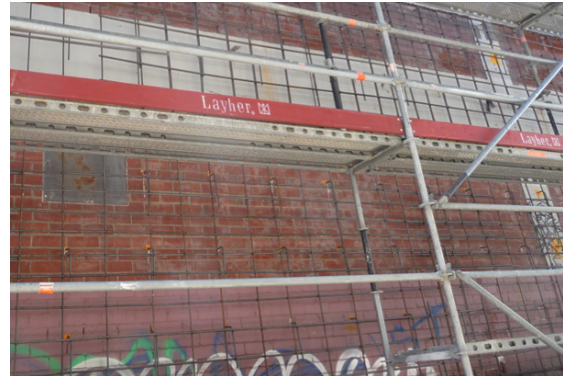
The approach taken in this building is to provide new reinforced concrete shear walls to enable the structure to meet current standards of seismic resistance. On two perimeter walls of the building it is possible to construct external walls, while other walls have been constructed inside. Before wall construction begins, extensive foundation work is required. Small-diameter tension-capable piles are drilled at the ends of each wall and then the pile reinforcement is bound into new reinforced concrete foundation beams approximately 600 mm deep. Vertical starters from these beams rise up the walls to begin the vertical steel which is tied to horizontal bars that resist wall shear forces (Figure 1).

Fig. 1 The rear wall of the building and the reinforcing cage for a new concrete wall.

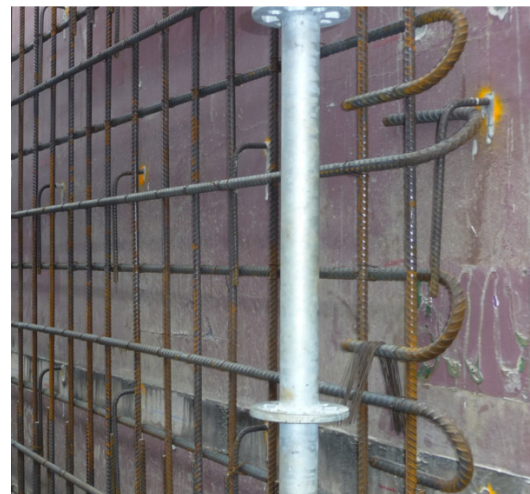
The new concrete walls must be strongly tied to the existing walls. That is achieved by horizontal grouting of steel bars into the masonry and tying the reinforcing cage to them (Figure 2).

Fig. 2 Grouted-in bars, bent into the wall thickness, provide the temporary attachment points for the wall reinforcing and strongly connect new construction to the old.

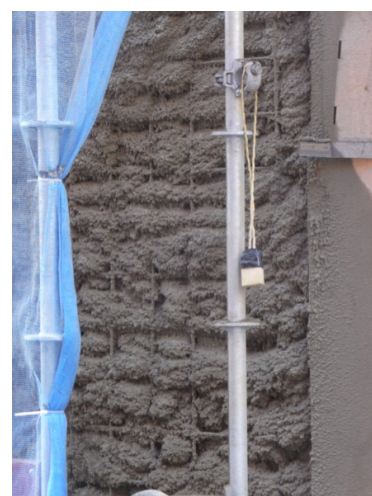
Before applying the concrete, in the form of shotcrete, a finer steel mesh is placed to prevent the freshly-applied concrete peeling off and falling. Once the concrete is placed (Figure 3), and after a short wait, the outer surface is worked over with trowels to achieve a smooth finish.

Fig. 3 The concrete has just been applied. It is trowelled over to form a smooth finish.

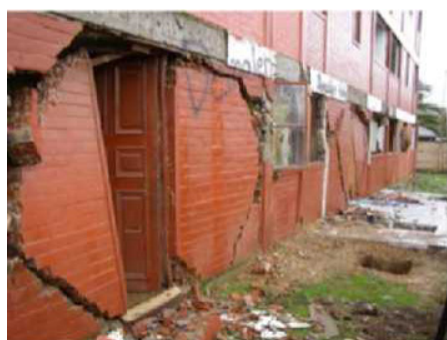
The most common damage pattern observed in unreinforced masonry walls in confined masonry buildings was in-plane shear cracking, which is characterized by diagonal (X-shaped) cracks. In-plane shear cracking occurs when the masonry tensile strength is exceeded due to the effect of combined shear and gravity loads. Alternatively, stair-stepped shear cracks develop due to sliding shear at the mortar bed joints due to a loss of bond at the mortar-to-unit interface. This type of damage was

mostly observed at the bottom floor level of three- and four-story buildings, as shown in Fig. 7a. Shear cracking was observed in walls built using all types of masonry units, including hollow clay tiles, clay bricks, and hollow concrete blocks. More extensive damage was observed when masonry walls were not confined at the openings (see Fig. 7b); this confirms the findings of a previous Chilean experimental study. Absence of RC tie-columns at openings is believed to be one of the main causes of severe damage in confined masonry buildings.

Fig. 7 In-plane shear cracking of masonry walls: (a) Damage at the ground floor level of a three-story building in Cauquenes and (b) shear cracking of an unconfined masonry pier (note a RC tie-column located at the center of the pier highlighted with an ellipse).

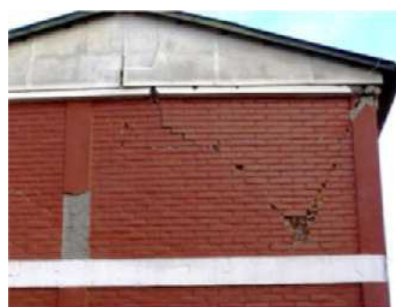
A few instances of wall damage due to out-of-plane seismic effects were observed. One notable example was a three-story building in Cauquenes with the damage concentrated at upper floors, as shown in Fig. 8a. The building had RC floors and a timber truss roof. Cracks in the third-floor wall panel extended into the RC tie-beam, as shown in Fig. 8b (note that the tie-beam is wider than the wall). The out-of-plane damage was observed in the transverse direction of the building (note that the building was severely damaged in longitudinal direction due to in-plane seismic effects).

Fig. 8 Out-of-plane damage of confined masonry buildings: (a) Wall damage at the top floor level and (b) damage in the RC perimeter beam.

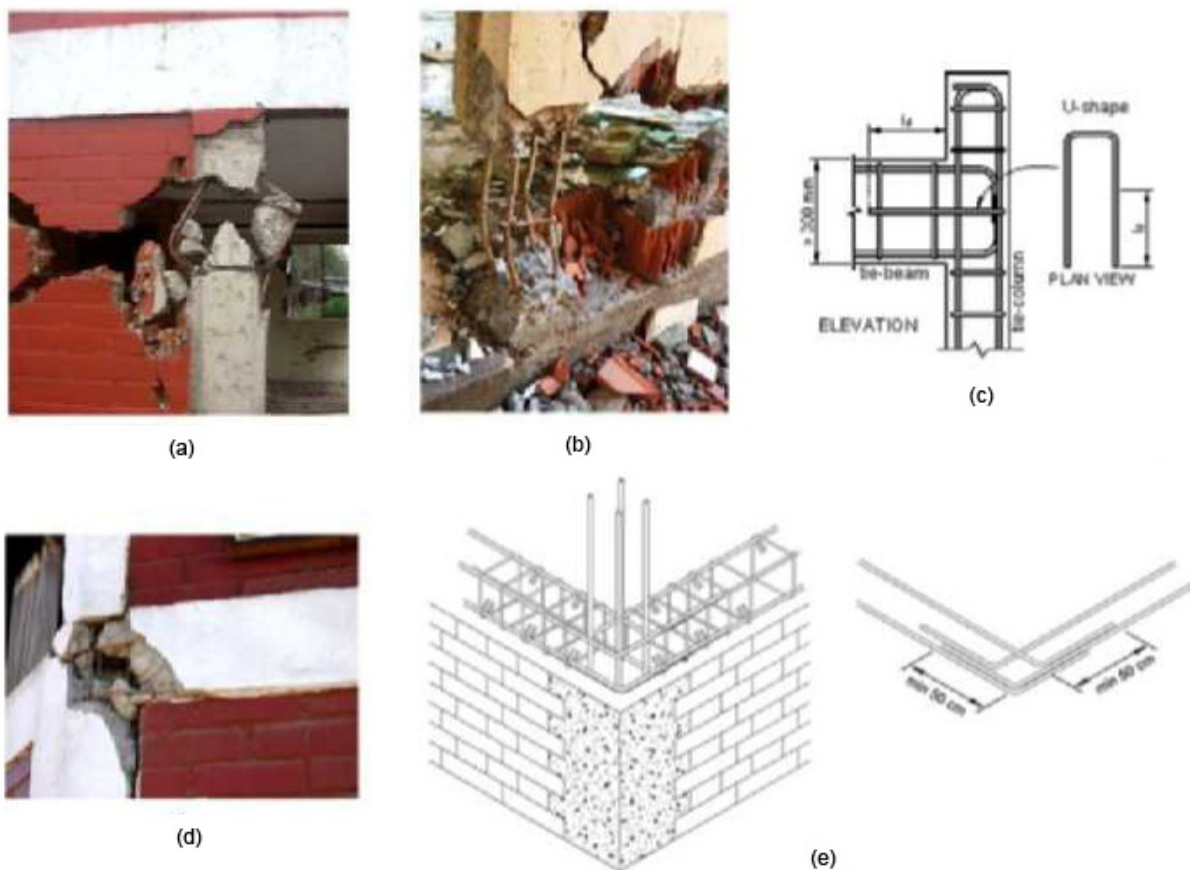
Inadequate confinement (tie size and spacing) at the ends of RC tie-columns was observed in all damaged buildings. The code and other design guidelines prescribe a closer tie spacing of 100 mm in end regions compared to the middle portion of a tie-column (200 mm). Buckling of longitudinal reinforcement was observed where size or spacing of ties at tie-column ends was inadequate, as shown in Fig 9a, and the masonry crushing was severe, as shown in Fig 9b. The buckling took place due to excessive combined compression and shear stresses developed

Fig. 9 Construction and detailing deficiencies in the RC tie-columns: (a) buckling of longitudinal bars; (b) severe crushing at the wall toe; (c) additional confinement for vertical reinforcement in the tie-beam and tie-column end joint region (EERI 2011); (d) discontinuous longitudinal reinforcement, and (e) recommended detailing practice.

in RC tie-columns after the masonry was crushed and disintegrated at the wall toe.

Inadequate detailing of reinforcement in tie-column-to-tie-beam joint zones was observed in all cases where the joints were exposed. An absence of ties in end columns is a deficiency, and it causes a severe damage in the joint zone. A good practice would be to provide additional ties, as shown in Fig 9c. Another deficiency is related to a lack of continuity in longitudinal reinforcement through tie-beam intersections with end columns, as shown in Fig. 9d. This is contrary to Chilean detailing provisions for reinforced concrete structures, which state that “longitudinal bars should have a 90° hooked anchorage at intersections to ensure the effectiveness of tie-beams to resist earthquake load,” as shown in Fig 9e. It should be noted that reinforcement cages for tie-beams and tie-columns are often assembled off the building site, therefore additional “continuity reinforcement” should be provided once the cages are placed in the final position.

2. **Closer spacing of ties in end zones of RC tie-columns is critical for maintaining their stability and strength.** Inadequate confinement (tie size and spacing) at the ends of RC tie-columns was observed in all damaged buildings. Adequate bar size and tie spacing in the end zones of RC tie-columns is critical for preventing shear failure and buckling of longitudinal reinforcement in localized areas of tie-columns where masonry is completely disintegrated.
