# EARTHQUAKE HAZARD CENTRE NEWSLETTER

APRIL 2015

# A Summary of the paper “Lessons Learnt from Damage to Buildings by Bohol Earthquake and Typhoon Yolanda 2013 in the Philippines,”

by Tatsuo Narafu, Toyokazu Shimizu, Yasushi Sanada, Yukio Tamura, Noriyuki Mita, Susumu Takahashi, Hayato Nakamura, Atsuko Itsuki. From Bulletin of ISEE 49, 39 – 61, 2015.

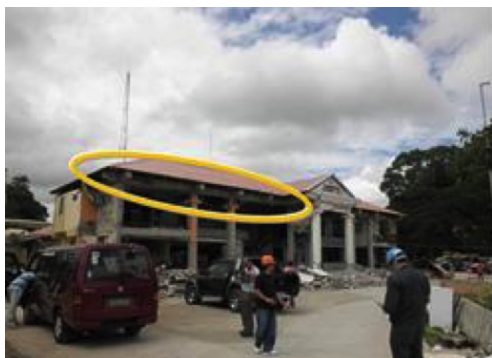
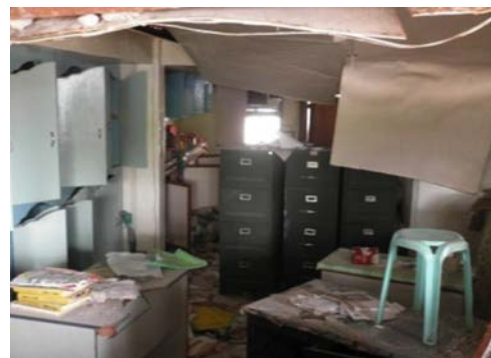
The highest intensity of the shaking motion reported was VII in PHIVOLCS Earthquake Intensity Scale (PEIS). Many totally collapsed buildings were found to have furniture standing inside them. Figure 1 shows an example of Municipal building of Sagbayan, Bohol. The left photo shows heavy damage to exterior walls, partition walls, ceilings and other elements in spite of limited damage to the structure. The right photo shows inside the buildings where most of cabinets, lockers and other furniture were found standing. Usually in developed countries, buildings collapse in far stronger shaking motions than those that cause furniture to fall. This implies buildings in the affected areas are very vulnerable.

Figure 1. Municipal building of Sagbayan, Bohol. (Left): Heavy damage to partition walls and other elements, and (Right): inside the buildings.

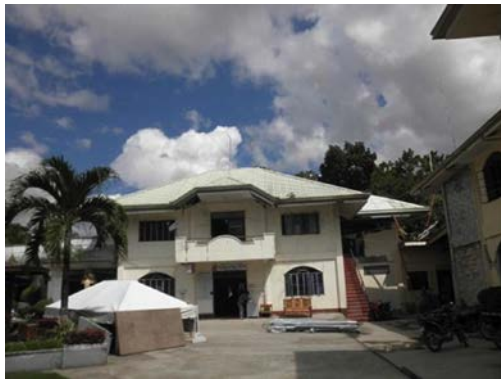
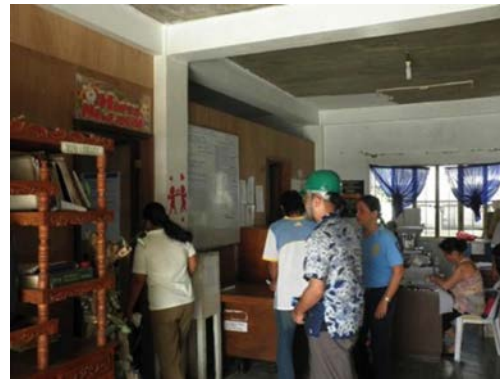
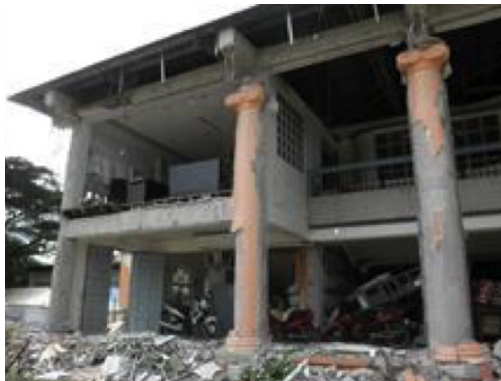
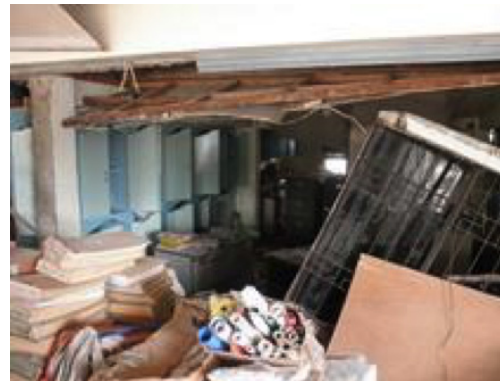
*Figure 2. Huge differences in damage among municipal buildings of Antequera and Sagbayan, Bohol. (Upper left): Municipal office of Antequera (Building 2). (Upper right): First floor. (Lower left): Municipal office of Sagbayan. (Lower right): Interior view of Lower left.*

structural members. Huge differences in the degrees of damage were observed. Figure 2 shows differences among municipal buildings of Antequera and Sagbayan, Bohol. Upper left photo shows the Municipal office of Antequera (Building 2). It suffered little and the upper right shows the conditions of the first floor of the upper left that enabled it to start operation soon after the earthquake. The lower left photo shows the exterior view of the Municipal office of Sagbayan. Lower right photo shows heavy damage to non-structural members such as partition walls and ceilings while damage to the structure was limited. This building will be demolished due to the damage.

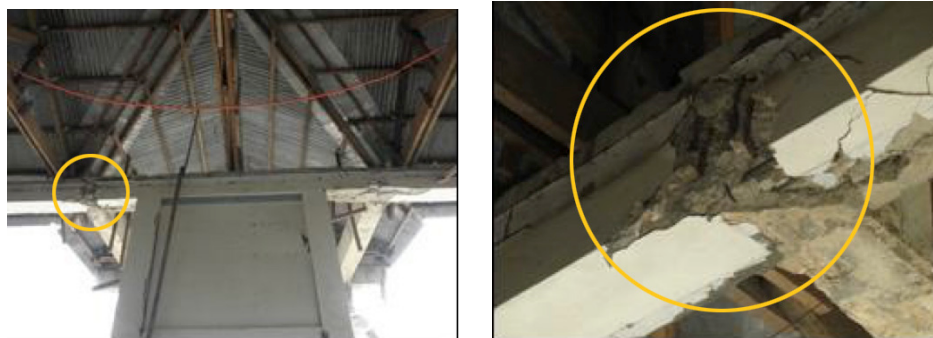
Several cases of damage from improper structural design were found during the field surveys. Typical ones are shown in Figures 2, 3, 4 and 5. The irregularities shown in Figure 3 are beams of the canopy not attached to the main structure in a consistent manner and were connected to a beam without support from columns. In Figure 4 levels of beams differ, causing unexpected stress in columns. Figure 5 shows irregular configuration of columns and

*Figure 3. An example of improper structural design in Municipal building of Sagbayan, Bohol (For exterior view: refer to Figure 1). (Left): damaged connection of beams of canopy and main structure, (Right): Detail of the damage.*

More redundant design is recommended which could avoid serious damage even when buildings have a certain level of inaccurate construction. A push-over analysis could also be an effective tool in addition to the usual design method. It provides the deformation of the structure by push-over loading (large deformations that cause serious cracks in the concrete and failure of the cover concrete). It provides: 1) the failure mechanism of total structures which informs possible vulnerable types of failure such as failures at ends of columns, which might lead to total collapse of structure, 2) the types of failure (shear failure or flexural) at each point, which suggests an effective way of improving the resilience of the total structure, and 3) deformation of each of the storeys, which might indicate possible soft story collapse. All this information could contribute to realizing more redundant designs by avoiding vulnerable types of failures and increasing resilience.

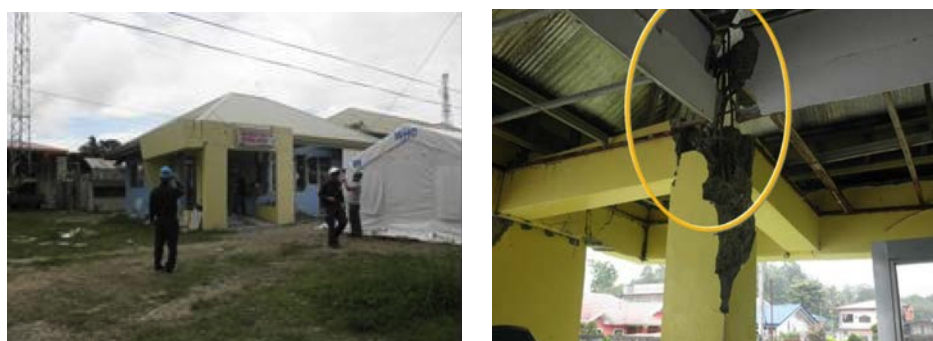
*Figure 4. An example of improper structural design. (Left): Exterior view of District Health Care Center of Sagbayan, (Right): connection of a column and beams.*

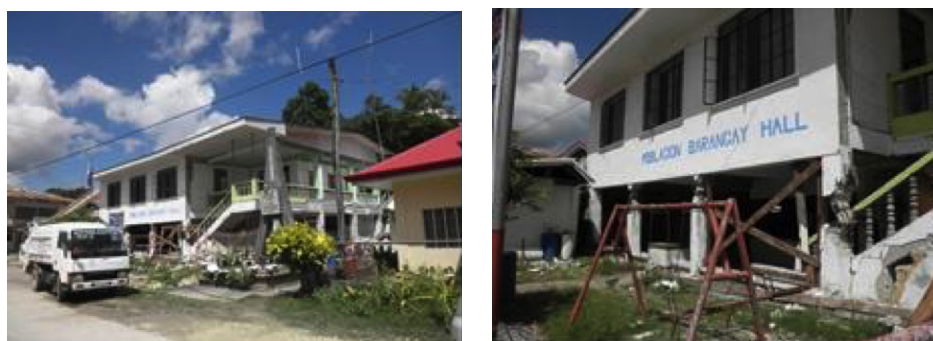
imbalanced layout of non-structural walls which invite torsion on the total structure.

*Figure 5. An example of improper structural design in Barangay office in Antequera. (Left): exterior view, (Right): damaged columns by irregular configuration.*

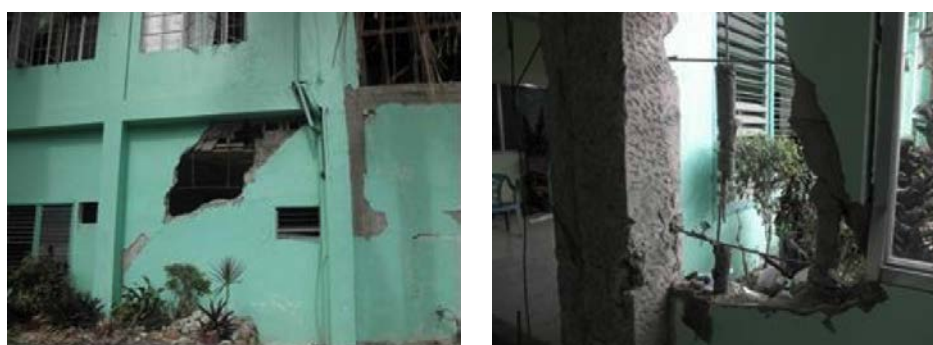
Damage to non-structural members dominated. Among them, concrete hollow block (CHB) walls were one of the most commonly damaged. One of the major causes of the damage is the poor strength of CHB. It was often observed that rebar and mortar filled the cavities, but most of the CHB disappeared due to its extremely low strength like in Figure 6. Regarding damage to ceilings, use of usual types of nails to fix ceilings is one of the causes of heavy damage. Appropriate nails with large diameter heads or nails with washers should be used.

*Figure 6 An example of poor quality of concrete hollow blocks (CHB). (Left): Damaged non-structural walls in Municipal Office of Catigbian. (Right): Details of a damaged wall.*

CHB non-structural walls (cladding walls and partition walls) are one of the most vulnerable of all building elements to ground shaking motion. Several issues need to be solved such as: 1) strength of the CHB, 2) filling and compaction of grout in the cavities, 3) installation of reinforcing rebar in CHB walls, and 4) connection of CHB walls to columns and beams.

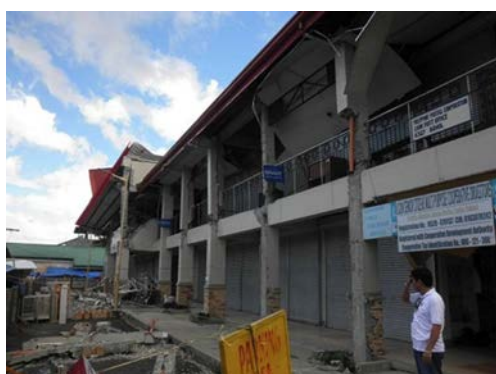
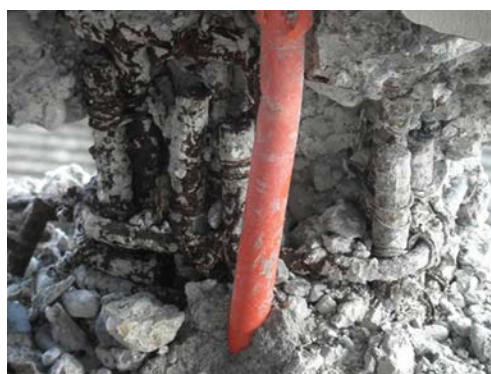
Poor workmanship seemed to be another dominant cause of damage in Bohol. The authors found various types of defects shown in Figures 7 - 12. In the case of Figure 7, several improper construction practices were identified. Longitudinal rebars were positioned inaccurately (placed inside rather than in the designed position). All the overlap splices of longitudinal rebars were located at the same level

at a critical position, the bottom of the columns. (A red pipe in right photo is for electric wire installation). In the case of Figure 8, failure of concrete occurred at one of the most critical structural areas, beam-column joints, where hoops were absent (right photo). Honeycomb caused by insufficient compaction of the concrete was often found (Left photo of Figure 9). There were some cases where pieces of board penetrated into columns in order to prevent fresh concrete coming out through gaps between formwork panels (Right photo of Figure 9). Figure 10 shows improper rebar bending. The left photo shows spacing of hoops that is too large, which reduces their ability to confine the concrete and the right photo has several poor rebar details: bending of the hooks of hoops is only 90 degrees, and all the overlap splices of the longitudinal rebars are located at the bottom of a column.

Figure 7. Examples of improper rebar works in Market Building in Loon: (Left) Heavy damage at the bottom of most of columns, (Right) Detail of the damage.

Regarding the sections of columns or beams, most of them have no description about the position of rebars. The designed position could be figured out only when the concrete cover thickness on another sheet of drawings was referred to. Workers without enough technical knowledge, who think the number of rebars is significant but their position is unimportant, might cause defects and damage like in Figure 7. Another possible way to avoid this kind of problem could be training to make standard coverage of concrete detailing to be common knowledge to all workers.

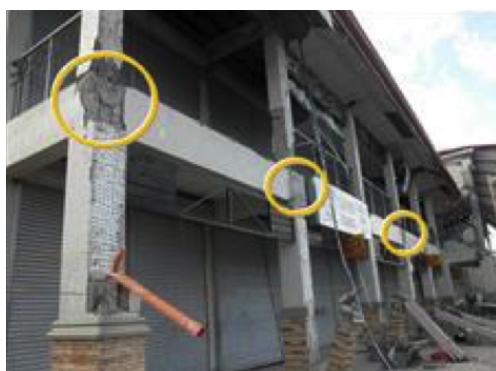
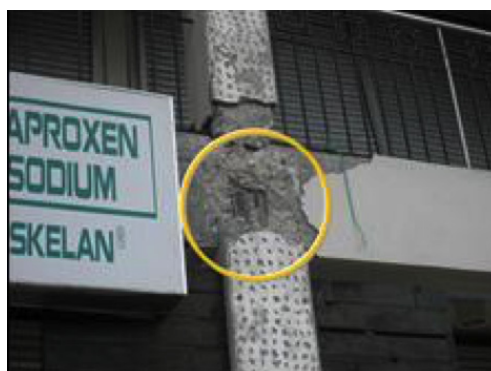
Figure 8. An example of improper rebar works in Market Building in Loon: (Left) Failures at panels, (Right) Detail of damaged part.

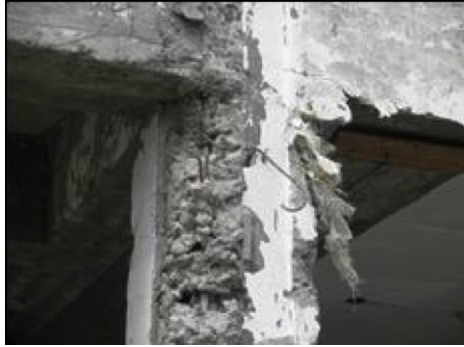
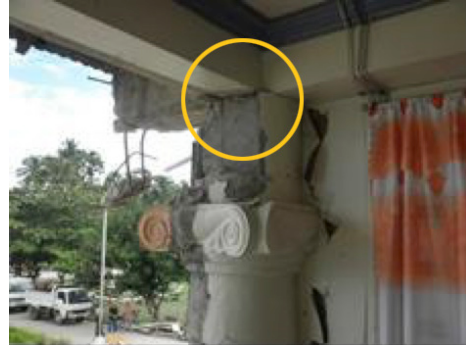
Figure 9. Examples of improper concrete placing: (left) Market Building in Loon, (Right) Sagbayan Municipal Office.

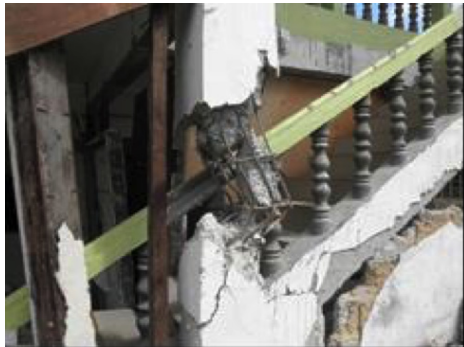
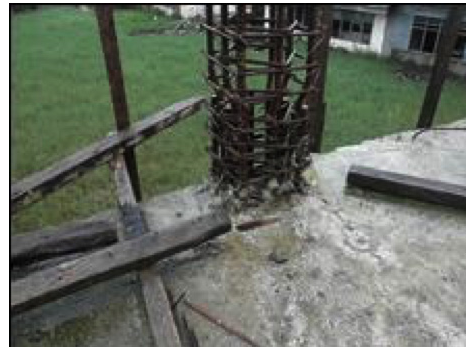
Figure 10. Examples of improper rebar works: (left) Barangay Office in Antequera, (Right) A building under construction, Basesy National High School.

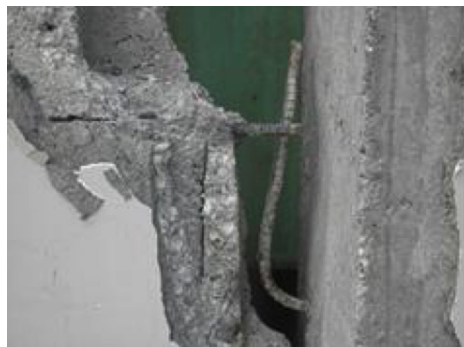
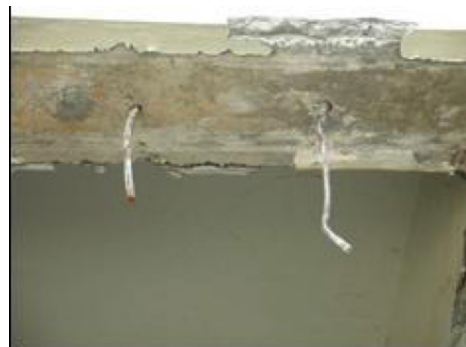
Figure 11 shows examples of poor anchorage of CHB walls to RC members in the Market Building of Loon. The left photo shows a horizontal rebar in a wall that is not correctly anchored to a column and on the right an anchorage to a beam seems inadequate.

Figure 11. Examples of improper anchorage of CHB walls to RC members in Market Building of Loon: (Left) a case of horizontal rebar, (Right) a case of vertical rebar.

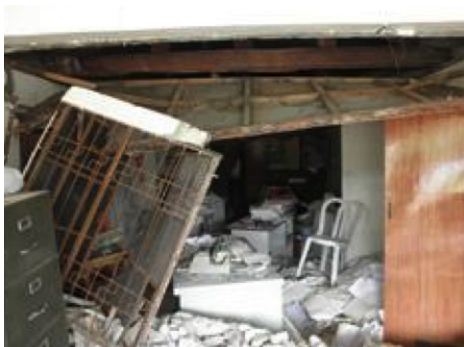
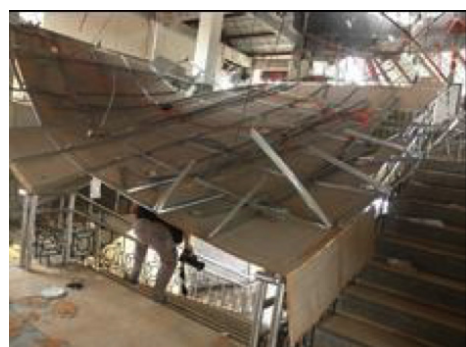
Figure 12 shows damage to ceilings. The left photo shows the extreme damage to most of the ceilings damaged in the Sagbayan Municipal Building, and the right is a case of a ceiling of the second floor that fell down onto a stairway in the Market Building in Loon.

Figure 12. Examples of improper fixing of ceiling boards: (Left) Sagbayan Municipal Building, (Right) Market Building in Loon.

only covers type and quality of materials and not the design of ceiling frames and hangers, and fixing methods like the type of nails and their spacing. Therefore workers might not understand the proper way of fixing, and fix them in a way which might result in the defects and damage shown in Figure 12.

Ceilings are other heavily damaged elements. Damage is caused both by the shaking motion affecting nail fixings and collisions of adjacent ceiling boards or against walls.

Supporting frames, hangers, nails and spacing all need to be described clearly so foremen and construction workers know how to construct ceilings as shown on design documents.
