EARTHQUAKE HAZARD CENTRE NEWSLETTER

Vol.15 No.3

JANUARY 2012

M_w 7.1 Eastern Turkey Earthquake on October 23rd 2011

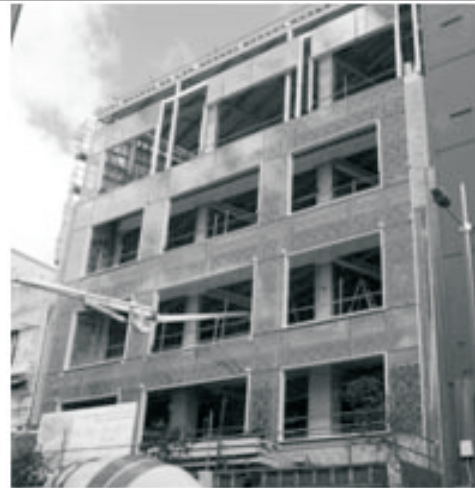
On this virtual site visit we observe a five storey commercial building under construction. At this stage decorative glass façade panels are being attached. They suggest a three bay moment frame behind them - which is indeed the case, but unlike most buildings, the frame is set back several metres into the building (Fig.1).

Fig. 1 Façade panels under erection with structural frame behind.

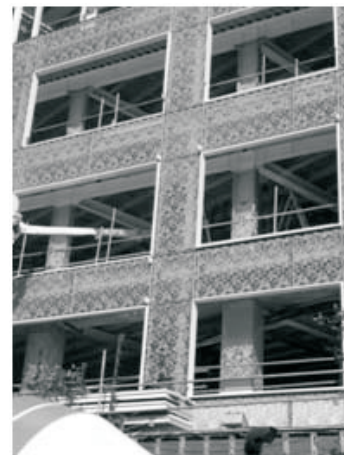
Fig. 2 The RC columns of the lower two storeys and the upper steel

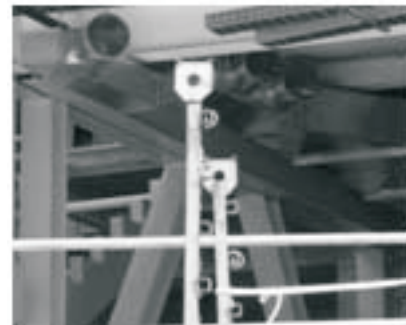
Fig. 3 One bay of a longitudinal eccentrically braced frame.

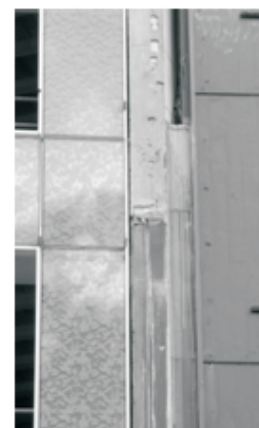
Finally, note the seismic separation gap between the new and existing building (Fig.4). It is always necessary to build back from one's site boundaries so that, during an earthquake, a building doesn't deflect beyond that line and hammer an adjacent building. Most seismic codes specify the gap that must be provided between the new building and a boundary. The width of the gap depends on a number of factors, but is most sensitive to the flexibility of the building. In order to minimize gap width a stiff, rather than flexible, structural system, is designed. Sometimes designers need to size the structure, like these moment frames, to limit deflections and hence gap widths, rather than to ensure sufficient strength which is less critical.

Fig. 4 The seismic gap between two buildings. The upper section of flashing has yet to be installed.

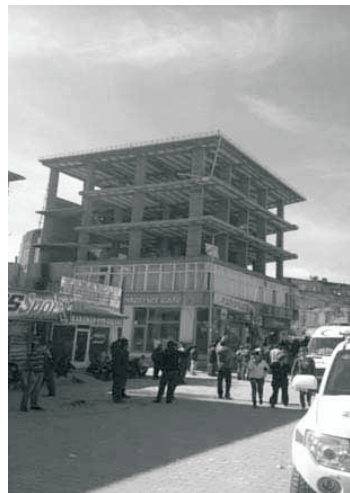
Buildings in Van and Ercis Center are predominately 4-8 storey reinforced concrete structures, which is a common in Turkey. In most of these buildings, asmolten slab (in filled joist slab) is used. This system has been observed in many collapsed buildings where two times the normal floor height have been determined. In the villages, buildings consist of mainly adobe, stone and brick masonry construction. These one or two storey buildings are often built by local people without considering regulation, standard and earthquake resistant design rules. In the masonry structures the horizontal and vertical supporting members are made from wood and many are inadequate and placed irregularly. Furthermore the lengths of their connections to load bearing walls are short and weak. The main reasons of damage can therefore be attributed to poor quality construction materials, structures with non-conforming earthquake code and lack of inspection (Fig 5-8).

Fig. 5 Weak storey and asmolten slab

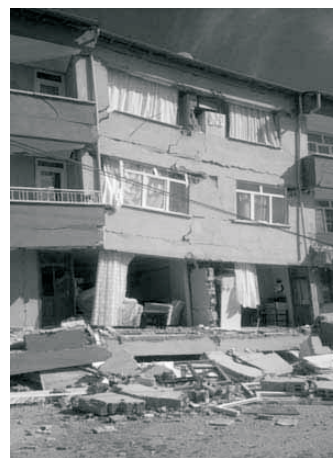
Fig. 6 Ground floor destroyed

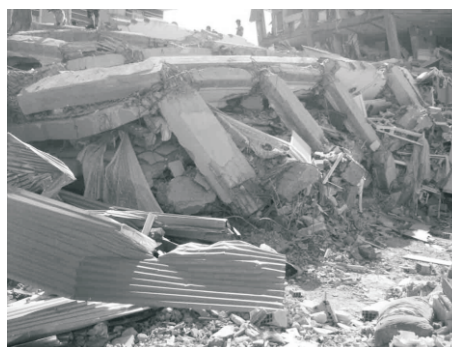
Fig. 7 Example of a collapsed RC frame building

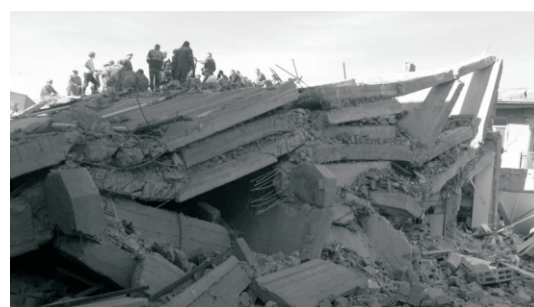
Fig. 8 Weak storey example

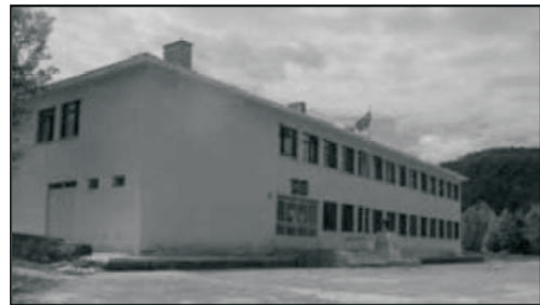
Fig. 10 Two-storey template reinforced concrete dual system school building in Kaynasli near Duzce. Building did not sustain structural or nonstructural damage during august 17,1999 and November 12, 1999 Duzce earthquakes.

Figure 10 shows a two story reinforced concrete dual system template school building built according to the 1975 Turkish seismic code. Despite close proximity to the fault, the dual system building sustained no damage during the two earthquakes in 1999.

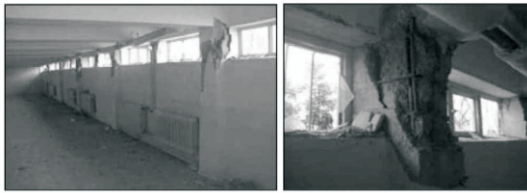
Fig. 11. View of dual system reinforced concrete template school building in Duzce after November 12, 1999 Duzce Earthquake. Captive exterior columns in basement failed.

Figure 11 shows another dual system reinforced concrete template school building. This one is four stories and sustained no damage in its shear walls. However the structure suffered heavy damage at its perimeter columns at the basement level. The infill masonry walls restrained the perimeter columns forcing them to deform over a very short length resulting in the formation of a captive column condition. As such, the captive columns failed in shear before they could develop their flexural capacity fully.

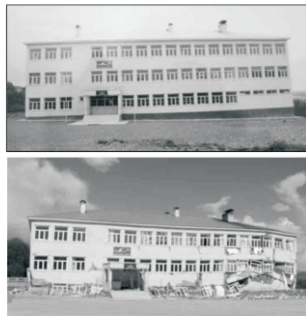
Fig. 12 Three story reinforced concrete moment-frame template school building with captive columns in Bingol before and after the may 1, 2003 Bingol earthquake.

The performance of template school buildings in which reinforced concrete moment-resisting frames form the lateral load resisting system were documented after the May 1, 2003 Bingol earthquake. Figures 12-13 show a three-story school building in Bingol after it was built in 1999 and after the 2003 Bingol earthquake. During the earthquake, the first-story columns failed, lowering the second floor to the ground level.

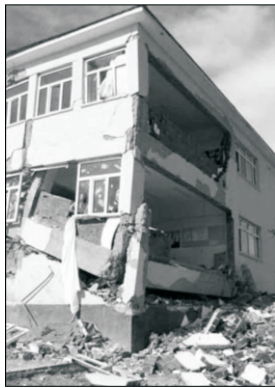
Fig. 13 Another view of collapsed school building. Note Column failure near beam joint.

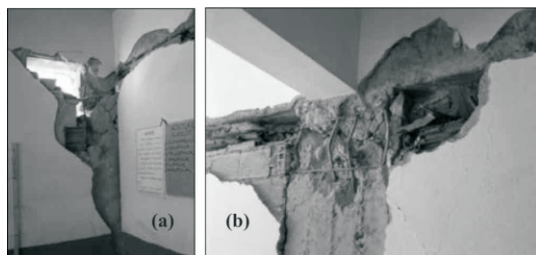
Fig. 14 Typical captive column failures observed in: (a) exterior; (b) interior columns restrained by full-bay masonry infill walls.

The most common failure patterns in interior and exterior columns that were initially restrained by full-bay masonry infill walls are shown in Fig. 14. These failure patterns indicate that captive column conditions can develop dynamically in columns restrained by full-bay masonry infill walls. Infill walls in contact with a column could cause formation of captive column conditions in directions orthogonal to their longitudinal axes. Figure 15 shows the state of a captive column in a three-story reinforced concrete moment-resisting frame template school building in Bingol after the 2003 earthquake. The crack patterns indicate that the infill walls constrained the columns in the direction perpendicular to the walls causing shear failure in the columns.

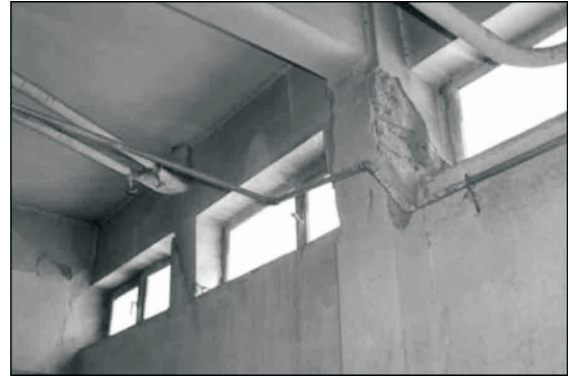
Fig. 15 Captive Column condition due to adjacent infill walls providing sufficient restraint in their out of plane direction.

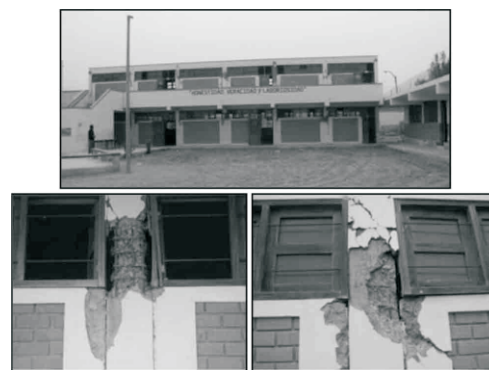
Fig. 18 Template school building designed according to 1977 code after 2001 Atico earthquake: (lower left) ground story column; (lower right) second story column

Figure 18 depicts a two-story reinforced concrete template school building in the coastal area of the Arequipa region. This building was designed according to the 1977 Peruvian seismic code where the

infill wall assemblies were not separated from the columns sufficiently. The architectural infill wall assemblies restrained the columns inappropriately and caused them to fail due to the resulting captive column condition.

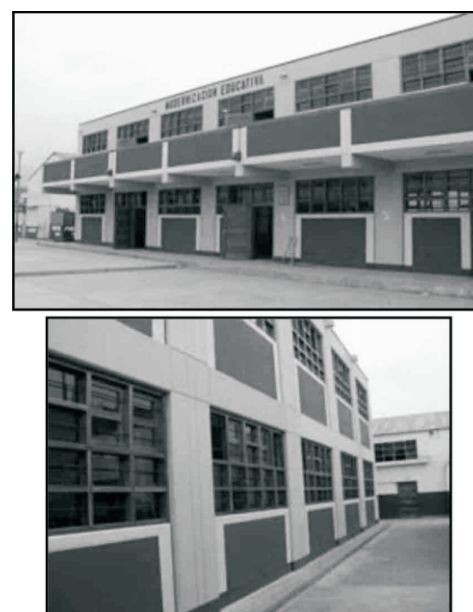
Fig. 19 Front and back views of reinforced concrete template school building built in accordance with 1997 Peruvian seismic code seen after June 23, 2001 Atico, Peru earthquake. School is located in Arequipa region. Structural and nonstructural elements sustained no damage.

In contrast school buildings built following the 1997 code that were shaken in the region during the 2001 Atico earthquakes sustained no damage in their structural or non-structural elements. Fig. (19) shows the front and back from the school buildings in the Arequipa region, designed and constructed by the 1997 code. A view of the elastomeric material filled 2.5 cm gap region from this school building can be seen in Fig. 17. None of the template school building designed and constructed per the 1997 code sustained any structural or non-structural damage during the 2001 Atico earthquake.
