EARTHQUAKE HAZARD CENTRE NEWSLETTER

Vol.18 No.1

JULY 2014

Virtual Site Visit No. 37: Seismic separation of masonry walls

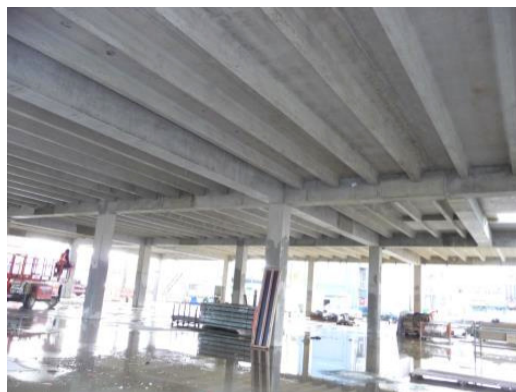
Fig. 1 The ground floor reinforced concrete structure consisting of two-way moment frames supporting precast concrete flooring.

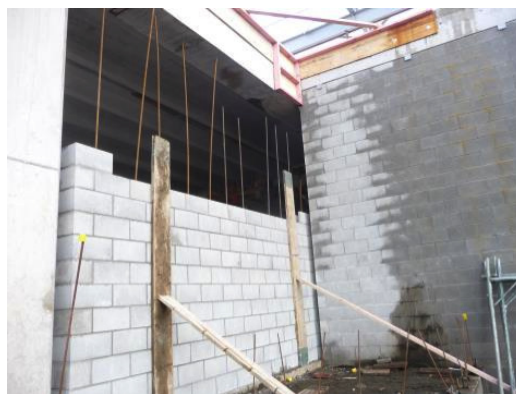
Figure 2 shows two partition walls, one under construction. Vertical separation gaps at each end of the partially-built wall are visible. With these gaps the frame can move towards the wall without hitting it. Note that the walls are not connected to the concrete structure above except by small welded steel plates. These plates allow the floor structure to move freely above the wall in the direction of its length, but they support the wall against face-loads, preventing collapse.

Fig. 2 A non-structural reinforced concrete masonry wall under construction. Vertical seismic separation joints are provided at each end of the wall.

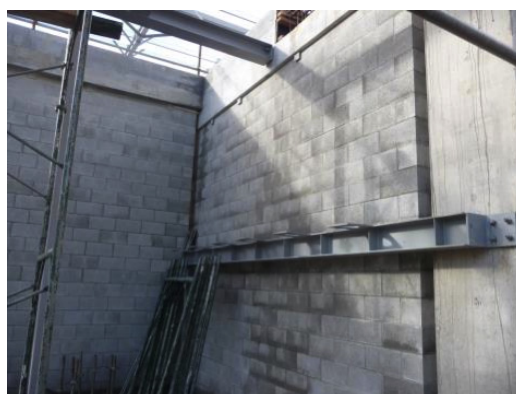
The steel plates are seen more clearly in Figure 3. The horizontal separation gap between the top of the wall and the concrete beam above will be filled with soft material, like fire-resistant sealant. Note the steel beam half-way up the wall. This will support stairs and the stair landing. Since it is bolted with four bolts to the right-hand column, it is essential that any bolts into the wall it runs along must pass through elongated holes. Relative movement between column and wall must not be prevented. If elongated holes are not used, then any sway of the column will shear off the bolts and the stairs will collapse.

Fig. 3 The wall is separated from the adjacent column. The connection between the steel beam and the wall at the left-hand end of the beam needs to allow for relative movement between column and wall.

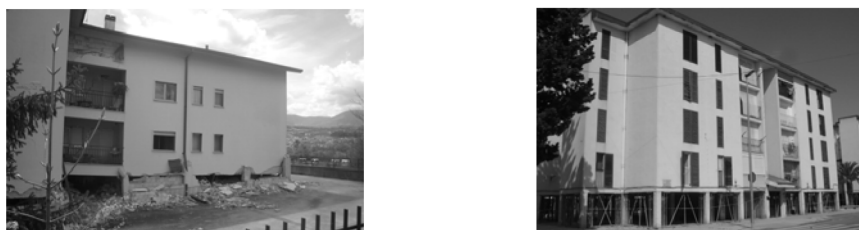
Fig. 6: Two recent examples of severe damage attributed to the soft first story irregularity in L'Aquila earthquake, Italy in 2009, (Photos, left: Holly Razzano, Degenkolb) and in Lorca, Spain in 2011.

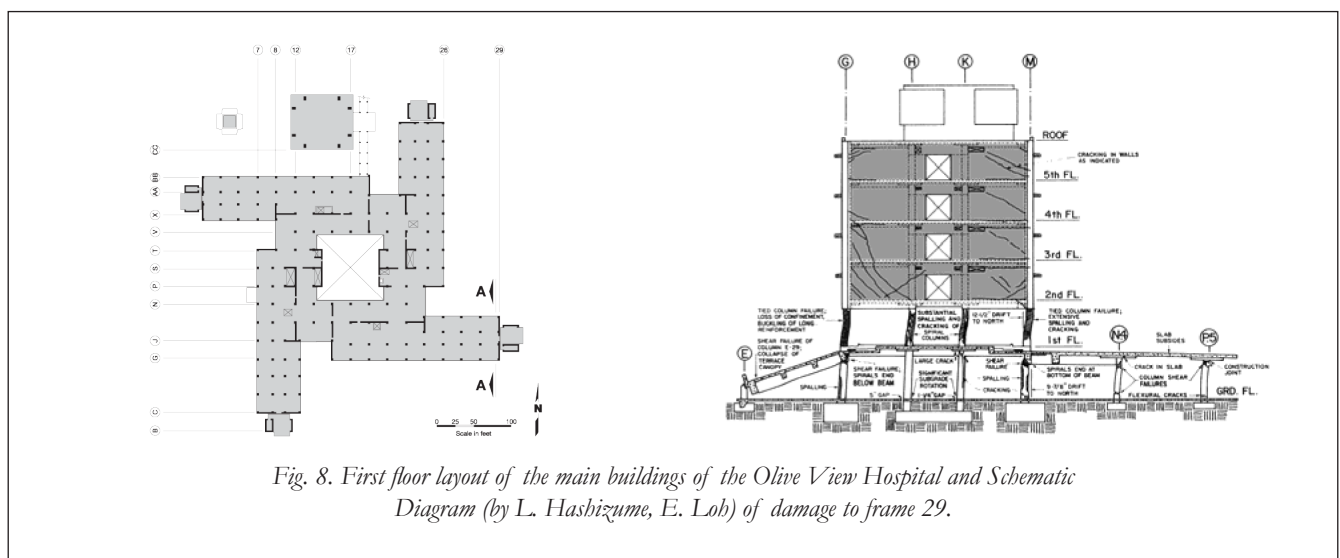
the 1971 San Fernando, California earthquake consisted of four blocks joined around a courtyard, as shown at the structural layout in Figure 8. Each block had six floors and a penthouse. Bertero (1978) describes: "The structural system has significant discontinuities. While the upper four stories consisted of shear walls combined with moment-resisting space frames, the lower two stories had only a moment-resisting space frame system. The floor system consisted primarily of a flat slab-column system with drop panels at the columns. Tied and spirally reinforced concrete columns were used. The shape and reinforcement of these columns differed from story to story." The large interstory drift in the main Treatment and Care Unit, which induced significant non-structural and structural damage and which led to the demolition of the building, was a consequence of the formation of a soft story at the first story level because on the lower floors there were columns, while there were reinforced concrete walls above the second floor level. See Figure 8.

Fig. 8. First floor layout of the main buildings of the Olive View Hospital and Schematic Diagram (by L. Hashizume, E. Loh) of damage to frame 29.

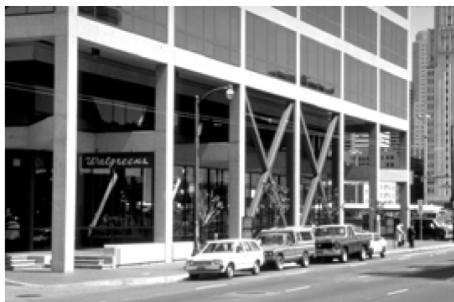
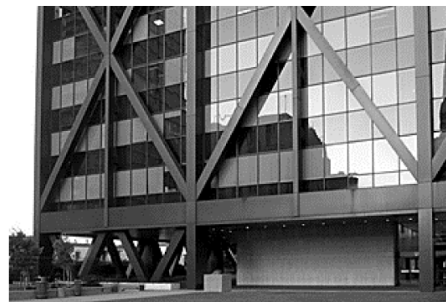
Fig. 9. Left: building in San Francisco (Photo: V. V. Bertero); right: former Alcoa Bldg. in San Francisco.

In 2010 Mayor Gavin Newsom of San Francisco proposed seismic mandates for retrofitting buildings with soft story buildings in the city. (See <http://www.spur.org/book/export/html/1955> and ATC-52-3 Report in http://www.sfcapss.org/PDFs/CAPSS_522.pdf) Figure 9 illustrates some examples of methods that have been used in San Francisco for retrofitting buildings with first floor soft

story. A multistory building that has been retrofitted by adding steel diagonal braces in two of the first story bays; and the recent retrofitting of former Alcoa Building are shown.
