# EARTHQUAKE HAZARD CENTRE NEWSLETTER

Vol.18 No.3

## Virtual Site Visit No. 39. Seismic retrofitting by infilling RC frames, low-rise building, Wellington.

# A Summary of “Seismic retrofitting of non-engineered masonry in rural Nepal,” by Joshua Macabuag, Ramesh Guragain and Subhamoy Bhattacharya. From *Structures and Buildings* Vol. 165, Issue SB6, 2012.

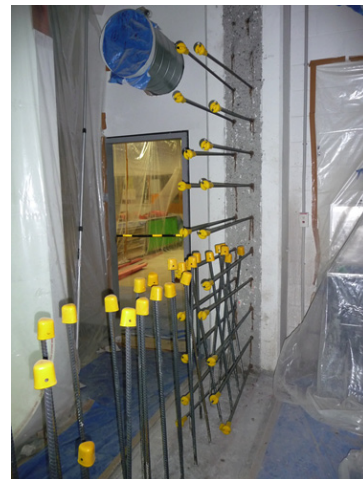
*Figure 1. Horizontal and vertical reinforcing starter bars have been grouted into the existing beams and columns of the moment frame.*

Each new wall is formed by infilling existing RC column and beam frames with 300 mm thick RC walls. The first step is to roughen the surfaces of the columns and beams. This enables horizontal and vertical shear forces to be transferred between infills and their surrounding frame members. Then begins the drilling and grouting of horizontal and vertical starter bars (Fig. 1). In this project 16 mm diameter Grade 500 bars are epoxy grouted 350 mm into the existing members. If no reinforcing steel is encountered one hole takes about two minutes to drill. Otherwise it takes longer as a new hole is drilled nearby.

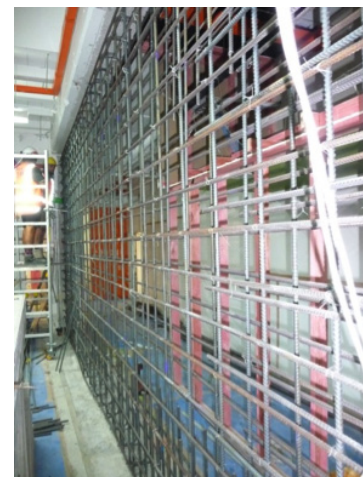
*Figure 2. A completed reinforcing cage ready to be enclosed by formwork prior to casting the concrete.*

Once all the starters have been grouted, horizontal and vertical shear reinforcing is placed and tied (Fig. 2). The bar spacing is determined by the amount of shear force the new wall will resist. Note that the bending moments on the walls are resisted by compression and tension axial forces in the existing columns. Their ability to resist these forces was confirmed during the design process. The columns can be considered as flanges to the infills which themselves can be thought of as webs of the structural walls.

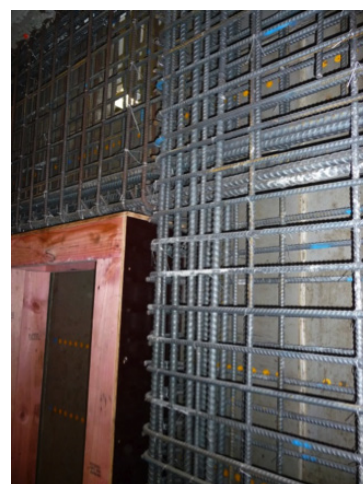
*Figure 3. Additional reinforcing steel is required to trim openings and to ensure adequate force paths within the infill.*

Door openings are necessary in some infills. In these areas additional reinforcing steel is required to ensure adequate force paths (Fig. 3). Horizontal drag bars ensure similar levels of shear stress on each side of the opening, and vertical steel trimming the opening resists secondary bending moments generated by the presence of the opening.

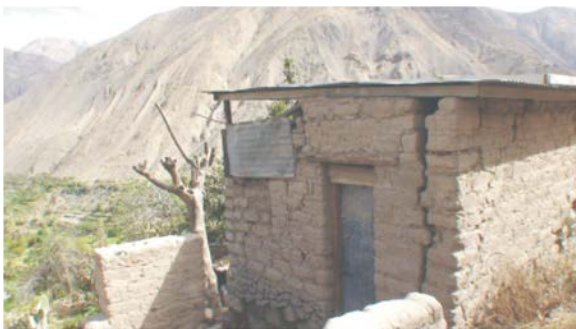
*Figure 4. Non-engineered adobe house in Peru showing vertical crack and separation of orthogonal walls owing to out-of plane forces*

Nearly 75% of all earthquake fatalities in the last century have resulted from building failures with a growing disparity between vulnerability of those in developing and developed countries. The greatest risk is by far presented to inhabitants of non-engineered masonry structures (Fig. 4) as demonstrated in the 2003 Bam (Iran) earthquake, where many of the thousands of deaths were attributable to vulnerable adobe (mud brick) structures. Similarly vulnerable, non-engineered masonry is widespread throughout the developing world and replacement of all such dwellings is both infeasible and undesirable, given that they are often the embodiment of local culture and

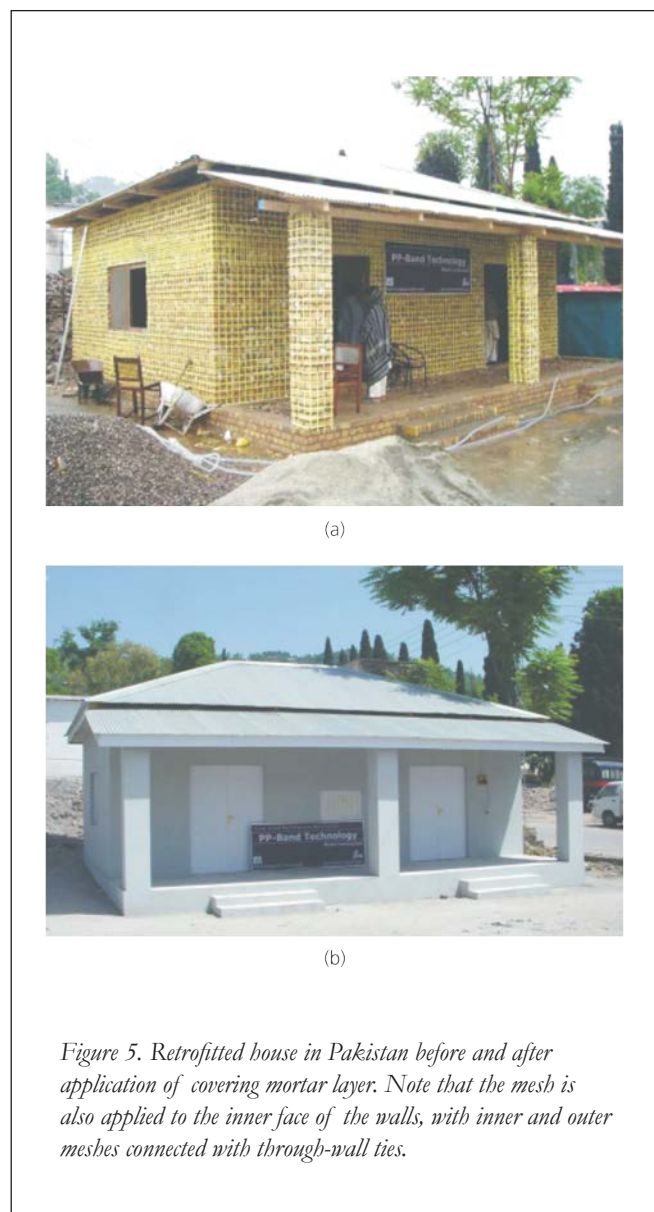
protecting the mesh from sunlight, improving fixity to the wall and making the retrofit invisible (Fig. 5).

and readily available, while the retrofitting technique is simple and suitable for local builders. PP meshing has had application in Nepal, Pakistan and Kathmandu. Fig. 5 shows a retrofitted house in Pakistan following the 2005 earthquake.

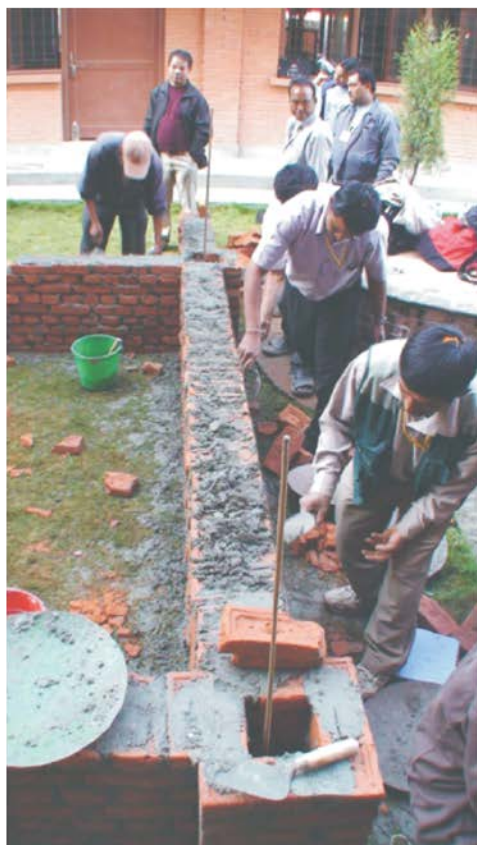
(a)

Figure 6(a) shows a load bearing masonry wall with buttressing and vertical reinforcement and with the masons preparing to add horizontal reinforcement at corners and orthogonal walls. Fig. 6(b) shows often-omitted details for local RC frames such as a double-cage for the column with a link within the beam/column joint and the beam rebar being completely contained within the column rebar and continuous through the joint.

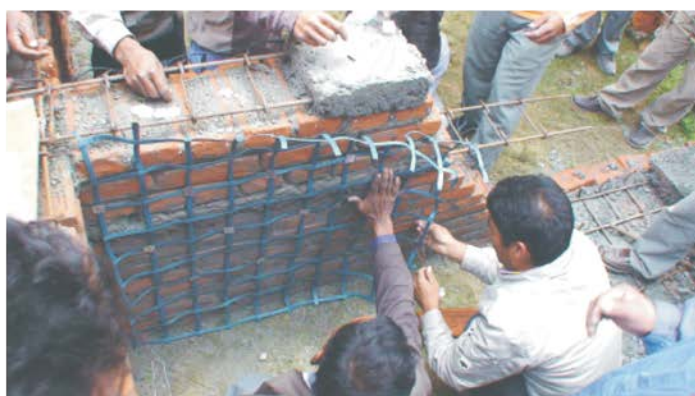
(c)

Fig. 6(c) shows a simplified introduction to applying the PP mesh to a masonry wall. Note that the PP mesh would not usually be applied in conjunction with internal reinforcement but was applied to the reinforced masonry model purely as a simple tool for demonstrating the basics of applying the mesh. During the course it was stressed that PP retrofitting is intended for use with

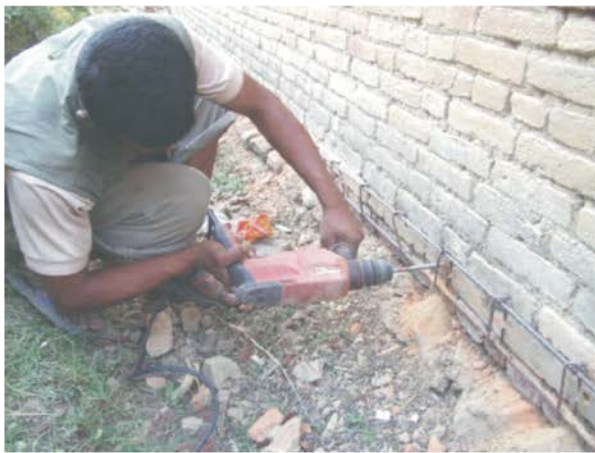
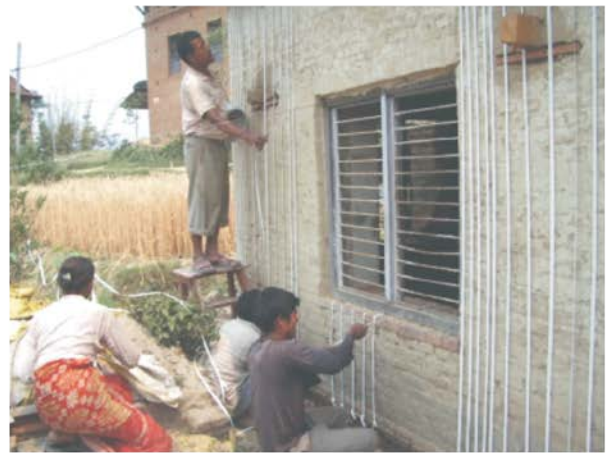
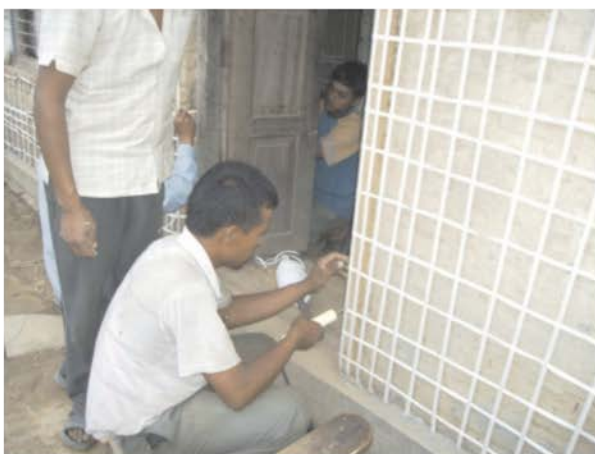
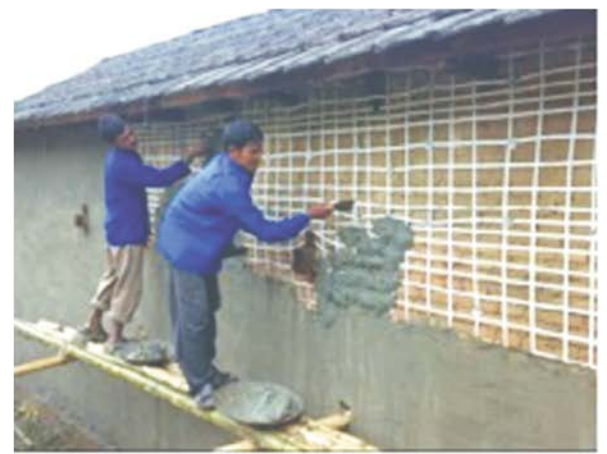
Figure 7. Retrofit of a real adobe dwelling, Nangkhel, Nepal 2009.

The general process of the retrofit can be seen in Fig. 7. An anchor beam was first fixed to the base of the wall inside and out; vertical PP bands were fixed between the internal and external base anchor beams; horizontal bands were then woven between and welded to the vertical bands; meshes on opposite faces of each wall were

connected to each other through the wall by steel wires passing through drilled holes; finally a render was applied to cover the mesh. Note that this house also required additional refurbishment work in replacing rotten floor and roof beams and infilling unnecessary openings.

adobe where holes can be drilled through bricks as well as mortar, allowing more accurate spacing of through-wall connectors, giving a tighter mesh. The real retrofit is also continued and overlapped around corners and through openings and connected to the foundations and ring-beam (Fig. 7, see below).

The retrofitting procedure differed from that used previously in that rather than preparing the mesh off-site and fixing to the wall, the mesh was formed directly onto the wall (Figs. 7(b) and (c)). This change was proposed by the masons themselves to improve buildability and it was suggested that in this way, it might no longer be necessary to connect the bands using the plastic welder for future projects (previously the most expensive part of the retrofit technique). This suggestion requires further investigation.
