EARTHQUAKE HAZARD CENTRE NEWSLETTER

Vol.17 No.4

Virtual Site Visit No. 36: Foundations for a ten storey apartment building

Summary of the paper “Overview of Seismic Strengthening Interventions in School Buildings in Portugal”

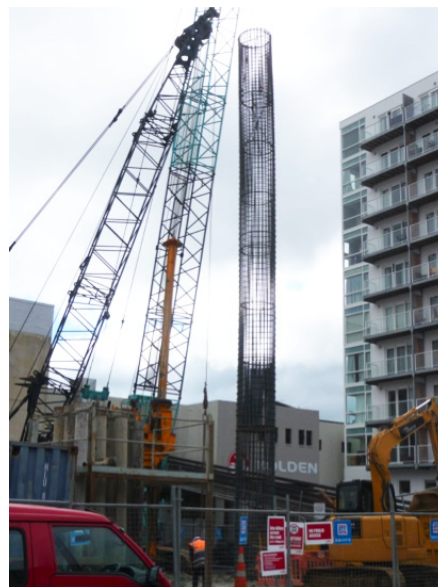
Fig. 1 A pile reinforcing cage with its welded spiral hoops to confine the concrete.

During the foundation construction process the presence of surface soft soils meant using cast-in place RC piles down to firm bearing. This was found at a depth of approximately 15 m. Figure 1 shows a typical pile reinforcing cage about to be lowered into the drilled shaft.

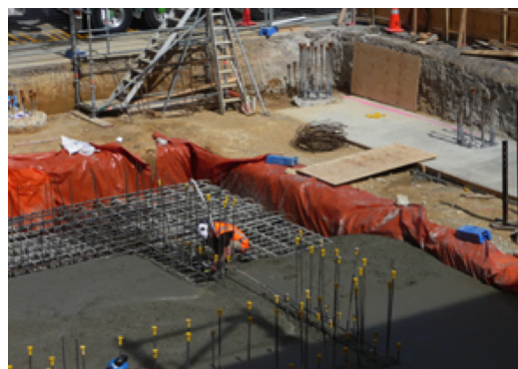
Fig. 2 The deep foundation beams under and outside the core, and perimeter pile reinforcing in the background.

As usual, the pile layout was determined by the structural configuration of the superstructure. In this case the structure consists of a centrally-placed RC core with perimeter steel frames. The front and rear frames parallel to the street frontage are designed for gravity loads, but on the ends of the building the frames are so much larger. They will resist gravity forces from suspended floors spanning between the core and frames, and as well, assist the core withstand wind and seismic forces. The other important function of these two perimeter frames is to increase the torsional stability of the building. The large distance between them, approximately the length of the building, means they will work together to provide torsional restraint. The core, due to its short plan dimensions and door openings that reduce its strength and stiffness, needs help against torsional moments acting in plan.

The structural layout can be seen in Figure 2, while Figure 3 shows the deep beams in the vicinity of the RC core being concreted. These beams are designed to distribute the axial, bending and shear forces from the core into the piles which have been placed outside the core so as to reduce the forces the piles need to resist.

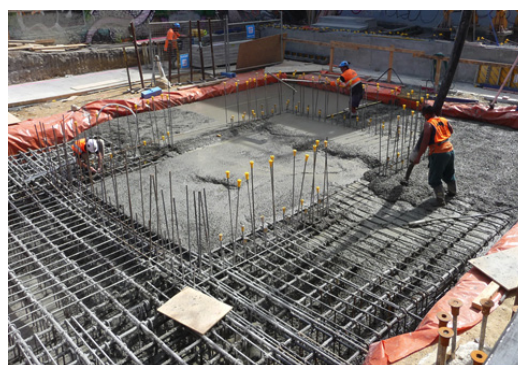
Fig. 3 Concreting of the foundation beams/raft under the structural core walls.

The placement of the core walls can be seen from the positions of the vertical starter bars that protrude above the slab surface. These bars will lap with other vertical reinforcement to resist the bending moments from wind and seismic loads. Shear forces in the wall will be resisted by layers of horizontal bars that are yet to be placed.

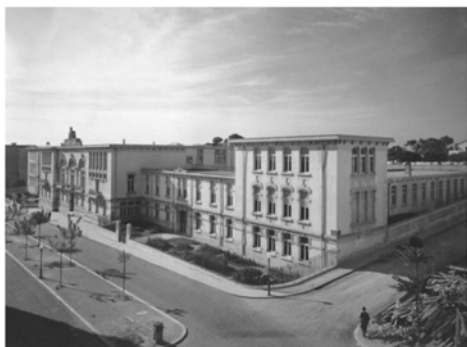
Fig. 4: Maria Amália V. De Carvalho

of Lycée (Fig. 4). The spatial configuration is varied, although dominated by those extending partially or fully occupying the perimeter of the city block, defining one or more open courts. These schools are now considered buildings of acknowledged heritage and symbolic value.

On the whole, the structures of these buildings consist of outer and interior walls made of stone masonry and solid brick, which support the floors. Stone masonry exterior walls are usually very robust and may be 1.10 thick at their foundations and varying between 0.80-0.90m and 0.60-0.70m higher up. Interior walls, mostly made of brick masonry, are less robust and are rarely any thicker than 0.30-0.40m. The construction of this group of buildings coincides with the first applications of reinforced concrete and structural steel in schools, comparatively new materials in the building industry.

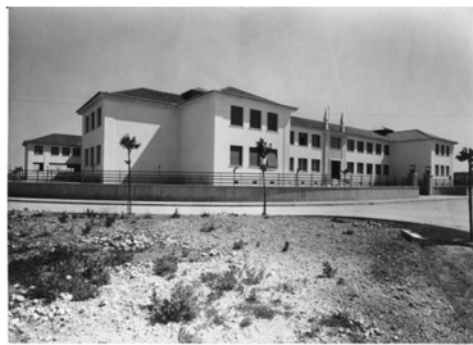
Fig. 5: Sá da Bandeira Lyceum, Santarém

During the 1930s and 1940s a new surge of secondary schools was built, initially adopting modernist architecture models and, later on, in the 1940s, progressing towards a more traditional architectural language (pitched roofs, decorative masonry in the main façades, etc) (Fig. 5).

The structure of these buildings can be considered robust and mostly consists of load bearing walls of stone masonry (the exterior ones being at least 0.60m thick), ceramic brick or concrete block masonry (the interior ones are only 0.25 to 0.30 m thick), which support reinforced concrete slabs (as a rule voided, ribbed and reinforced in one direction) and reinforced concrete beams. The stairs are also of reinforced concrete, but solid. In areas where an open space is required, generally the entrance lobby and covered play areas, there are usually reinforced concrete substructures consisting of grids of reinforced concrete beams (main and secondary), which, supported on columns, support the overlying floor. Load bearing masonry walls that support the slabs of the upper floors and the roof slab are often built over these reinforced concrete main beams. The roofs of these buildings are tiled, using wooden structures as support. Where there is a roof slab (nearly always with reinforced concrete inverted beams) these structures are directly supported on the slab (or on the beams). In the absence of a roof slab, the roof usually consists of steel or wood trusses supported on the exterior walls of the building.

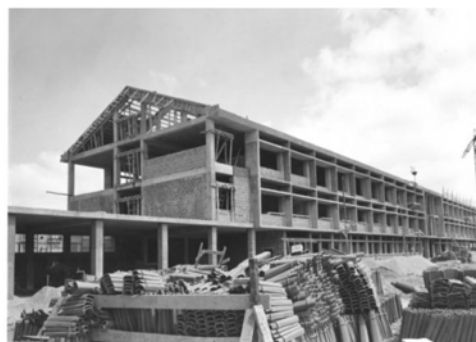
Fig. 6: Rainha D. Leonor Lyceum

The 1st Standard Design was developed based on a linear configuration of the main building with several aggregated bodies (separated by expansion joints) and a “central corridor” layout (Fig. 6). The blocks that constitute the main building have a longitudinal development from three to seven bays, and are separated by 2cm wide expansion joints. In most cases the main building is elevated two floors, with roof slabs and sloping roofs. The main building presents a reinforced concrete frame structure, with longitudinal façade and corridor frames made of columns and beams which bear the loads associated with the slabs. The floor slabs are voided in the classrooms and solid in the corridors. Longitudinally the structural system considered for seismic action consists of the aforementioned frames, façade and corridor, which were designed for the horizontal forces in this direction (seismic coefficient of 0.10). Transversely the designers planned a more unusual structural system in which the solid corridor slab acts as a horizontal beam, making it possible to gather the transverse inertia forces and route them to the transverse substructures at the end (joint), thus serving as (transverse) supports of this beam. The structure is locked transversely by reinforced concrete diagonals in both lines of classrooms, hence enabling the resultants of the inertia forces to be routed from the floors to the foundation. Leaving aside the thickening of slabs in the classrooms under the respective end walls, the only existing transverse beams are in the joint alignments, in the same plane as the aforementioned diagonals. Considering the current seismic design actions, there is a widespread deficiency of strength in structural elements, as well as the risk of pounding between bodies separated by joints.

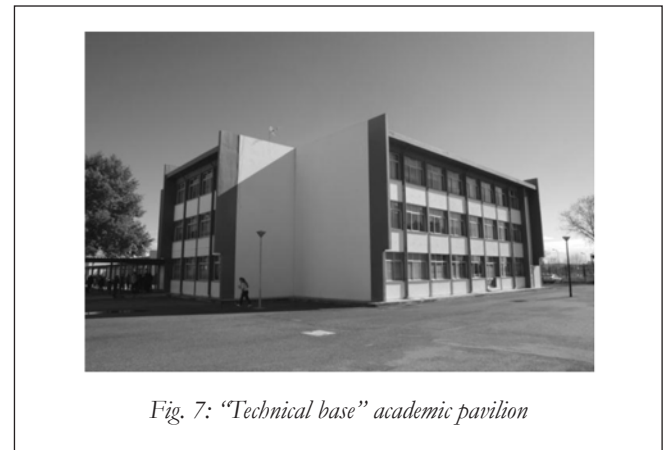
and became steadily more important (Fig. 7). The more numerous academic pavilions, with variable height up to three storeys high, are developed based on a square plan around a central courtyard covered by skylights. Structurally speaking, all the pavilions have a framed structure using a reinforced concrete beam-column-slab system; the slabs are voided in the classroom areas and solid on the stairs and accesses (which are narrow cantilevered balconies).

Fig. 7: “Technical base” academic pavilion

The reinforced concrete frame structure of the classrooms consists of frames in the two directions, with expansion joints separating each of the blocks in four independent buildings. In all buildings inspected, with one or two elevated floors, weaknesses were identified near these joints, resulting from differences in deformability of neighbouring structural elements (slabs and beams). These deficiencies have consequences particularly with respect to the use of the building and its durability. The expansion joints were only 2-3cm wide, which is not enough given the foreseeable amplitude for the vibration of the buildings and may lead to the pounding effect. As expected, the seismic vulnerability assessment studies also pointed out to a general lack of strength (particularly in the

Another of the most common standard designs in this period corresponds to the “technical base” pavilion model. As stated before, the corresponding academic pavilions consisted of four blocks, separated by expansion joints (with increased risk of pounding) in which the structural elements (particularly the most generous columns) presented insufficient strength and inadequate detailing.

One of the most common strengthening solutions comprised the following operations: (1) elimination of expansion joints, stitching these and building a peripheral beam at roof level tying all four blocks; (2) construction of external slender reinforced concrete shear walls in some of the facades, tied to the existing structure and with independent foundations (through micro-piles).
