EARTHQUAKE HAZARD CENTRE NEWSLETTER

Vol. 20 No. 3

JANUARY 2017

Comparative Assessment of Performance of School Buildings in the 2015 Gorkha (Nepal) Earthquakes

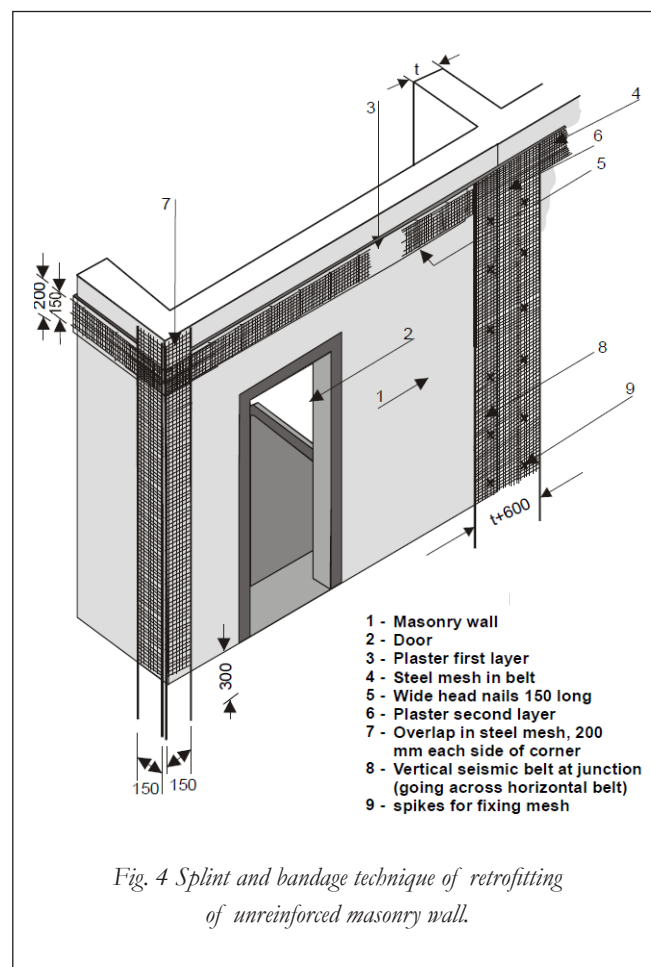
Fig. 4 Splint and bandage technique of retrofitting of unreinforced masonry wall.

Because of the inherent weakness of the URM school buildings and socio-economic condition of the society of the developing country, any strategy of seismic intervention to those buildings should have considered affordability along with safety. That demanded a simple and cost effective seismic upgrade with use of local material avoiding any complex construction system. NSET started seismic upgrade of URM school buildings with selective reinforcement in splint and bandage along with stitching of orthogonal walls. The focus was to enhance the integrity of the building. The connections between orthogonal walls were improved by continuous reinforced micro concrete strips in the corners and T-junctions. The vertical continuous strips, called splints, were provided from foundation to roof level. Similarly horizontal strips, called bandages were provided to run horizontally around all the walls on both side of walls. The splints and bandage were 50 mm thick reinforced micro concrete section applied on bare wall after racking mortar from the brick work joints. The two face of bandages were connected using staggered dowel bars. The bandages were provided at sill and lintel levels. Figure 4 shows a typical construction of splint and bandage.
