# EARTHQUAKE HAZARD CENTRE NEWSLETTER

Vol.15 No.2

November 2011

# **SUMMARY OF “DEVIL IN THE DETAILS: SUCCESS AND FAILURE OF HAITI'S NON-ENGINEERED STRUCTURES” by Lang, A and Marshal, J.**

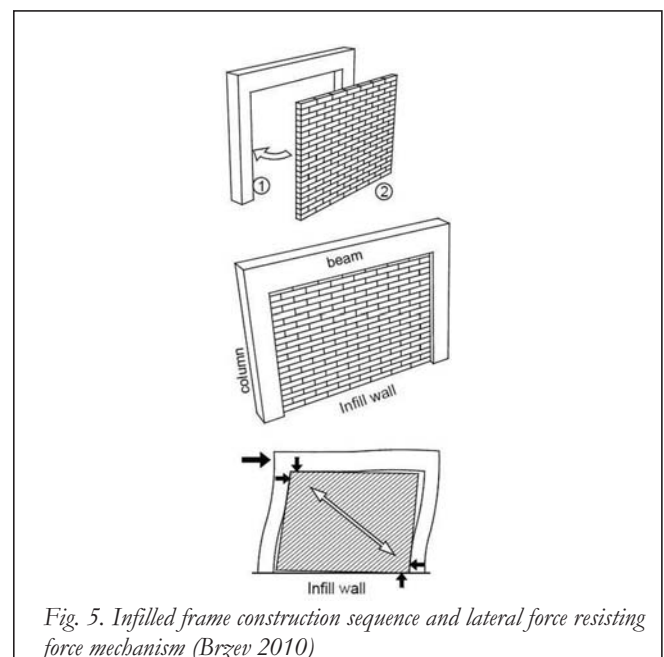
Traditional infilled frame construction consists of reinforced concrete frames with masonry infill walls. The frame elements—columns, beams, and slabs—are poured and finished before masonry is placed. This construction type is identifiable by a clean delineation between masonry walls and columns. Under well engineered circumstances the frame is moment resisting, designed to carry all vertical and lateral forces. The masonry wall panels are normally considered non-structural elements and are not included in capacity analysis, despite well documented evidence of their influence on structural response. Infilled frame construction results in a lateral force resisting mechanism composed of two independent systems: a shearwall and a moment resisting frame. Dissimilar stiffnesses of the two systems commonly results in localized damage to the columns and wall during in-plane action (see Figure 5). Out-of-plane, toppling of the wall panel is common.

Fig. 5. Infilled frame construction sequence and lateral force resisting force mechanism (Brzev 2010)
