EARTHQUAKE HAZARD CENTRE NEWSLETTER

Vol.17 No.2

OCTOBER 2013

A Summary of “Lessons to be Learnt from Seismic Disasters in Algeria”, by M. Chemrouk, from the Proceedings of the 15th World Conference on Earthquake Engineering, Lisbon 2012.

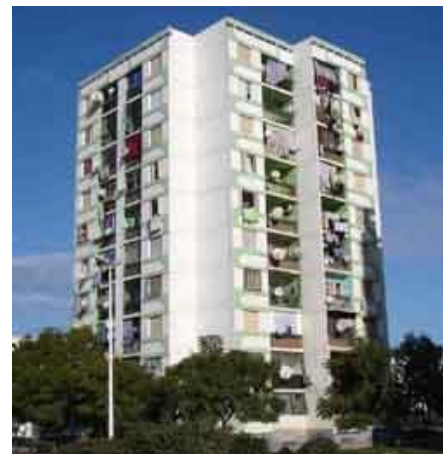
A tight site control and a better workmanship to build correctly and implement the seismic design in practice is, indeed, what is needed to reduce the damaging effects of earthquakes on constructions and hence reduce the seismic risks. Figures 8 and 9 show two types of buildings,

Fig. 8 Example of a building that did not suffer from the earthquake, it was saved by adequate design/detailing and better workmanship.

beam-column concrete frames and shearwalls that have not suffered from any damage despite their location in the epicentral zone. In effect, 63% of the buildings located within the epicentral zone did not suffer from any serious damage at all despite the fact that they were originally designed to resist a lesser ground shaking event. What is certain is that the important number of concrete buildings which did not suffer from the major earthquake of Boumerdes-Algiers in 2003 is in itself prove that it is possible to resist a major seismic event that is not taken into consideration by the seismic regulations provided that the 'building rules' are fully respected and hence the quality of workmanship is adequate; such building rules can be summarized as follows:

- Carry out a site investigation to select an adequate building site and study the bearing soil.
- Follow-up tightly the local seismic guidelines for the architectural conception as well as the structural analysis and design.
- Use the targeted concrete material and ensure a better quality execution and workmanship under the supervision of a tight site control from both the design office and from an independent control body.
- Ensure a regular maintenance and repair work during the service life of the building.

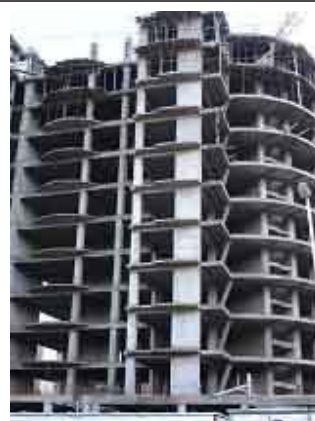
In contrast to beam-column concrete framed buildings, concrete shearwall braced structures behaved well and showed no signs of distress and no collapses at all. This type of stiffer bracing presents the advantage of limiting greatly lateral deformations induced by seismic or other lateral forces. This reduced displacement due to increased lateral stiffness protects any existing concrete columns and non-structural elements such as masonry panels. Moreover, the use of shearwalls reduces the risk of construction defects and weaknesses often created at the beam-column joints and which was found to be the cause of most failures in beam-column concrete framed buildings.

Fig. 9 Buildings with combined shearwalls/ beam-column framed structure under construction at the time of the 2003 earthquake – no sign of distress was shown.
