EARTHQUAKE HAZARD CENTRE NEWSLETTER

Vol.17 No.3

JANUARY 2014

A summary of the Seismic Performance of Confined Masonry Buildings from “Seismic Performance of Engineered Masonry Buildings in the 2010 Maule Earthquake”

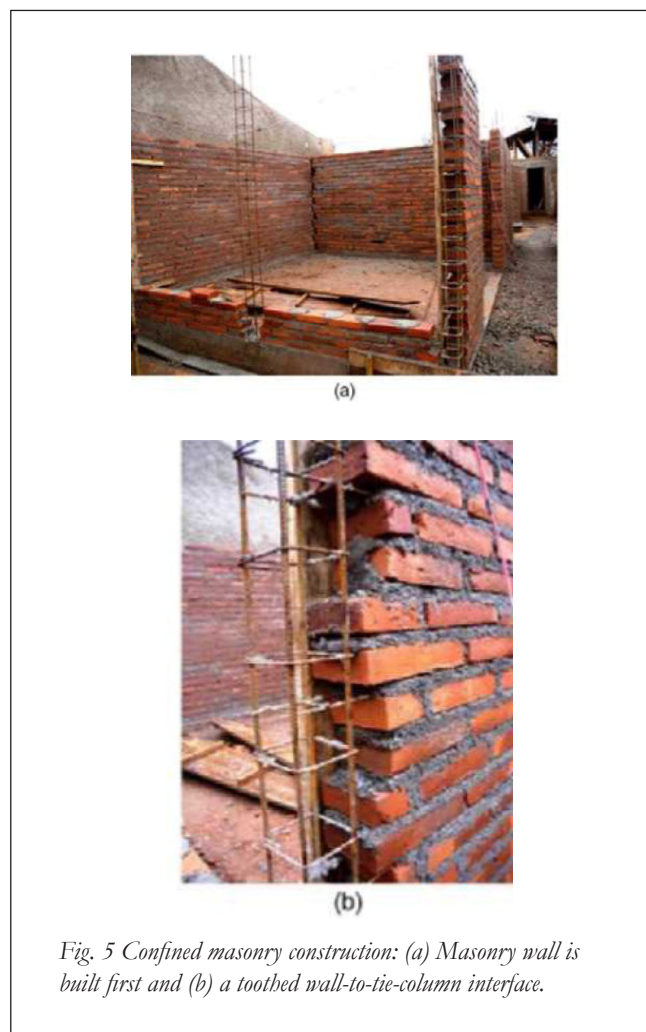
A toothed interface between the walls and the tie-columns is used, as shown in Fig. 5b. Tooothing enhances an interaction between masonry walls and RC confining elements and prevents vertical cracking at the wall ends; this was confirmed during the field visit. The construction sequence, a presence of tooothing, size, and detailing of RC confining members are the key differences between confined masonry and RC frame construction with masonry infill walls, as shown in Fig. 6 (EERI 2011).

Fig. 5 Confined masonry construction: (a) Masonry wall is built first and (b) a toothed wall-to-tie-column interface.
