EARTHQUAKE HAZARD CENTRE NEWSLETTER

JANUARY 2011

EDITORIAL: MASONRY INFILL – A BLESSING OR A CURSE?

Virtual Site Visit No. 23. Apartment building with RC shear walls and steel gravity structure.

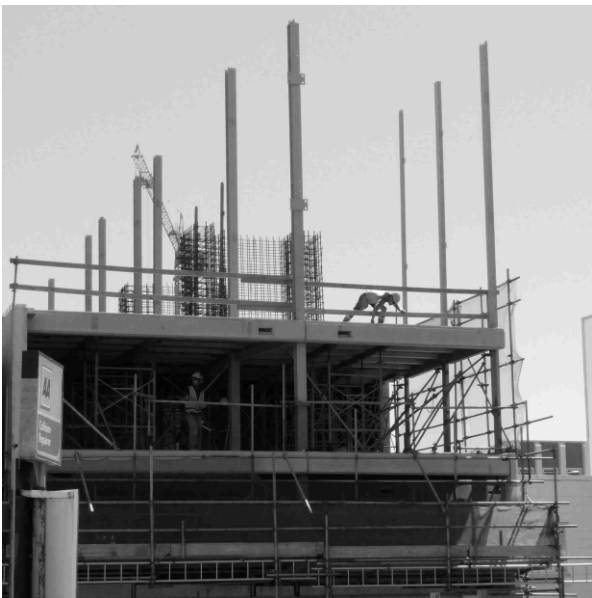
Fig.1. The superstructure under construction with transverse shear wall reinforcement and gravity-only steel columns.

Now the superstructure construction is well under way. In Fig. 1 the transverse load resisting shear wall reinforcement and the slender gravity-only steel columns are visible. Fig. 2 shows the gravity system in more detail. The precast floor planks are seen loading primary steel beams that are pin-jointed to the steel columns. Precast fascia beams that run parallel to the precast ribs carry little load other than their self-weight and the wall cladding to be installed, which is likely to consist of glazing.

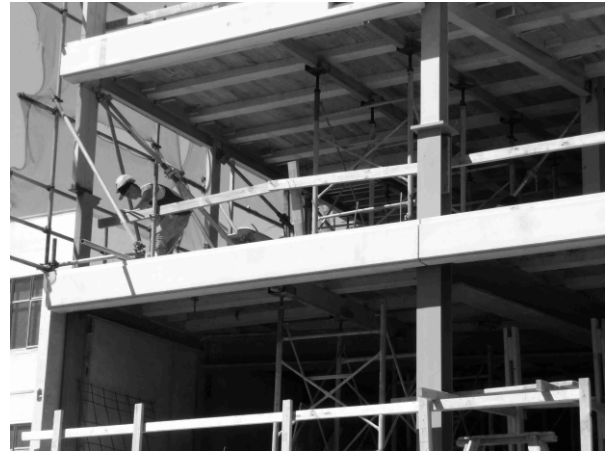
Fig.2. Suspended floors consist of primary steel beams carrying precast concrete planks with timber infills supporting 75 mm RC topping.

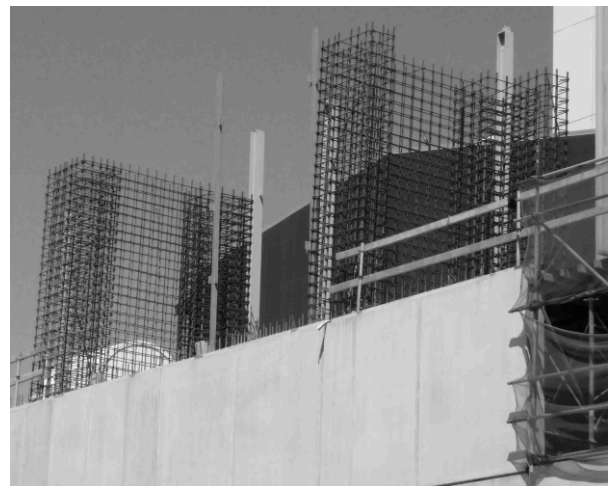
Fig.3. A longitudinal precast panel shear wall with the two transverse shear walls behind.

The reinforcing cages for the two transverse shear walls are seen in Fig. 3. Their large returns, at each end, provide room for the longitudinal steel that resists the wall bending moments and at the same time prevents any possibility of compression buckling of the wall ends under the combination of gravity and bending compression stress. Close horizontal reinforcement spacing will help carry shear forces within the webs of the walls. In the wall returns, flanges or chords, as they are called, the closely-spaced ties will prevent the longitudinal reinforcement from buckling after any cover concrete spalls off during a major quake. Because the walls are designed to be ductile, there is a high likelihood that they will experience seismic overload and need all this horizontal steel.

The longitudinal resisting system is not so obvious but it takes the form of two shear walls along each side of the building. As seen from Fig. 3 these walls are constructed from many precast concrete panels, joined horizontally and vertically. Vertical starter bars, very short by normal standards will be grouted into the panels to be placed above them using high-strength grout. By being strongly connected to each other the panels will act as one very rigid and strong wall along each boundary line. So this building has its seismic resistance provided by shear walls while a pin jointed steel structure provides the primary gravity support.

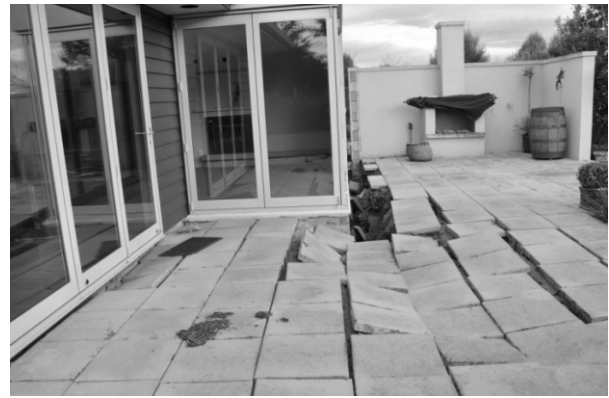
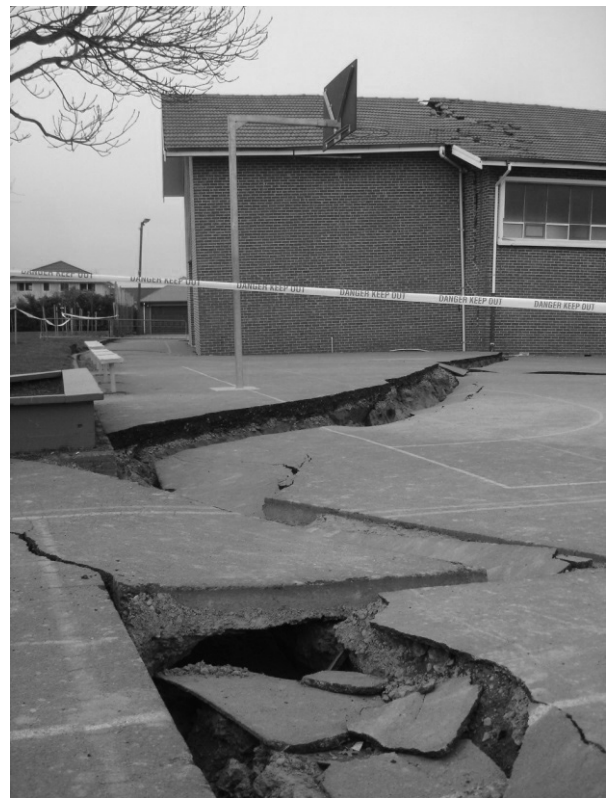
Fig. 6. Structures damaged by lateral spreading and post-liquefaction differential settlement. Above: Residential structure in Spencerville. Below: St. Paul's Church in Dallington.

Liquefaction and lateral spreading were pervasive in portions of Christchurch and neighboring communities (Fig. 6), causing extensive damage to buried utilities (water and wastewater pipelines), residential housing, and other building structures. To a lesser extent, roads, railroad embankments, and levees were also affected. According to a 2004 liquefaction susceptibility study in Christchurch, approximately 50% of Christchurch residential areas are vulnerable to liquefaction (Environment Canterbury, 2004). Between 5% and 10% of residential properties in the Christchurch area were actually affected by liquefaction. By far one of the greatest impacts of this earthquake on the residents in the Canterbury region was the lateral spreading and post-liquefaction differential settlement that damaged numerous residential and other structures (Fig. 7).

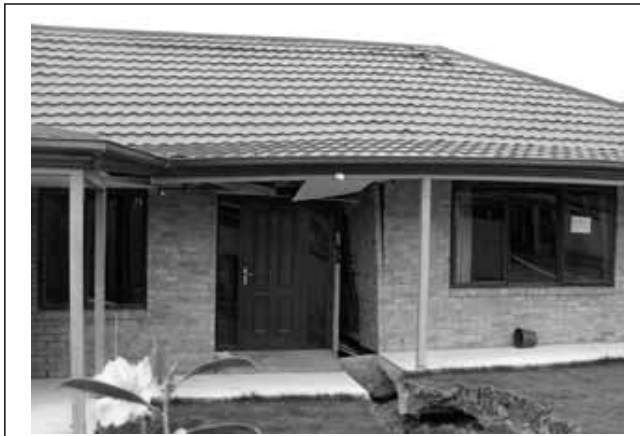
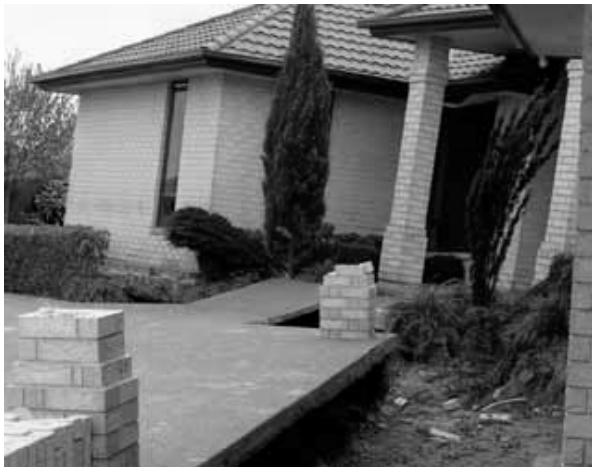
Fig.7. Above: Large lateral spreading like a rupture passed through the foundation near Courtenay Drive in Kaiapoi. Below: This house slid more than 1.2 m and tilted significantly (near Courtenay Drive in Kaiapoi) (photos: Lai).

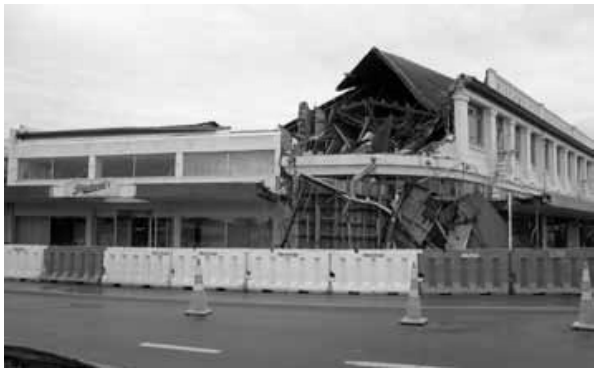
Fig.8. Blackwell's Department Store on William Street in Kaiapoi suffered extensive structural damage (photo: Arendt)
