# EARTHQUAKE HAZARD CENTRE NEWSLETTER

Vol.16 No.4

APRIL 2013

## Virtual Site Visit No. 32: Incorporating a facade into a new building

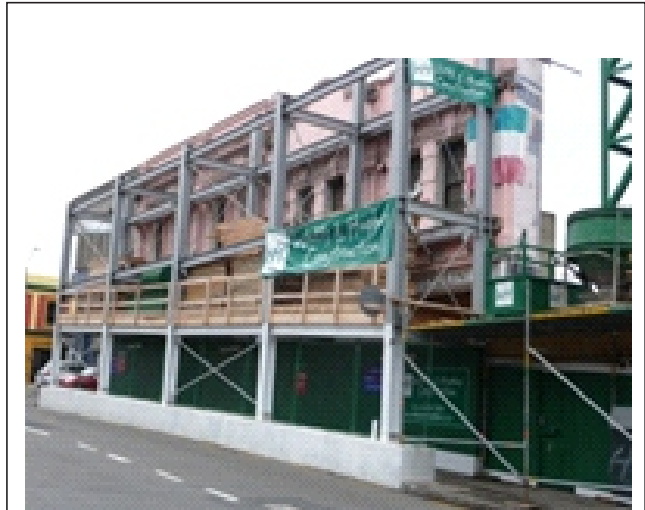
*Fig. 1 Unreinforced masonry facade with its temporary restraining structure.*

Before demolition of the main body of the building is complete, the façade is given temporary support. As shown in Fig. 1, on this site five steel frames protect it and ensure its stability during the construction period. Once demolition is complete, the foundations for the new construction begins and after piles are placed down to firm founding material (about 15 m deep here) and foundation beams poured, work begins on new shear walls (Fig. 2). The vertical and horizontal reinforcement ensure the walls can resist bending moments and shear forces. In this building, shear walls resist lateral loads in both orthogonal directions in plan. This is a sensible decision given that the walls are supporting the brittle masonry façade. If stiff structure like walls didn't limit horizontal deflections in an earthquake the façade would suffer considerable damage.

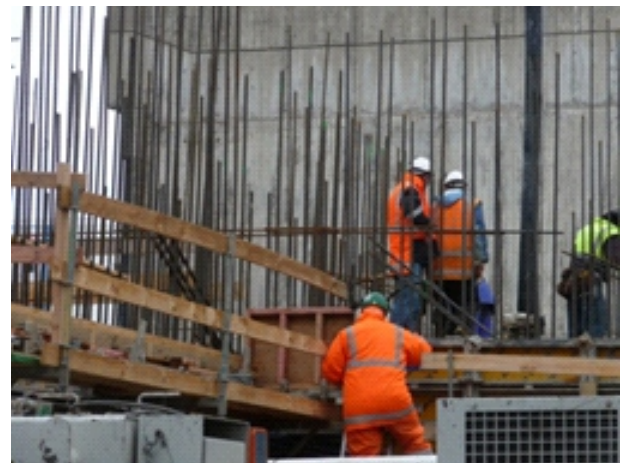
*Fig. 2 Workers fix reinforcing steel for the new RC shear walls.*

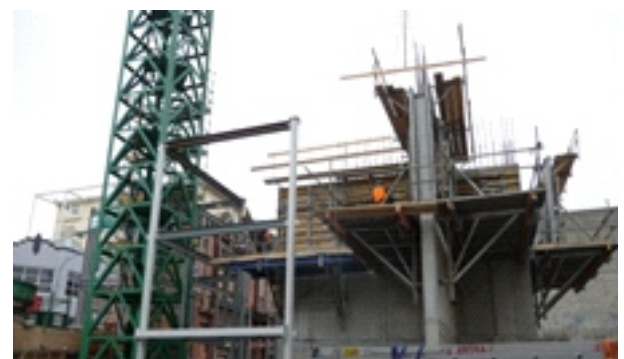
*Fig. 3 New shear walls in each direction with the old facade behind.*

Fig. 3 shows some of the walls, but there are others on two boundary lines that provide additional strength and as well as necessary torsional resistance. In Fig. 3 we can see the brick façade beyond the shear walls. It has been given extra face-load support by vertical steel members fixed behind it, and then each suspended floor will also be firmly attached to it to prevent damage under face-loading. We also observe new steel posts and beams. These members comprise the gravity-only structure to support the new floors, all of which will have their horizontal loads resisted by the shear walls.

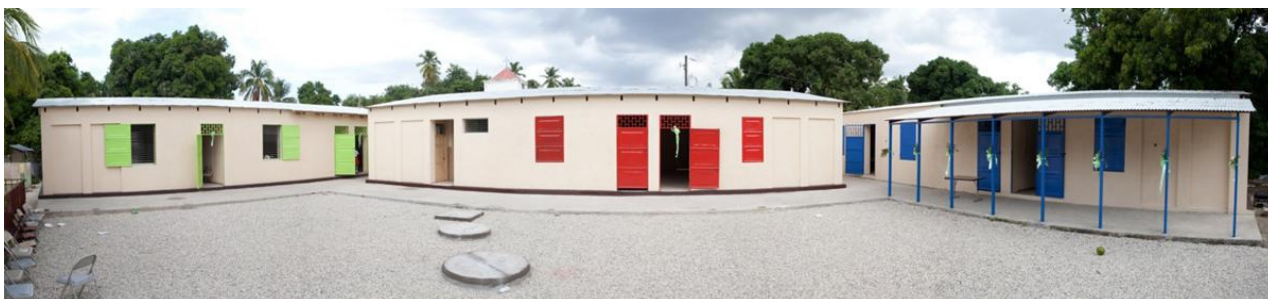
*Fig. 4 St. Matthieu School Concrete Shear wall Prototype.*

Following initial reconnaissance it became clear that the extensive earthquake damage in the Zone extending from Port au Prince west to Leogane and south to Jacmel, presented communities and terrain which ranged from reasonably flat and accessible by road to extremely rugged terrain only accessible by foot. To respond to both of these conditions, the four firms designed two structural prototypes concepts for new schools. A heavyweight structure (Figs 4,6,7) incorporating reinforced concrete columns, beams, and shear walls with rubble masonry infill walls, was designed for areas accessible by road (e.g., St. Matthieu School in Leogane). Also, an alternative, lightweight structure was designed (Fig. 5) for rural areas where there is no road access and building materials must be transported on foot. The lightweight structure relies on timber stud wall construction with plywood shear walls (e.g., St. Joseph School).

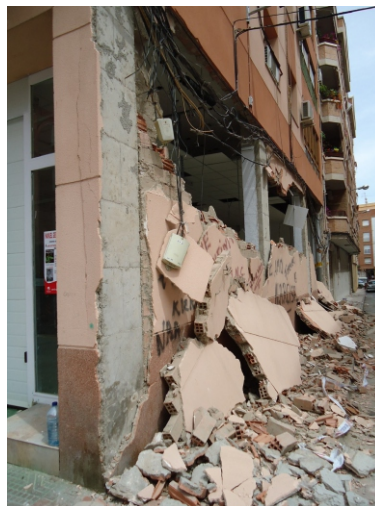
*Fig. 9 Damaged masonry infill walls at ground floor.*

On lower floors the failure of masonry infill panels was caused by excessive in plane loads, displacements of the frame structure (see Fig. 9) and in some cases by pounding of adjacent buildings. The interstory height at ground floor level is usually higher than that of the upper floors as the ground floors are usually occupied by shops. In these cases both the stiffness of the framing structure and that of the masonry infill are comparable and the resistance of
