EARTHQUAKE HAZARD CENTRE NEWSLETTER

Vol.19 No.2

Virtual Site Visit No. 40. Precast concrete panelled and steel framed apartment building

A Summary of “Safer Schools, Resilient Communities: A Comparative Assessment of School Safety after the 2015 Nepal Earthquakes”

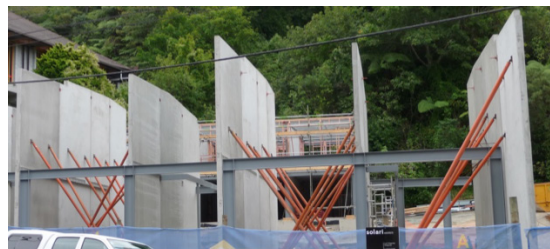
Figure 1. Overview of apartment building under construction

This building under construction is located on the outskirts of Wellington's CBD. As can be seen from Figure 1, the structure consists of precast concrete tilt-up panels combined with steel moment frames. The majority of the gravity loads will be resisted by the precast walls, and they will be more than adequate for resisting transverse earthquake forces. That is, they will be very strong and stiff against forces acting across the width of the building. However, when longitudinal seismic loads occur, these panels are extremely vulnerable given their height and thinness. They require stabilizing. To achieve this, the designers have introduced two perimeter steel moment frames, one at the front, and the other at the rear of the building. These two frames resist all longitudinal loads. You can observe that, because they are only one storey high, the walls are designed to cantilever above the first floor level. This is feasible as the roof and all wall framing above first floor is of lightweight construction.

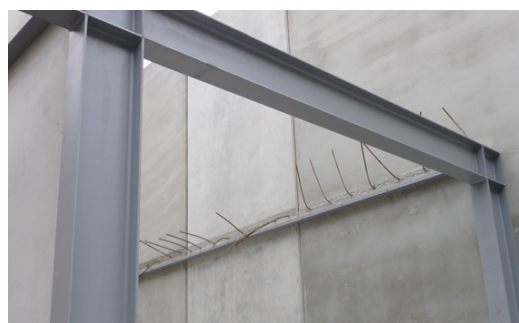
Figure 2. Steel frame and panel to suspended floor connection detail.

To ensure that longitudinal seismic forces can travel from the wall panels into the frames it is important that the first floor slab is strongly attached to the panels (Figure 2). The starter bars protruding from the panels will be bent horizontal and lapped with the first floor reinforcing that is placed over the precast floor slabs yet to be craned into place. A strong connection is also required between that floor slab and the beams of the moment frames. Now an effective force path exists between walls and frames. Figure 2 also shows a steel angle bolted along the sides of the wall panels. This member supports the ends of the precast floor units and transfers their gravity forces into the walls.

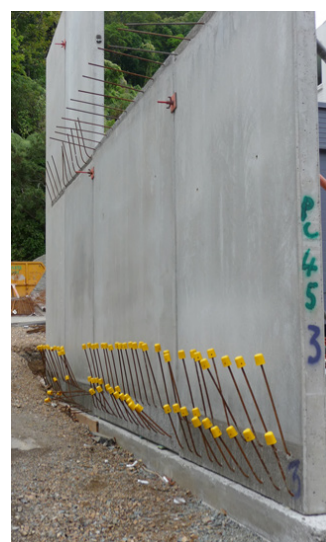
Figure 3. Reinforcement at the base of a precast panel to tie it into the floor slab.

The bottoms of the wall panels need to be tied to the ground floor slab which may also help transfer gravity forces from the walls into the underlying foundation material. Figure 3 shows the starters that will be bent horizontal and lapped with the main ground floor slab reinforcing.

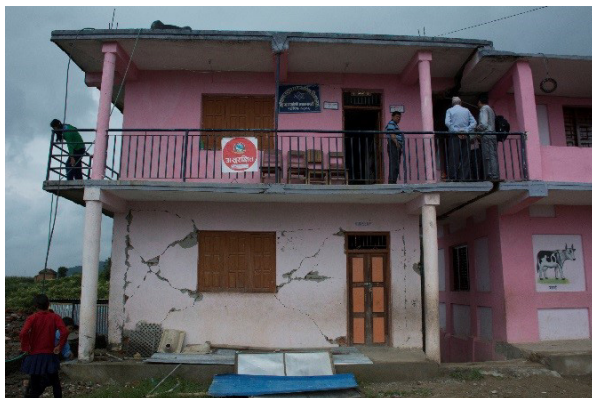
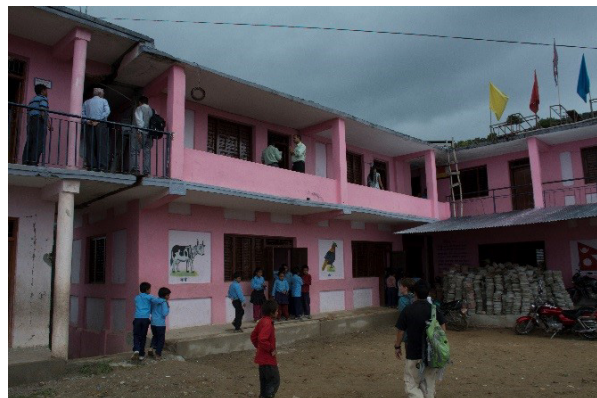
Figure 4. At a school in Kathmandu, two school buildings on the same sight performed very differently. The building on the left, a reinforced concrete frame structure with brick infill walls, was moderately damaged and received a red tag. Its frame joints and infill walls will need to be repaired before the building can be reused for classrooms. The building on the right, an adobe and stone masonry structure, was recently retrofitted with stitch banding. It was undamaged and immediately able to be reopened, despite being made of a weaker building material. The retrofit proved to be successful.

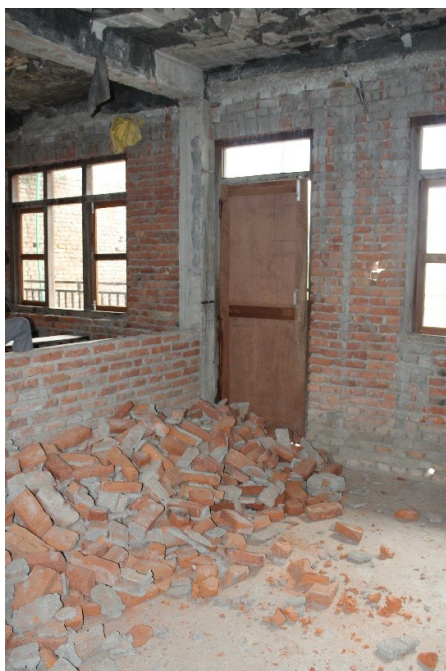
Figure 5. School building 101-1, which experienced only moderate shaking in Bhaktapur, was deemed unsafe for school use because unreinforced partition walls separated from the reinforced concrete frame and became unstable. Damage to unreinforced partition or infill walls can injure or kill students and block exits. The safety of these walls is routinely ignored by engineers and communities alike.

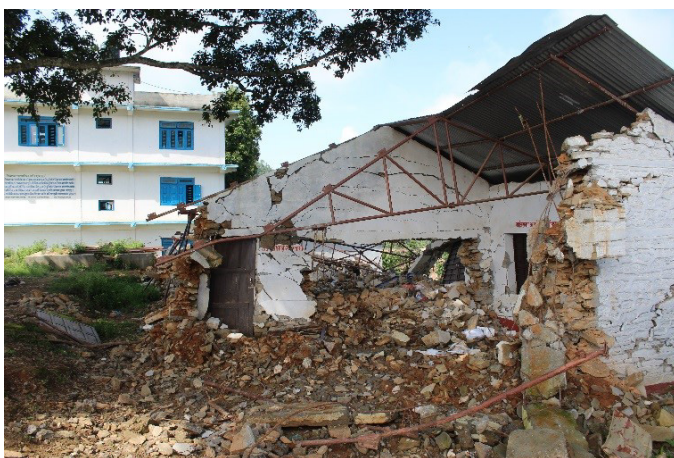
Figure 6. This teaching resource centre on school grounds was built with stone and mud mortar. The masons employed earthquake-safety measures, such as a reinforced concrete lintel band and vertical reinforcement in the walls. However, even with these measures, the heavy shaking in Sindhupalchowk caused the stone building to collapse swiftly and completely. It may be difficult to rebuild safe schools out of this brittle material unless alternative technologies are developed, tested and extensive mason training and strict oversight are feasible during construction.
